UNDERWATER BRIDGE INSPECTION REPORT

STRUCTURE NO. 83001

WATONWAN RIVER

JOB NO. 2107

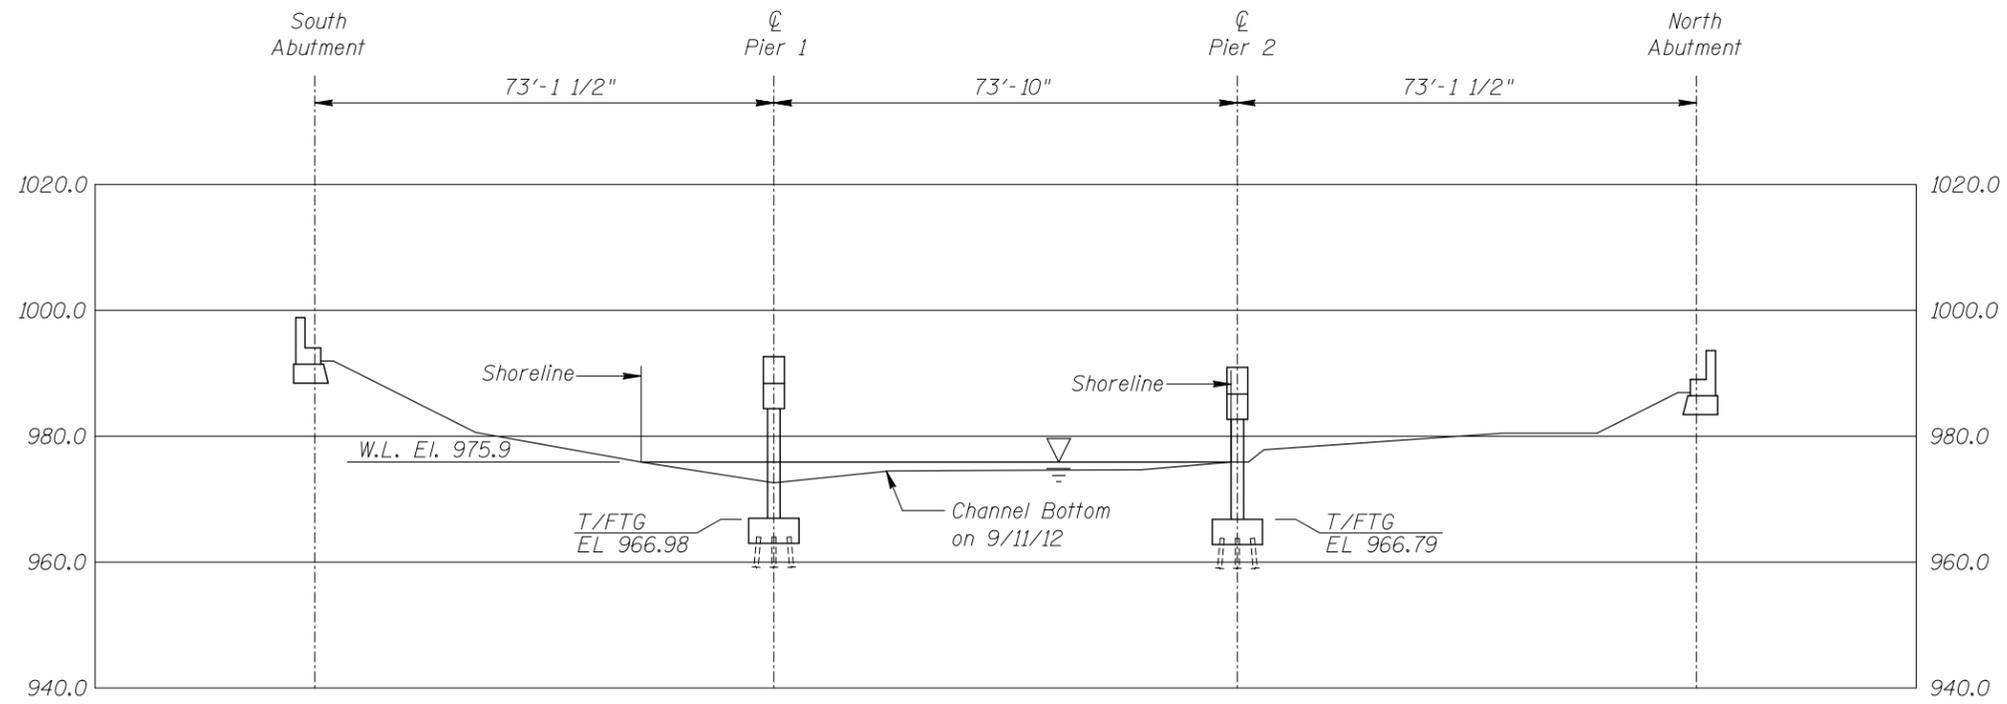
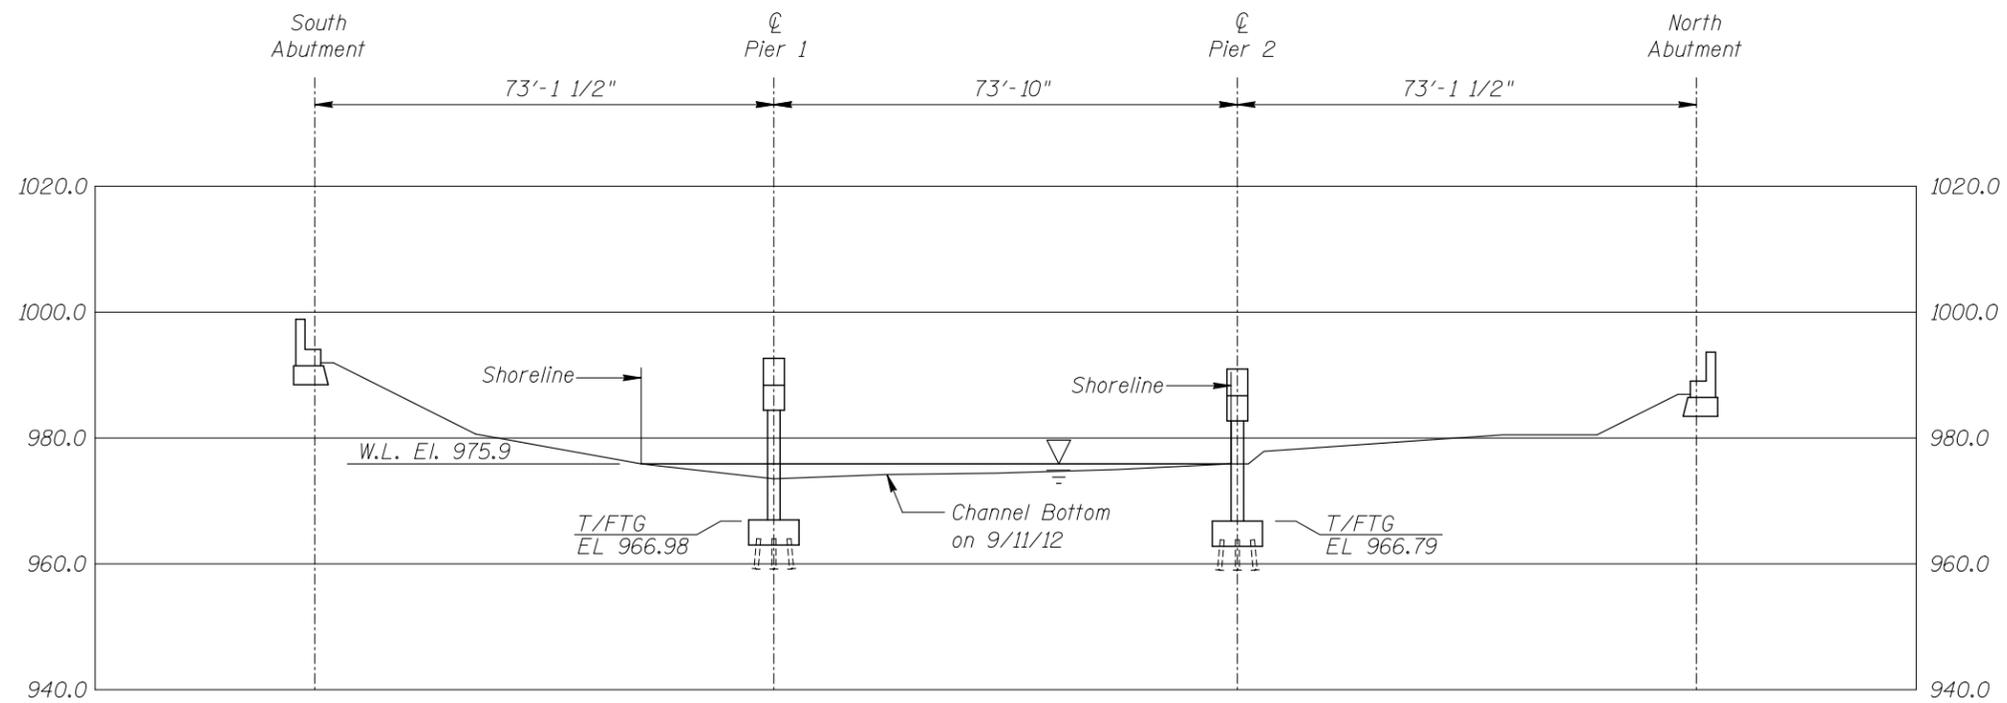
- ① The channel bottom material consisted of firm silty sand with cobbles and random riprap allowing up to 2 inches of probe rod penetration.
- ② The concrete of both piers was typically smooth and sound with no appreciable defects.
