UNDERWATER BRIDGE INSPECTION REPORT

STRUCTURE NO. 2110

CSAH NO. 8

MINNESOTA RIVER

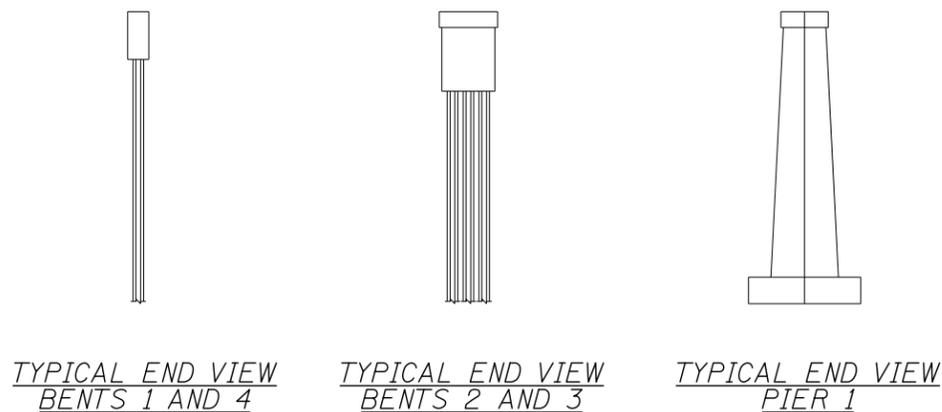
MINNESOTA DEPARTMENT OF TRANSPORTATION UNDERWATER BRIDGE INSPECTION	
STRUCTURE NO. 210 OVER THE MINNESOTA RIVER DISTRICT 8, BROWN COUNTY	
INSPECTION AND SOUNDING PLAN	
Drawn By: JAC	Date: OCT, 2012
Checked By: BKS	Scale: NTS
Code: 74232110	Figure No.: 1

- 3 Heavy deterioration/section loss was present on the upstream footing with up to approximately 2 feet of horizontal penetration.
- 4 Moderate scaling with 3 to 4 inches of maximum penetration was present on all faces of the downstream column concentrated near the waterline.

- 5 Moderate to heavy deterioration was present all the way around the footing with up to 12 inches of horizontal penetration.
- 6 The diaphragm wall exhibited light scaling with 1/8 inch typical penetration. Timber debris, consisting of 6 inch to 8 inch diameter branches, was present between the columns below the wall.

- 7 Scaling was observed on all piles of Bent 3 from 5 to 9 feet above the waterline, with 1 inch of maximum penetration.
- 8 Concrete spall along the pile extended from pile cap down 5 feet, measuring up to 1.5 foot wide with 1.5 inches of maximum penetration and exposed reinforcing steel with moderate corrosion.

- 9 A heavy accumulation of timber debris, consisting of logs and branches up to 2 feet in diameter, was observed at the upstream end of Bent 3 extending from the channel bottom to 1 foot above the waterline.

Repair the section loss on the footings of Pier.

Repair/patch the areas of spalled concrete with exposed reinforcing steel on the piles of Bent 3.

Consideration should be given to placement of scour countermeasures along the exposed foundation of Pier 1 or a scour analysis should be performed to determine the ultimate scour depths and stability of the substructure.
