UNDERWATER BRIDGE INSPECTION REPORT

STRUCTURE NO. 7132

CSAH NO. 33

LAC QUI PARLE RIVER

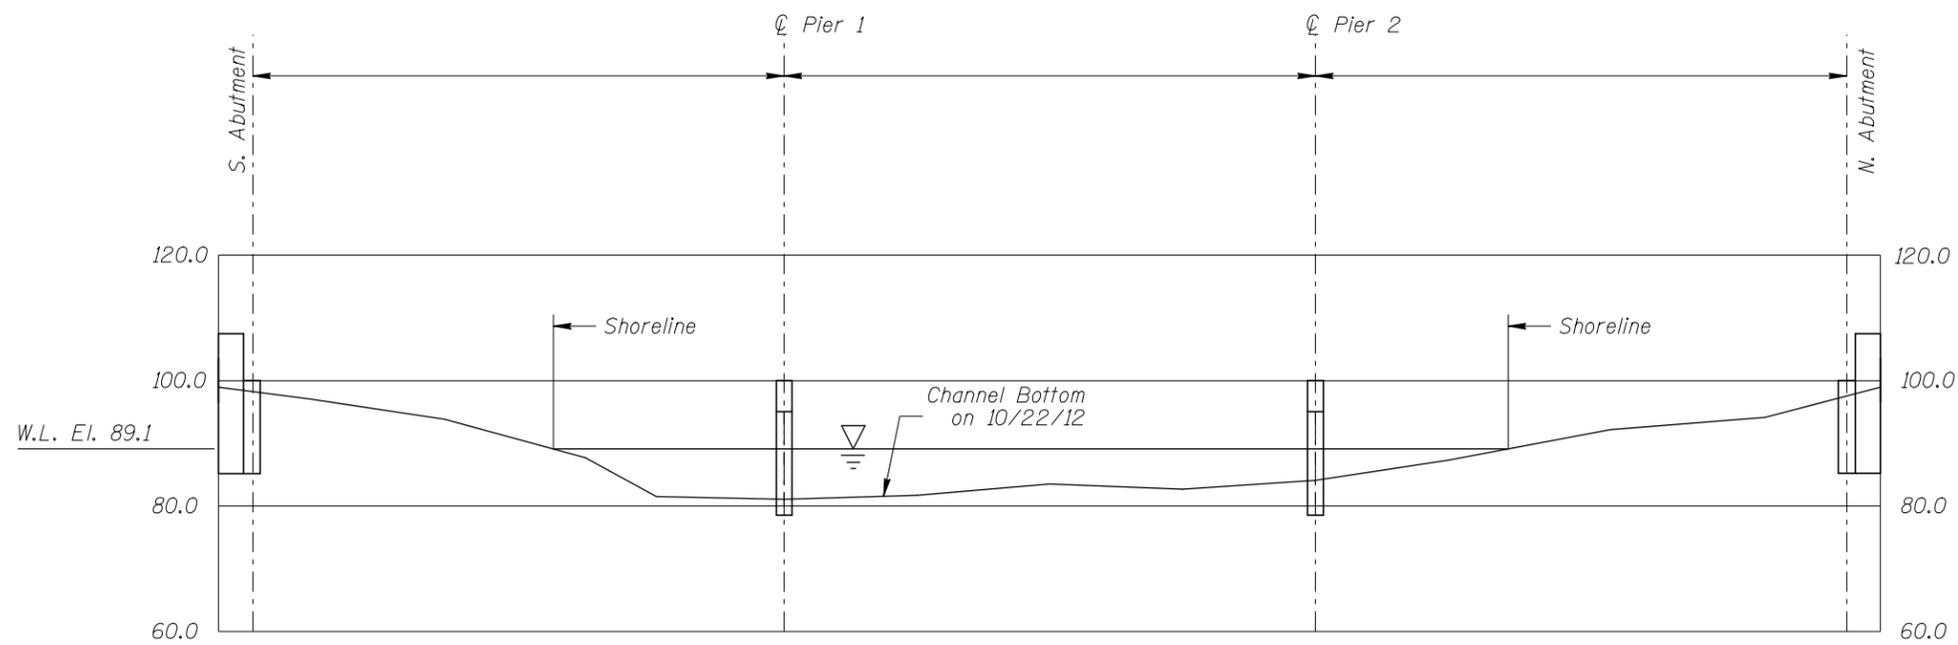
UPSTREAM FASCIA PROFILE

- INSPECTION NOTES:**
- ① The upstream and downstream column of Piers 1 and 2 exhibited scaling up to 1/8 inch deep, 1 foot above and below the waterline.
 - ② The streambed material at Piers 1 and 2 consisted of silt allowing a probe rod penetration of up to 1 foot.
 - ③ 1 foot diameter and smaller timber debris was observed between the upstream and downstream columns at Pier 2.
