UNDERWATER BRIDGE INSPECTION REPORT

STRUCTURE NO. 02501
CSAH NO. 24
OVER THE
RUM RIVER
DISTRICT 5 - ANOKA COUNTY

PREPARED FOR THE
MINNESOTA DEPARTMENT OF TRANSPORTATION
BY
COLLINS ENGINEERS, INC.
JOB NO. 3512 (CEI 103)

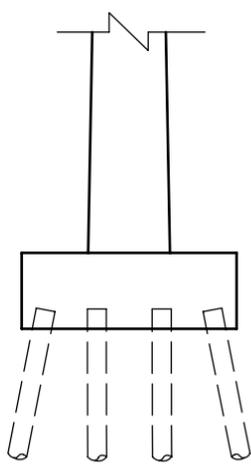
TYPICAL END VIEW OF PIERS

- 3 Moderate scaling was observed from the channel bottom to 1 foot above the waterline with a maximum penetration of 1 inch. The heaviest scaling was along the west face and the upstream nose of the pier.

- 4 Light scaling was observed along the east face of the pier from the top of the footing to 2 feet above the footing with a maximum penetration of 1/8 inch.

- 5 A 3-foot-radius area of the top of footing was exposed at the upstream end of the pier with no vertical face exposure.
- 6 Heavy scaling and cracking was observed on the top of the footing from the shaft to the footing edge with a maximum penetration of 5 inches. Numerous 1/16-inch- to 1/2-inch-wide cracks and areas of section loss were also observed on the top of footing from the pier shaft to the edge of the footing.

- 7 A light accumulation of 1-foot-diameter and smaller timber debris was observed at the upstream end of the pier.

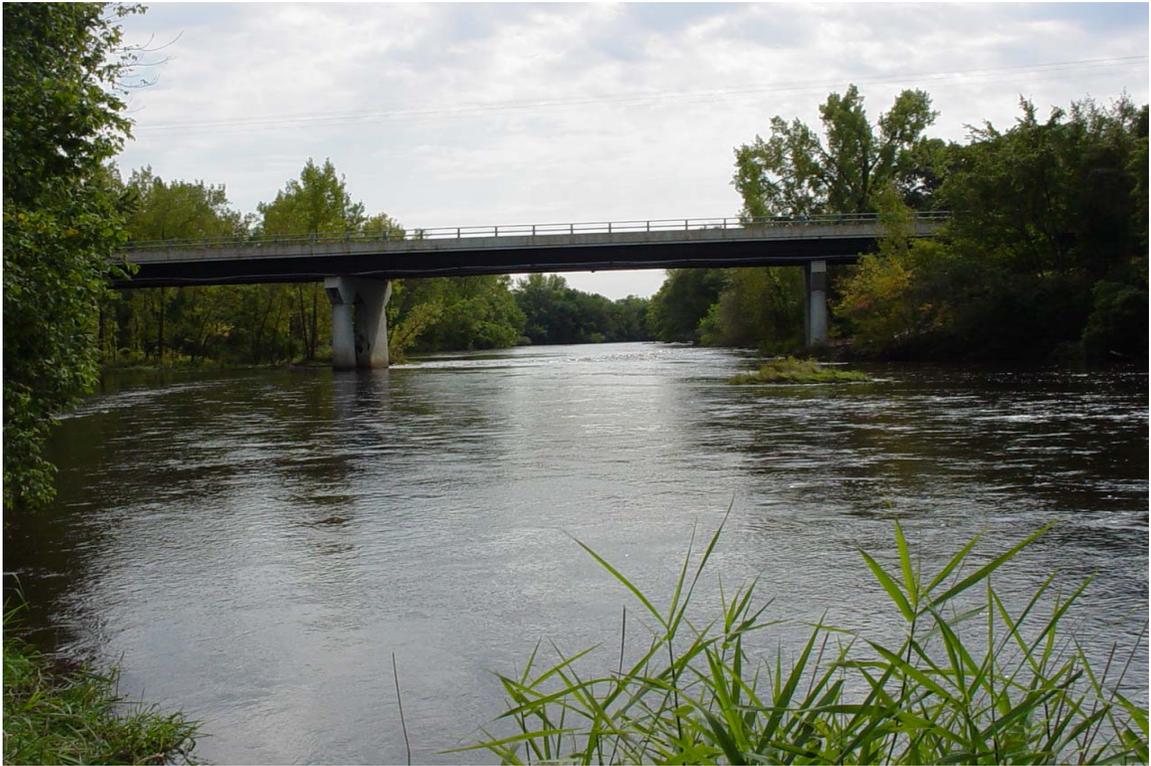
Photograph 1. Overall View of the Structure, Looking South.
