UNDERWATER BRIDGE INSPECTION REPORT

STRUCTURE NO. 62580  
RASPBERRY ISLAND ROAD  
OVER THE  
MISSISSIPPI RIVER  
DISTRICT 9 - RAMSEY COUNTY

PREPARED FOR THE  
MINNESOTA DEPARTMENT OF TRANSPORTATION  
BY  
COLLINS ENGINEERS, INC.  
JOB NO. 3512

MINNESOTA DEPARTMENT OF TRANSPORTATION  
UNDERWATER BRIDGE INSPECTION

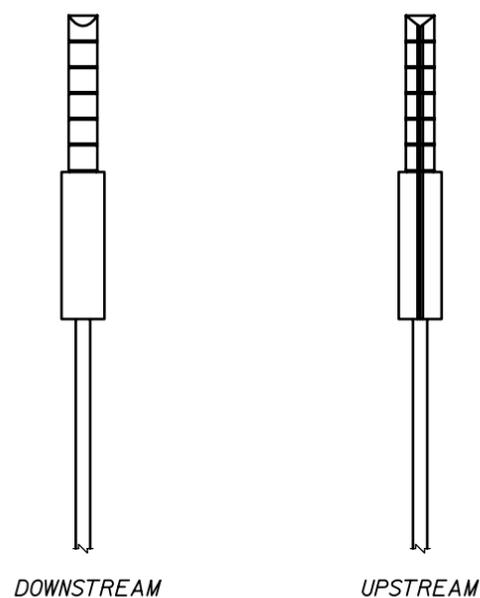
| Code: 35I262580 | | Figure No.: 2 |

- 3 The channel bottom consisted of 6 inch diameter cobbles and gravel.
- 4 A minor accumulation of timber debris, with pieces up to 12 inches in diameter, was observed on the channel bottom randomly scattered throughout the piles of Pier 3.

- 5 Minor timber debris was observed between Pier 4 and the shoreline and consisted of a tree with an 8 foot diameter root ball.
- 6 Timber formwork and steel angles were observed at the base of the concrete shaft of Pier 4. The bottom of the shaft was poorly formed with rough edges and reinforcing steel protruding from the base observed.

- 7 The concrete shaft was in good and sound condition and extended 2 feet below the waterline. The submerged steel piles exhibited light surface corrosion with rust nodules up to 1/16 inch in diameter.

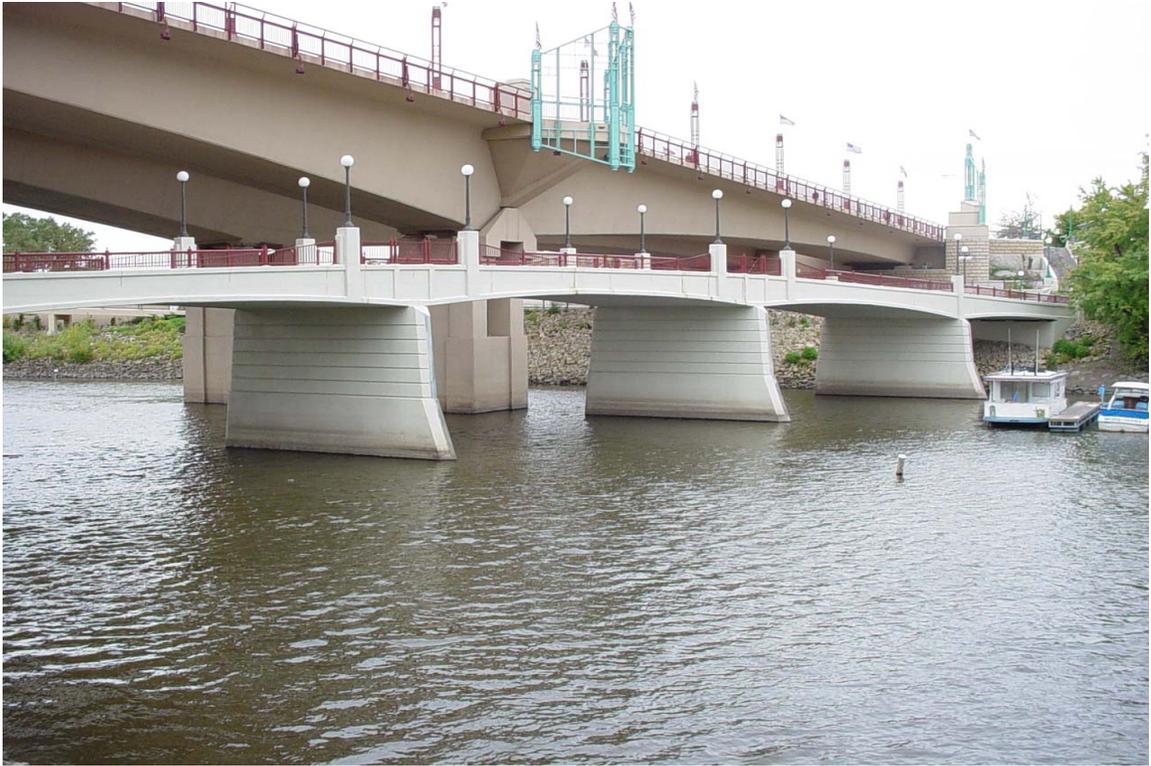
Photograph 1. Overall View of the Structure, Looking Southeast
