UNDERWATER BRIDGE INSPECTION REPORT

STRUCTURE NO. L8159

MISSISSIPPI RIVER OVERFLOW

DISTRICT 9 - WASHINGTON COUNTY, CITY OF COTTAGE GROVE

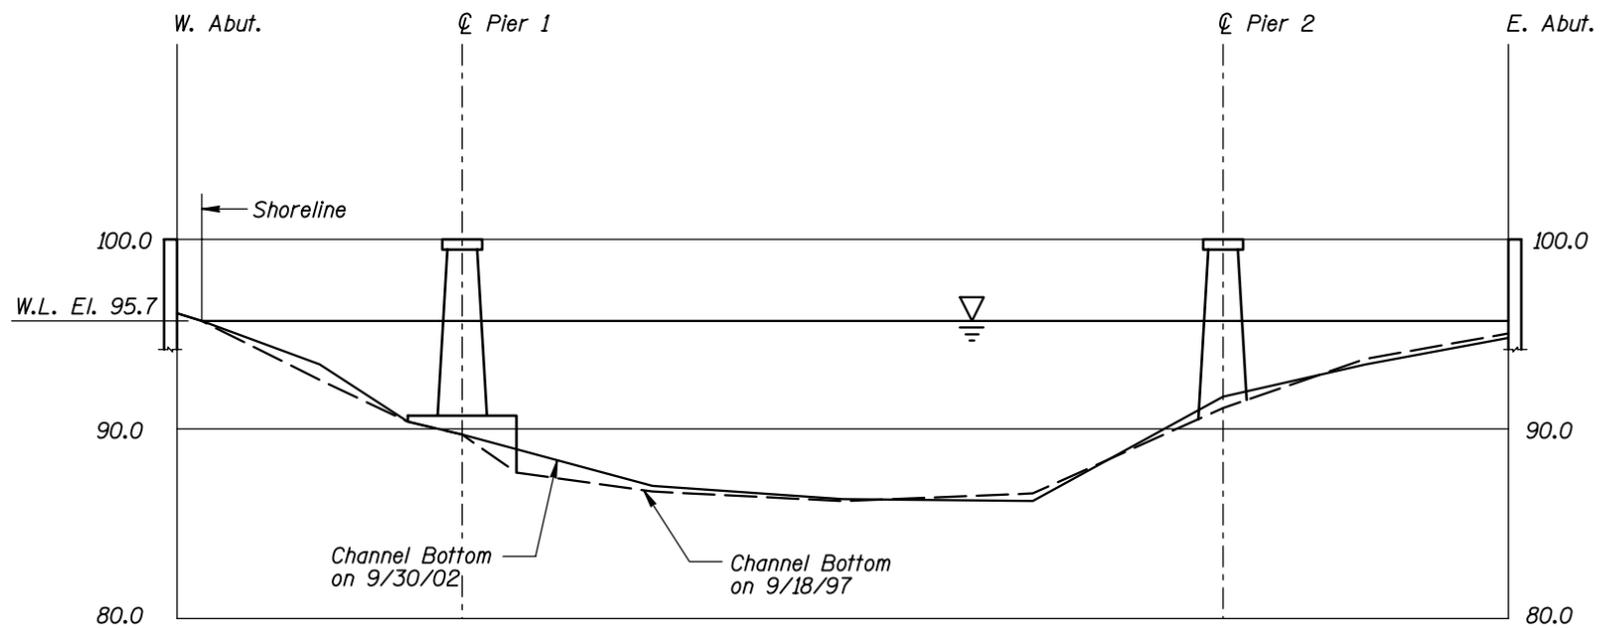
UPSTREAM FASCIA PROFILE
Vertical Scale: 1"=10'-0"

- 1 Three evenly spaced vertical hairline cracks were observed at the center of the East Abutment from the top of the abutment to 1 foot above the waterline.

- 4 A 6-inch-wide band of minor scaling was observed at the waterline at Piers 1 and 2.
- 5 An area of section loss, 3 inches in diameter, was observed 6 inches above the channel bottom on the upstream end of Pier 2 with up to 1 inch of penetrtrion.

- 6 Two areas of section loss, 6 inches in height and 12 inches wide, were observed 4 feet below the waterline with up to 1 inch of penetration.
- 7 An area of section loss, 6 inches in diameter, was observed on the corner at the channel bottom with up to 2 inches of penetration.

- 8 An area of section loss, 8 inches in diameter, was observed at the waterline with 1.5 inches of penetration.
- 9 The channel bottom consisted of sand, riprap, and broken concrete with a probe rod penetration of 1 inch.

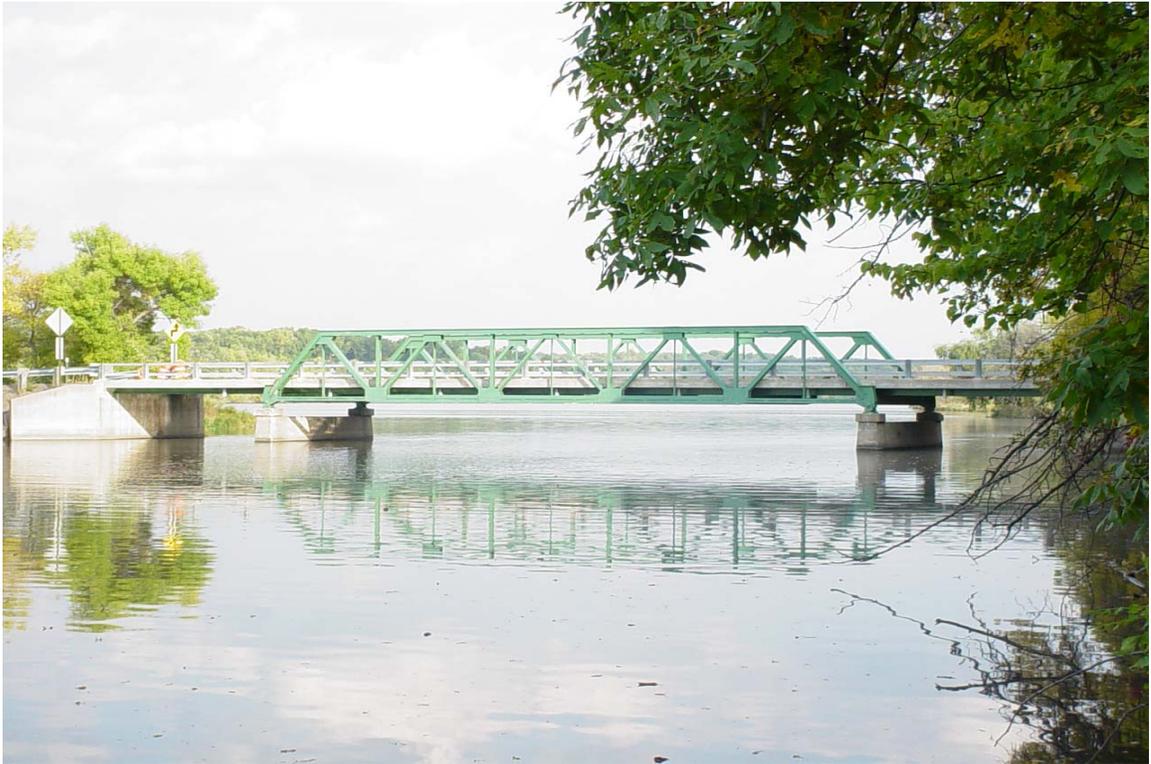
Photograph 1. Overall View of Bridge, Looking East.
