UNDERWATER BRIDGE INSPECTION REPORT

STRUCTURE NO. 2501

RUM RIVER

JOB NO. 5221 (CEI 103)

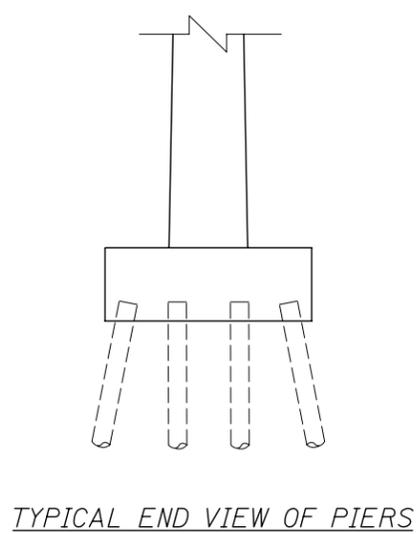
- 3 Moderate scaling was observed around the entire perimeter of the downstream shaft of Pier 2 from the channel bottom to 2 feet above the waterline with a maximum penetration of 2 inches. The heaviest scaling was along the west face and the upstream nose.

- 4 Heavy scaling and cracking was observed on the top of the footing from the shaft to the footing edge with a maximum penetration of 5 inches. Numerous 1/16-inch- to 1/2-inch-wide cracks and areas of section loss were also observed on the top of footing from the pier shaft to the edge of the footing with the cracks extending into the channel bottom along the vertical face of the footing.

- 5 The concrete shaft was in smooth and sound condition with no noted deficiencies.
- 6 The waterline elevation was approximately 6 inches lower along the downstream fascia compared to the upstream fascia.

- 7 The grouted riprap was deteriorated with missing riprap extending from the west side of the upstream shaft of Pier 1 to the slope protection mat along the western embankment.
