UNDERWATER BRIDGE INSPECTION REPORT

STRUCTURE NO. 27608
BROADWAY AVENUE
OVER
THE MISSISSIPPI RIVER
DISTRICT 5 - HENNEPIN COUNTY

PREPARED FOR THE
MINNESOTA DEPARTMENT OF TRANSPORTATION
BY
COLLINS ENGINEERS, INC.
JOB NO. 5221 (CEI 116)

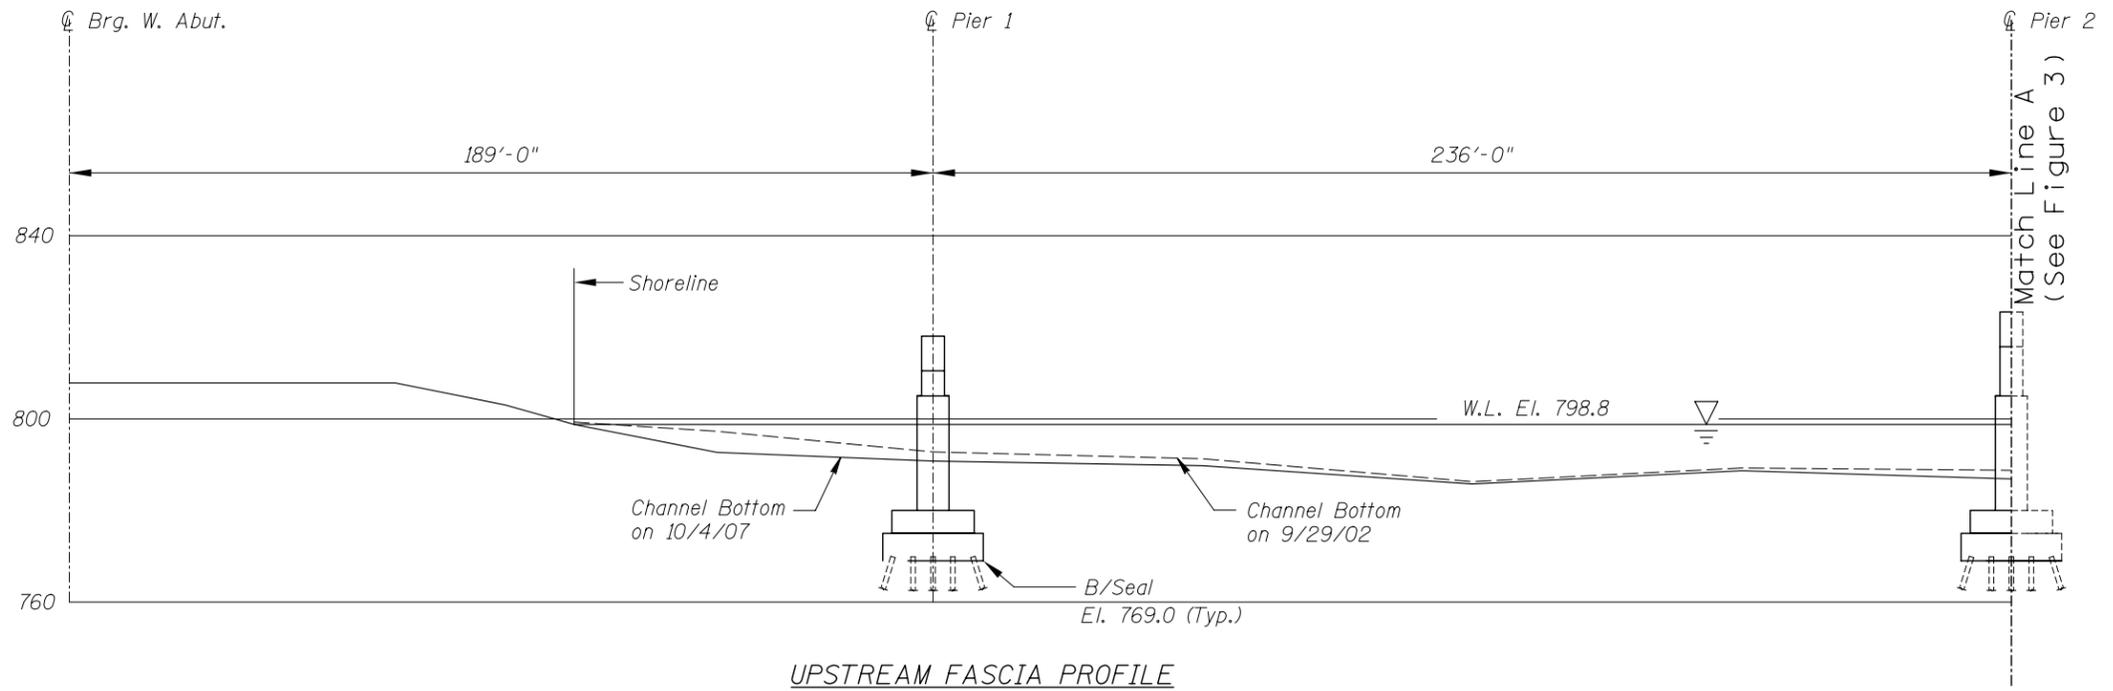
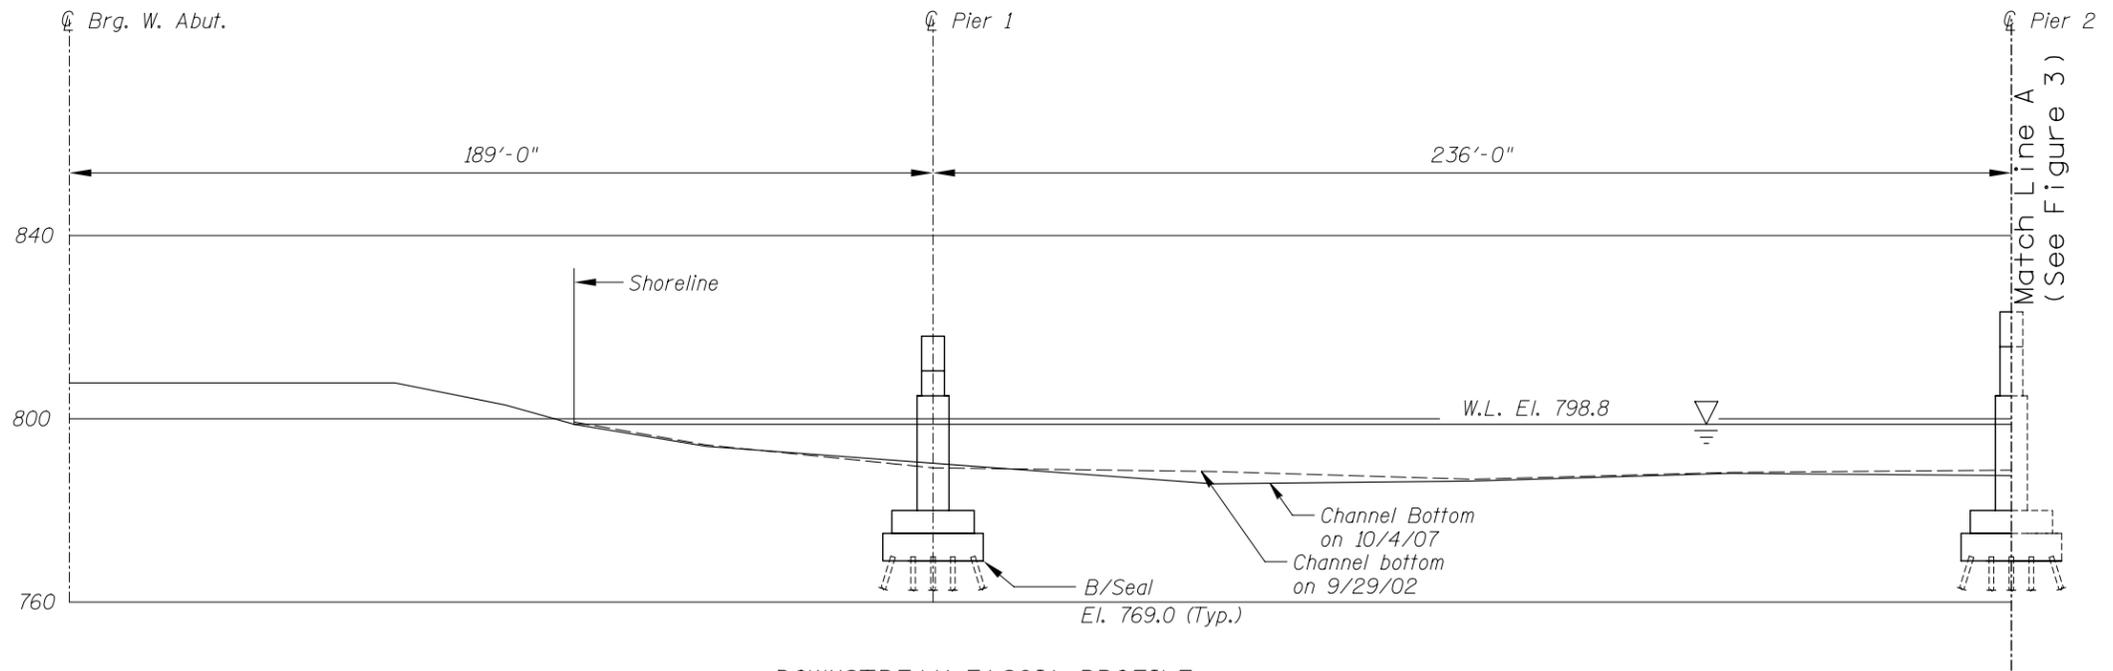
MINNESOTA DEPARTMENT OF TRANSPORTATION UNDERWATER BRIDGE INSPECTION		
STRUCTURE NO. 27608 OVER THE MISSISSIPPI RIVER DISTRICT 5, HENNEPIN COUNTY		
UPSTREAM AND DOWNSTREAM FASCIA PROFILES I		
Drawn By: PRH	COLLINS ENGINEERS	Date: OCT., 2007
Checked By: MDK		Scale: 1"=40'
Code: 52210116		Figure No.: 2

- 3 Vertical crack (1/16 inch wide maximum) extended from the top of the above water step in shaft to the waterline.
- 4 Timber debris consisting of two tree trunks, 2 feet in diameter, was observed along the east face of Pier 3.

- 5 Overall, concrete was smooth and sound.
- 6 Light to moderate accumulation of timber debris located along the upstream nose and to the west side of Pier 1 was observed scattered along the channel bottom extending up 2 feet.

- 7 Vertical cracks (1/16 inch wide maximum) were observed from above water step in shaft to the waterline on west side of Pier 3.
- 8 Rip-rap and concrete rubble was observed at upstream nose of Piers 2 and 3. On Pier 3, it extended along east side as well.

Monitor the timber debris at all of the piers, and if found to be increasing in the future, removal operations may become warranted.

Reinspect the submerged substructure units at the normal maximum recommended (NBIS) interval of five (5) years.

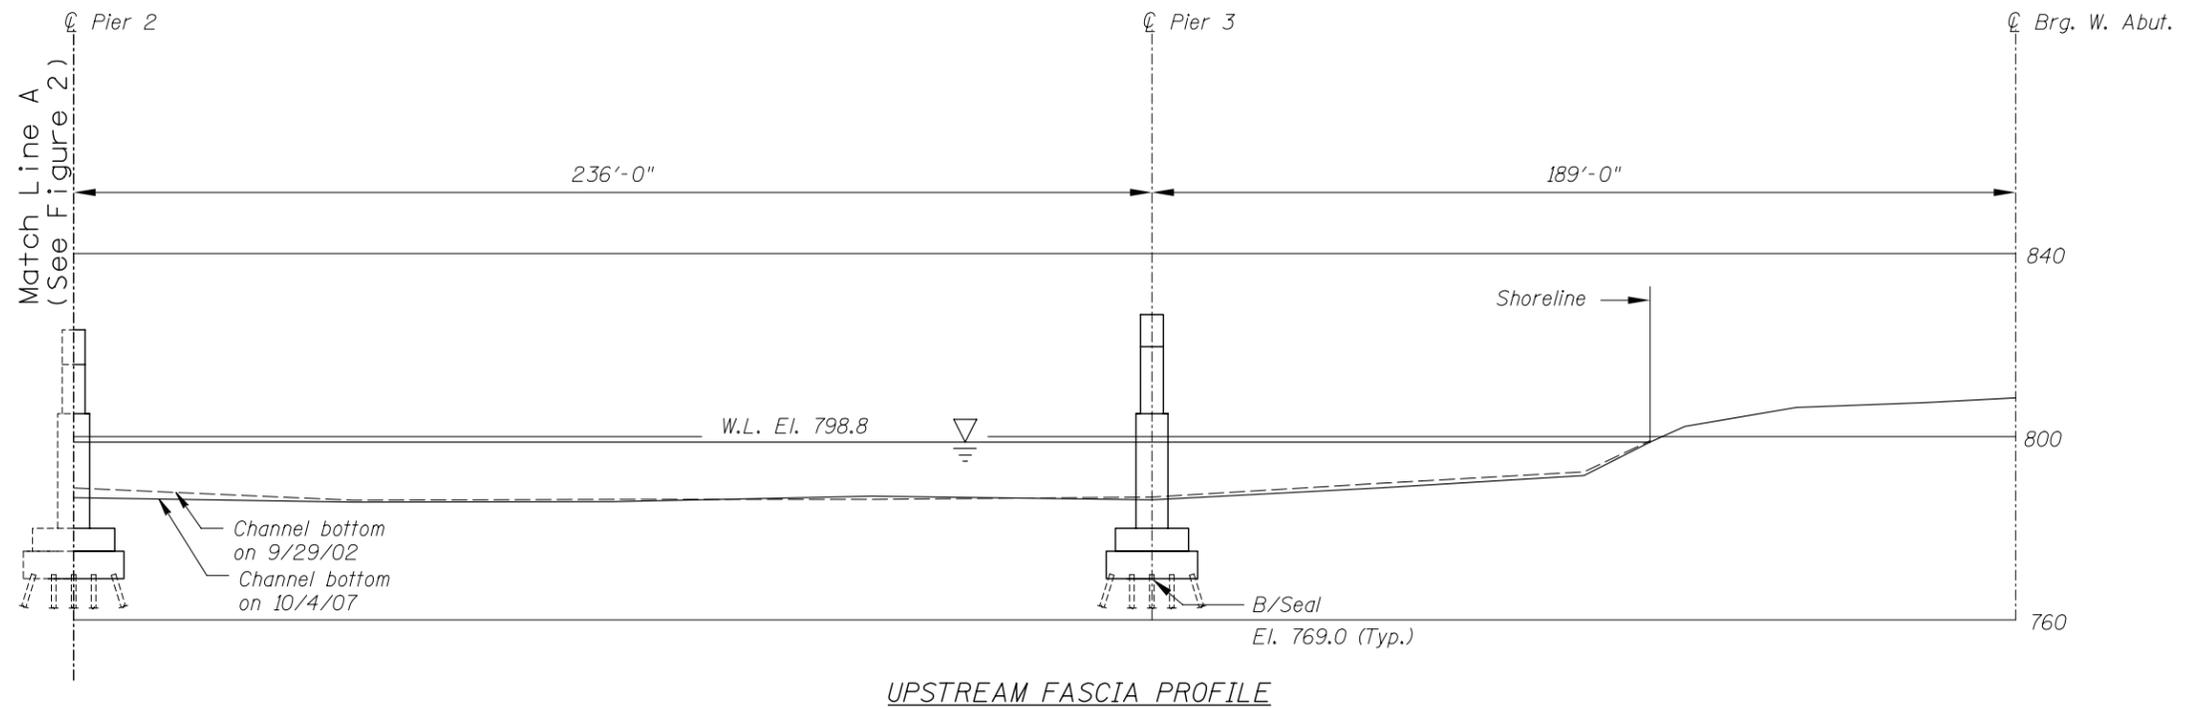
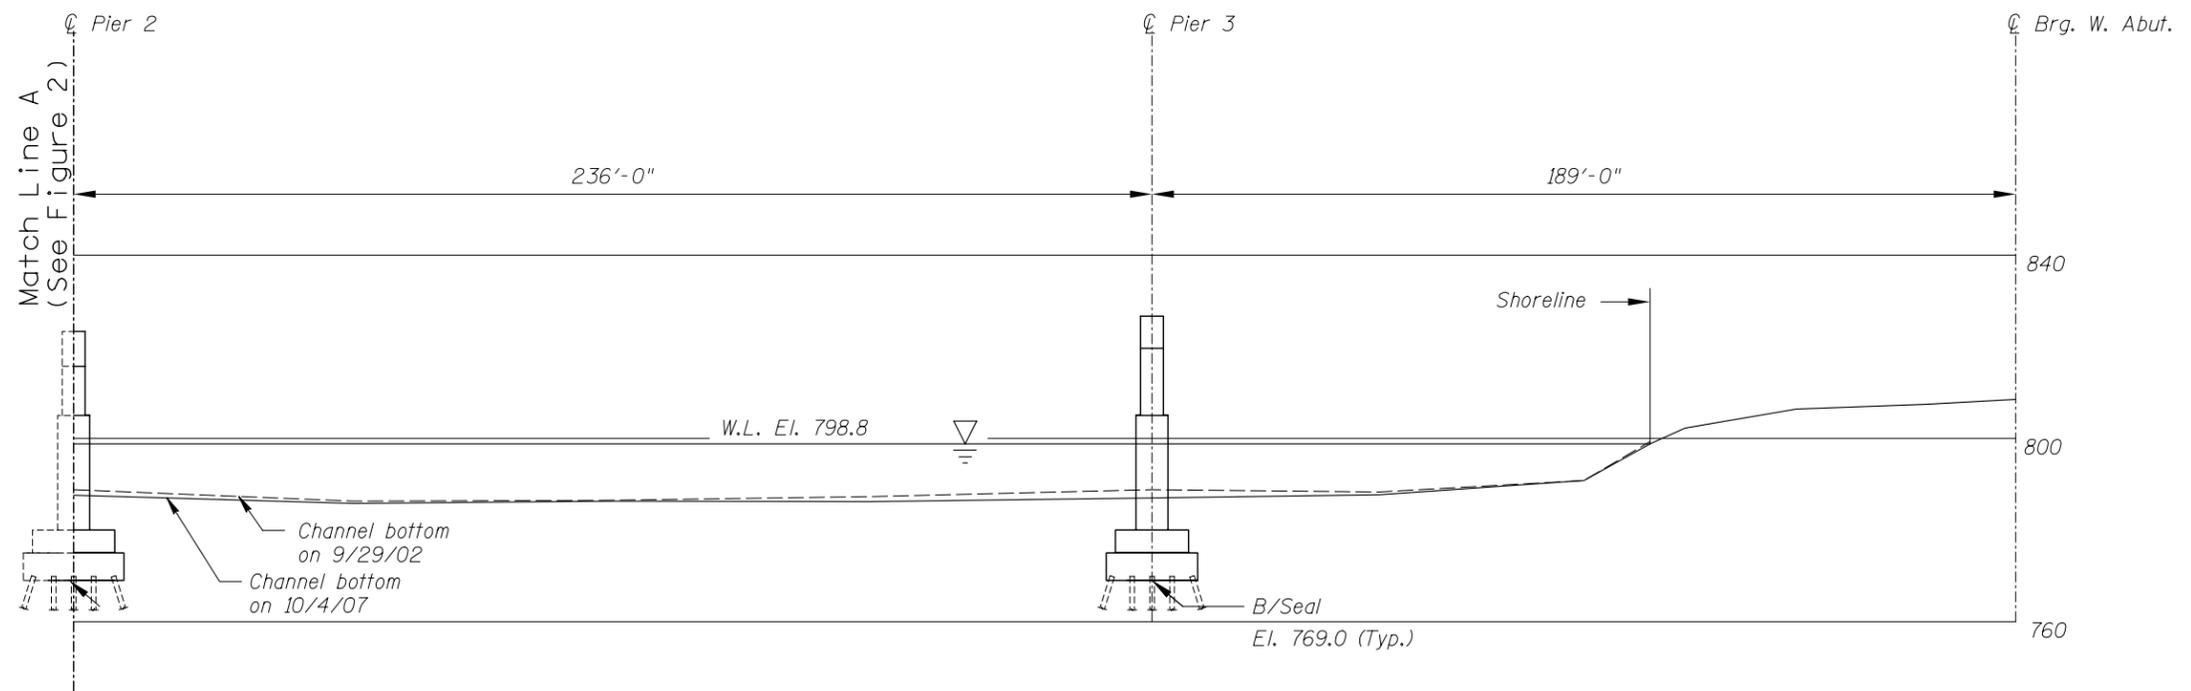
REMARKS: Overall, the concrete of the piers was smooth and sound. Several vertical hairline to 1/16 inch cracks were observed above the waterline on the faces of Piers 1 and 3. Light to moderate accumulation of timber debris located along the upstream nose and to the west of Pier 1 was observed scattered along the channel bottom extending up 2 feet. Timber debris consisting of two tree trunks, 2 feet in diameter, was observed along the west face of Pier 3. Riprap and concrete rubble was observed at the upstream nose of Piers 2 and 3, and at Pier 3, it also extended along the east side.
