UNDERWATER BRIDGE INSPECTION REPORT

STRUCTURE NO. 62580
RASPBERRY ISLAND ROAD
OVER THE
MISSISSIPPI RIVER
DISTRICT 9 - RAMSEY COUNTY

PREPARED FOR THE
MINNESOTA DEPARTMENT OF TRANSPORTATION
BY
COLLINS ENGINEERS, INC.

JOB NO. 5221

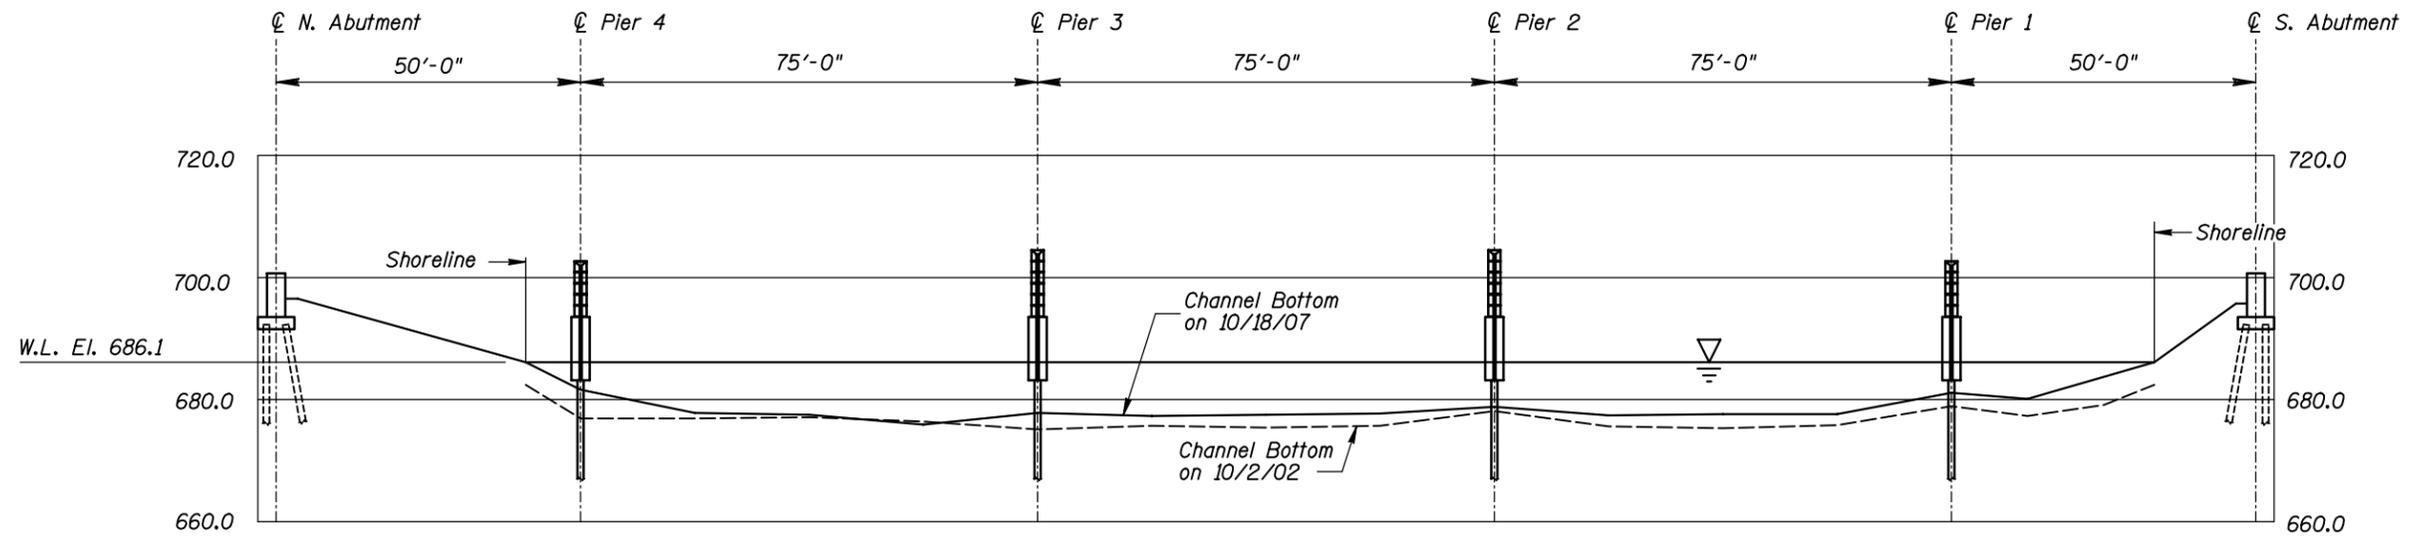
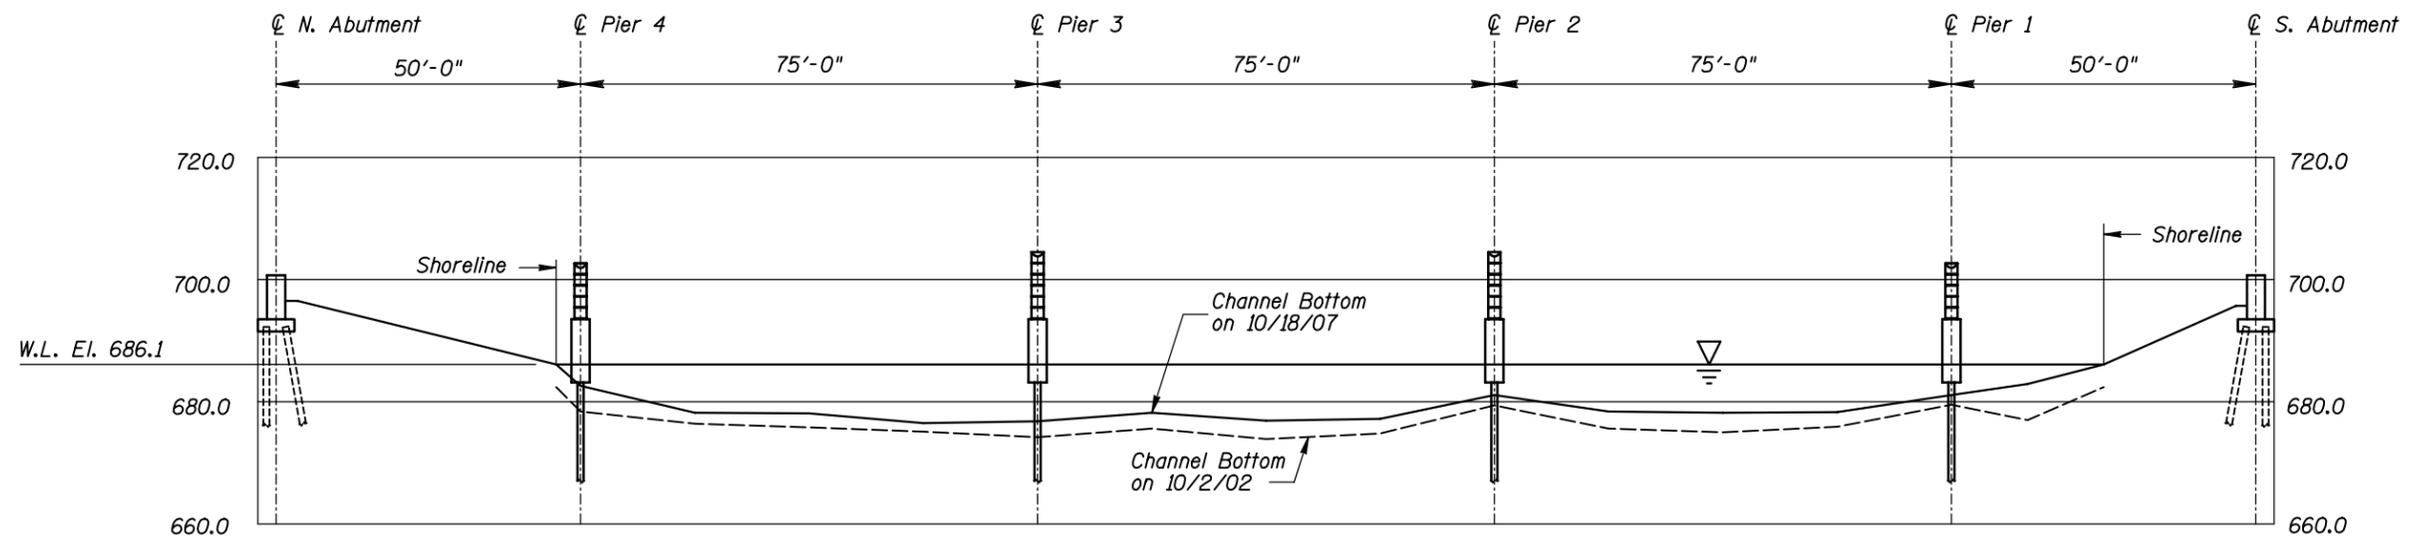
- 3 The channel bottom consisted of 6 inch diameter cobbles and gravel.
- 4 A minor accumulation of timber debris, with pieces up to 12 inches in diameter, was observed on the channel bottom randomly scattered throughout the piles of Pier 3 extending from channel bottom up 2 to 3 feet.

- 5 Timber formwork and steel angles were observed at the base of the concrete shaft of Pier 4. The bottom of the shaft was poorly formed with rough edges and reinforcing steel protruding from the base.

- 6 The concrete shaft was in good and sound condition and extended 2 feet below the waterline. The submerged steel piles exhibited light surface corrosion with rust nodules up to 1/4 inch in diameter.
