UNDERWATER BRIDGE INSPECTION REPORT

STRUCTURE NO. 02501

RUM RIVER

MINNESOTA DEPARTMENT OF TRANSPORTATION

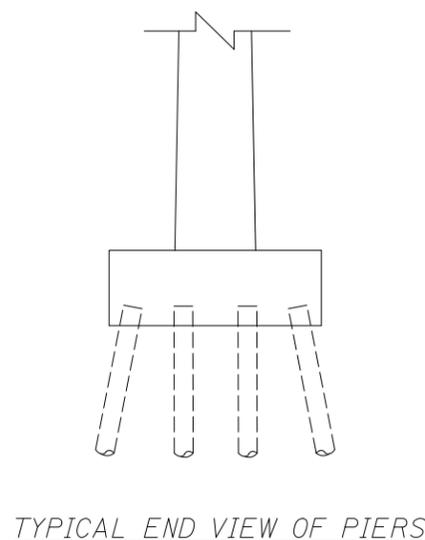
3. Moderate scaling was observed around the entire perimeter of the downstream shaft of Pier 2 from the channel bottom to 2 feet above the waterline with a maximum penetration of 2 inches. The heaviest scaling was along the west face and the upstream nose.

4. Heavy scaling and cracking was observed on the top of the footing from the shaft to the footing edge with a maximum penetration of 8 inches. Numerous 1/16 inch to 1/2 inch wide cracks and areas of section loss were also observed on the top of footing from the pier shaft to the edge of the footing with the cracks extending into the channel bottom along the vertical face of the footing. Partially exposed reinforcing steel was present at the downstream end of the exposed footing.

7. The grouted riprap was deteriorated with missing riprap extending from the west side of the upstream shaft of Pier 1 to the slope protection mat along the western embankment.
