UNDERWATER BRIDGE INSPECTION REPORT

STRUCTURE NO. 19563

CANADA AVENUE

CANNON RIVER

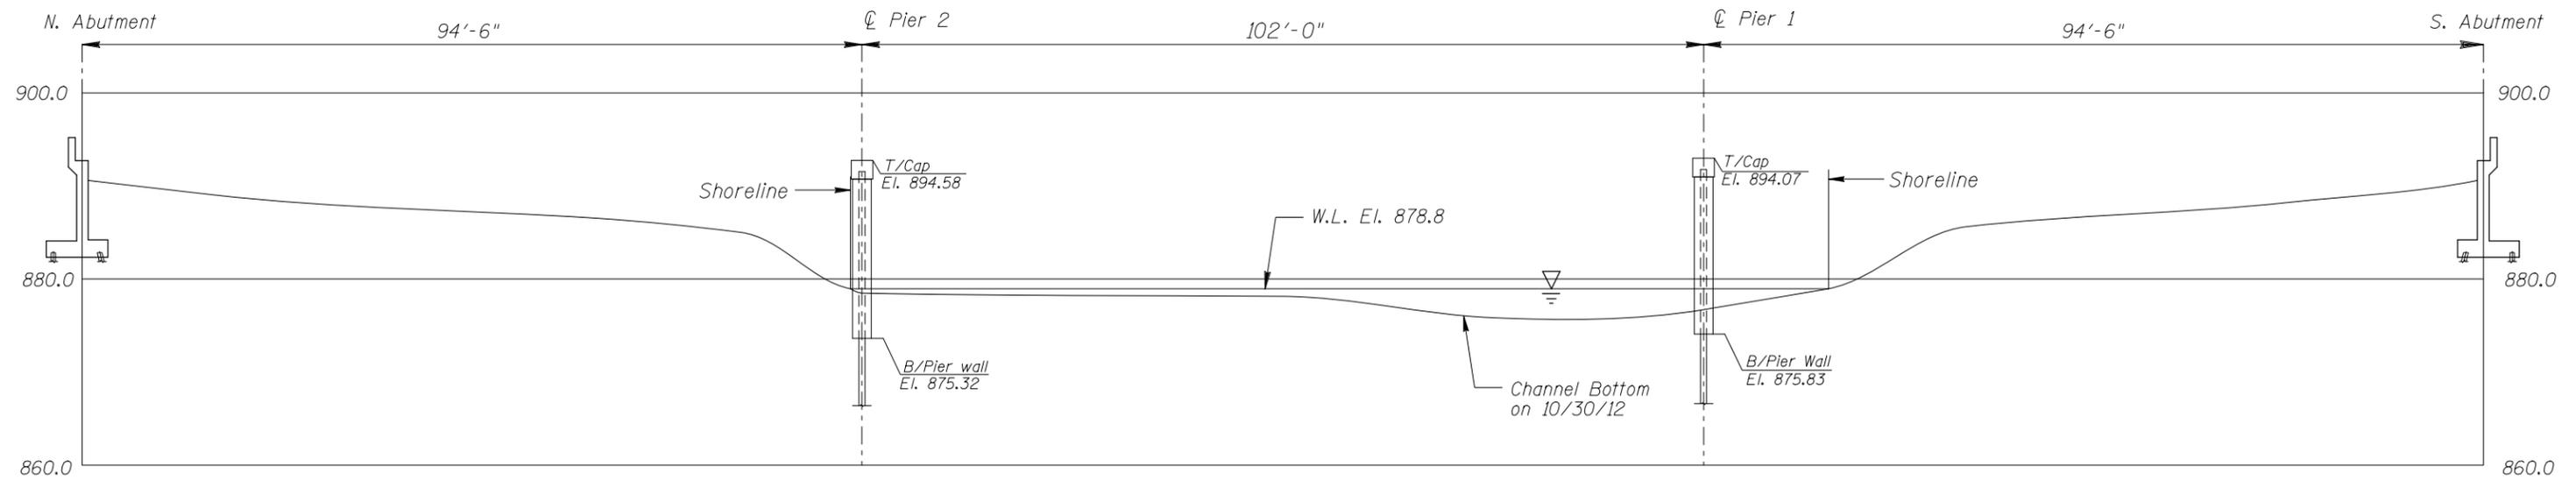
DOWNSTREAM FASCIA PROFILE

1. The channel bottom material on the channel side of each pier consisted of sandy silt with randomly scattered cobbles allowing up to 4 inches of probe rod penetration.
2. The channel bottom material along the south face of Pier 1 consisted of soft organic silt allowing up to 1 foot of probe rod penetration.
3. The concrete surfaces of both piers were smooth and sound.
4. A scour depression, measuring approximately 6 feet diameter and 3 feet deep, was observed at the upstream nose of Pier 2.
