UNDERWATER BRIDGE INSPECTION REPORT

STRUCTURE NO. 27510

ARCOLA CHANNEL

MAY 21, 2012

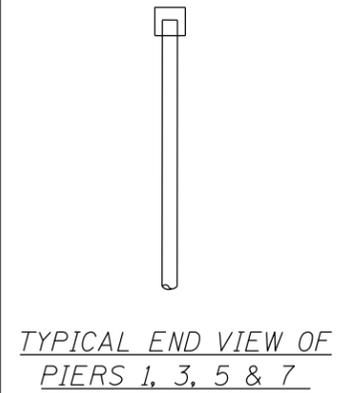
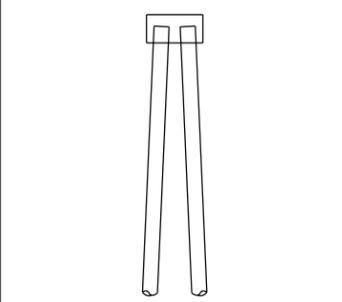
- 6 Abandoned concrete piers were encountered between Piers 1 and 2, 5 and 6, and 6 and 7, and extended approximately 2 feet above the waterline.
- 7 The steel pipe pile typically exhibited light surface corrosion with minor pitting and rust scale delaminations up to 1/8 inch thick from 2 feet above to 1 foot below the waterline.

- 8 The steel pipe piles exhibited a dent 4 feet above the waterline that was 8 inches in diameter with 1/2 inch of penetration. A second 12 inch diameter dent was observed from 1 foot above to 2 feet below the waterline, with a 5 inch deep indentation.

- 9 The concrete pile cap at Pier 7 exhibited areas of section loss approximately 1.5 feet long and 6 inches high on the west end with exposed reinforcing steel on the top and bottom faces where there was 2 to 3 inches of penetration and wide spread cracking with rust staining.

- 10 The concrete repair to the pile cap at the east end of Pier 3 exhibited map cracking and spalling with up to 4 inches of penetration and exposed reinforcing steel, extending from the top to the bottom of the pile cap on the south face.

- 11 Minor cracking at west end and heavy cracking at east end of pier cap at Piers 6 and 2.

- 12 The piles exhibited lighter corrosion and/or coating loss from channel bottom to 6 feet above waterline.
- 13 The pier cap at Pier 5 had a spall measuring 1 foot long by 6 inches high with 1 inch of penetration with partially exposed reinforcing steel at the east end on the south face.
- 14 The pier cap at Pier 6 had a spall measuring 3 feet by 2.5 feet with 2-1/2 inches of penetration and exposed reinforcing steel that had approximately 25 percent loss of section.
- 15 The pier cap at Pier 2 exhibited map cracking and spalling on the entire east end with up to 6 inches of penetration and up to 15 percent section loss on the exposed reinforcing steel.
