UNDERWATER BRIDGE INSPECTION REPORT

STRUCTURE NO. 27549

42ND AVENUE

MINNESOTA DEPARTMENT OF TRANSPORTATION
UNDERWATER BRIDGE INSPECTION

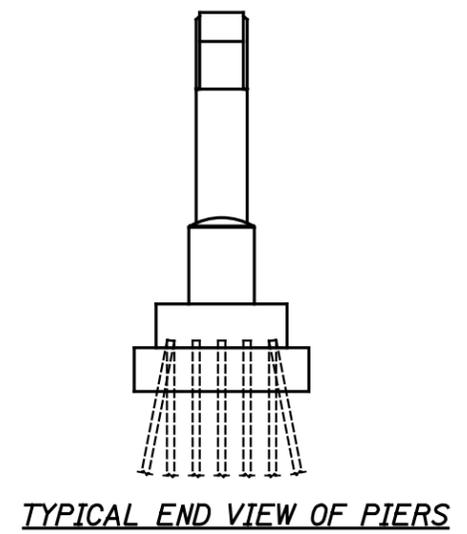
- (A) The channel bottom material around Pier 9 consisted of riprap up to 1 foot in diameter at the upstream nose and sand infilling around the rest of the pier that allowed up to 1.5 feet of probe rod penetration.

- (B) The top of the footing around the entire perimeter of Pier 9 was exposed with vertical face exposure between 1 foot at the upstream west corner, 2 to 4 inches along the downstream face, and a maximum of 2.5 feet along the west face.

- (C) An 18 inch diameter log was observed on the channel bottom at the upstream end of Pier 9.
- (D) A log that was 18 inches in diameter and 30 feet long was observed on the channel bottom along the east face of Pier 9.

- (E) Numerous vertical hairline cracks were observed extending from the top of the webwall to the waterline on both faces of Piers 9 and 10.
- (F) The channel bottom material around of Pier 10 consisted of 1 to 3 foot diameter riprap with sand infilling that allowed up to 8 inches of probe rod penetration.

- (G) A vertical 1/8 inches wide crack was observed extending from the top of the webwall

to the waterline on the west face of Pier 9.

Monitor the timber debris at Pier 9 and 10, and if found to be increasing in the future, removal operations may become warranted.

Monitor the footing exposure at Pier 9 during future underwater inspections. The scour evaluation indicates pier foundations are stable for the calculated scour conditions.
