UNDERWATER BRIDGE INSPECTION REPORT

STRUCTURE NO. 2796

10<sup>TH</sup> AVENUE

OCTOBER 29, 2012

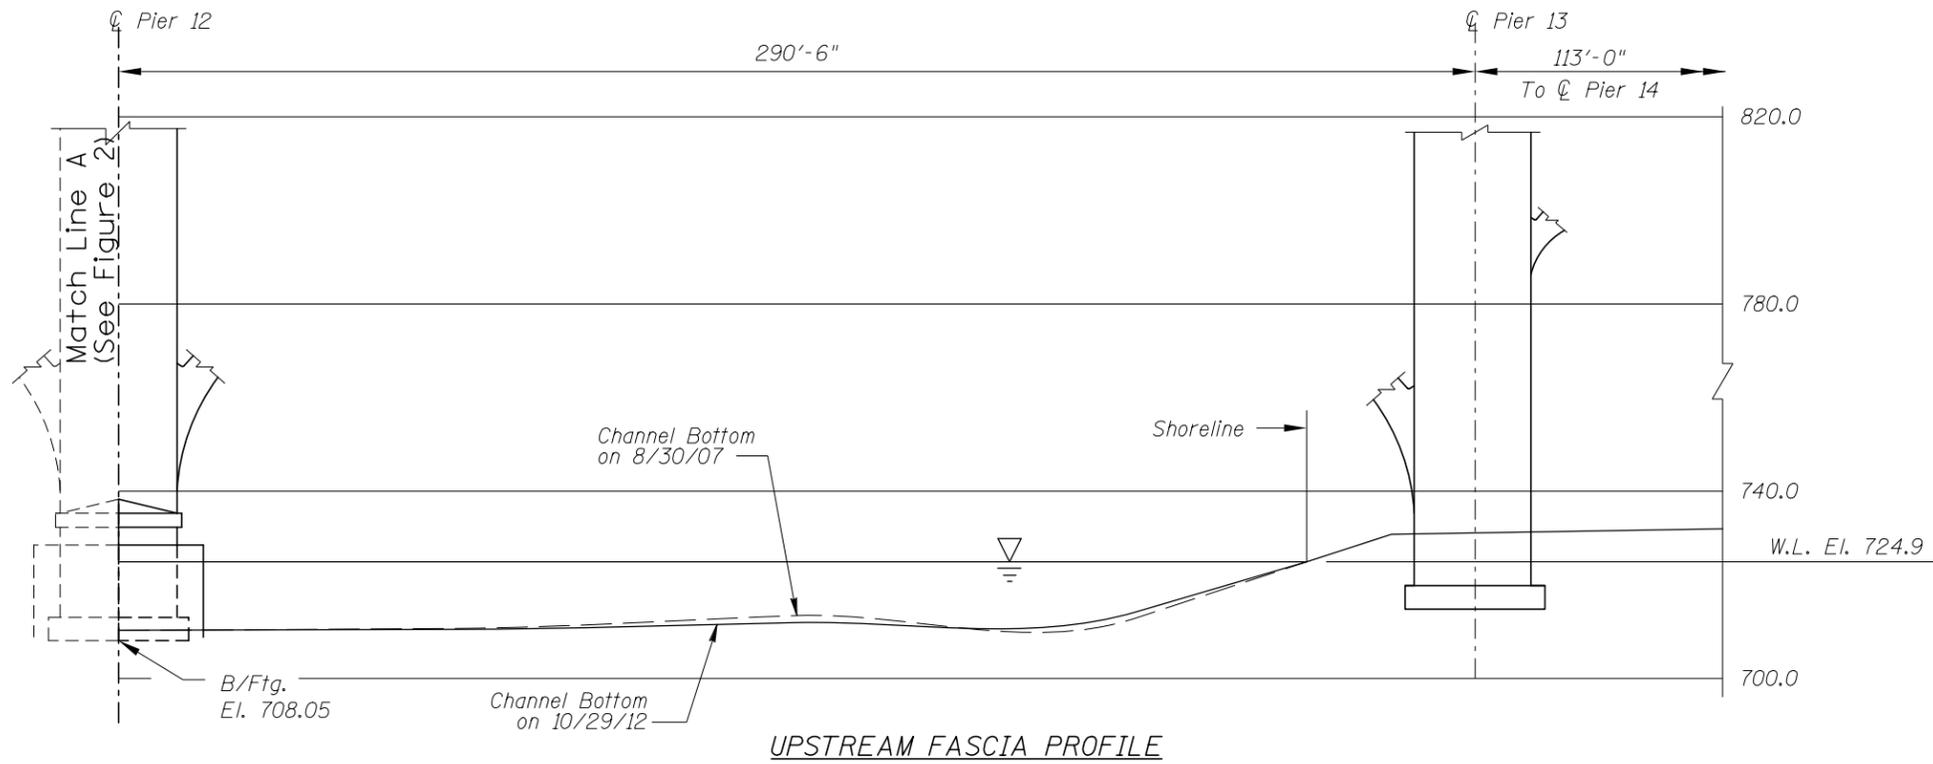
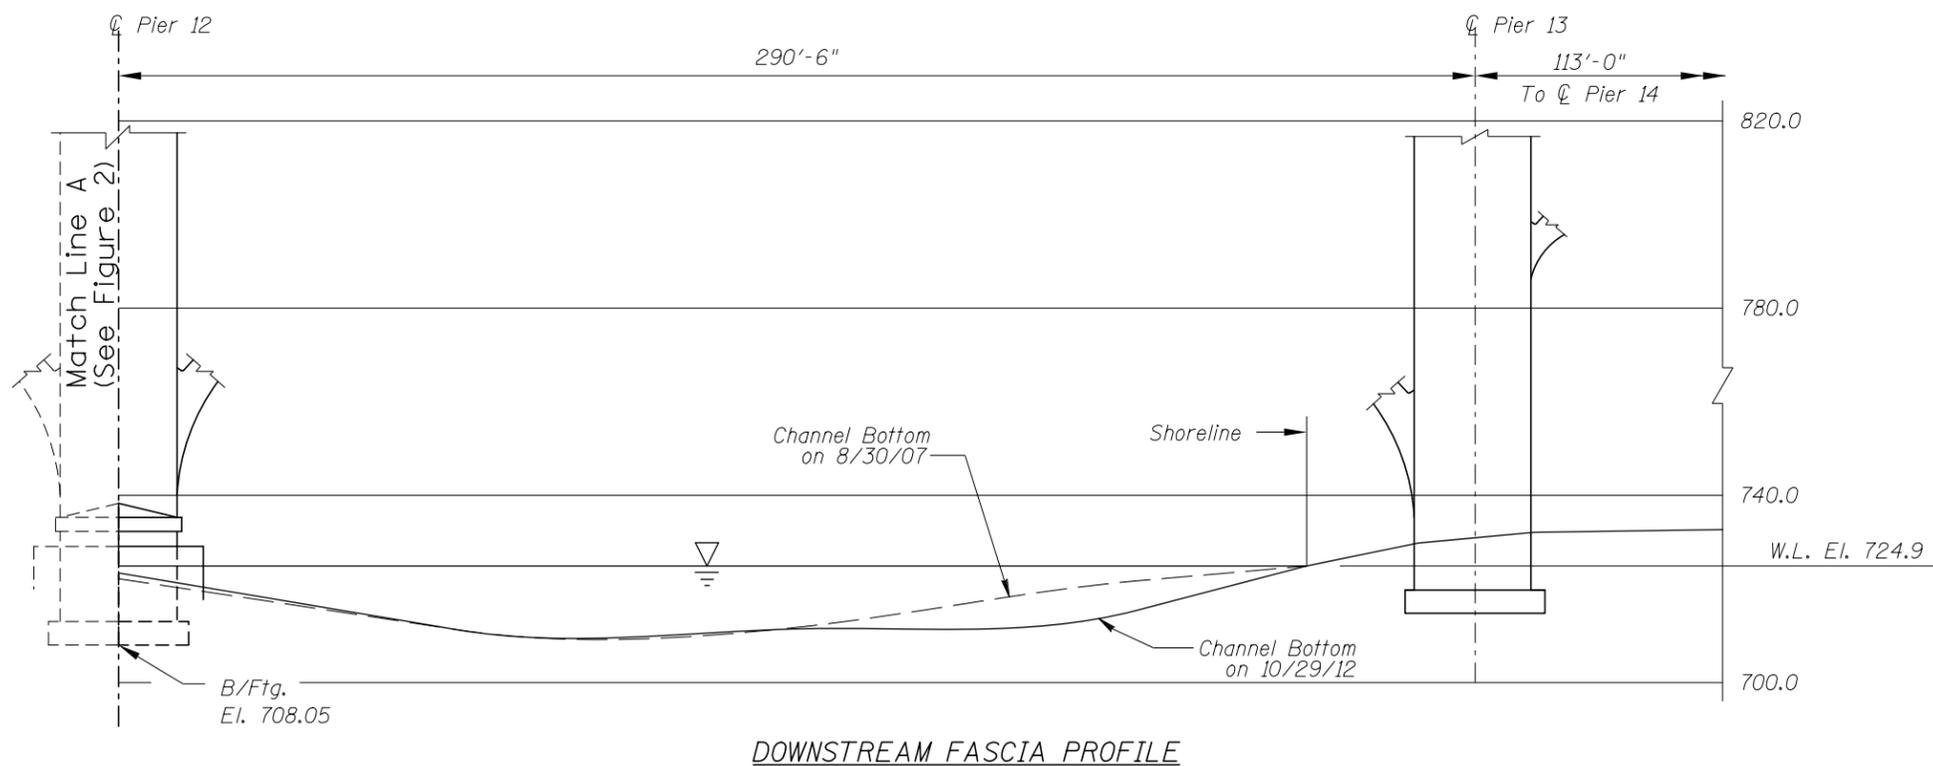
- ② Gaps in the lines of construction (not at interlocks), were observed in the steel sheeting at the east and west upstream 1/4 points with maximum widths located at the channel bottom. The west gap measured 15 inches in width and had a maximum penetration of 6 inches. The east side gap measured 36 inches in width and had no penetration.

- ③ A void between the horizontal C-channels and the vertical sheeting was observed at the east side upstream 1/4 point of the pier at 2.5 feet below the waterline with a height of 2.5 feet and 3.5 feet of maximum penetration.

- ④ The steel sheeting was in good condition with a uniform 1/8 inch layer of surface corrosion extending from the top of the sheeting to the channel bottom.

- ⑥ The topside concrete surface within the sheeting was sound, however, gaps/ cracks up to 1 foot maximum width were observed on both east and west sides of Pier 12.
