UNDERWATER BRIDGE INSPECTION REPORT

STRUCTURE NO. 3072

PEDESTRIAN BRIDGE

ELM CREEK

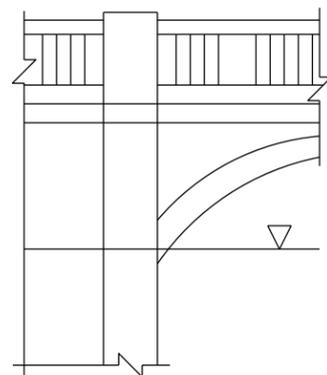
TYPICAL END VIEW OF ABUTMENTS

- 4 Spalls located on the upstream and downstream fascias of the North Abutment and the downstream fascia of the South Abutment, measuring 5 feet wide, extended from the channel bottom to 1 foot above the waterline with typical 6 inches and maximum 1 foot of penetration. Fully exposed reinforcing steel was observed, with up to 20 percent loss of section.

- 5 Spall, measuring 6 inches in diameter, located 1 foot below the waterline at the downstream quarter point on the North Abutment with typical 6 inches and maximum 8 inches of penetration. Exposed reinforcing steel with up to 20 percent loss of section was observed.

Repair areas of spalled concrete where reinforcing steel is exposed by removing unsound concrete to a minimum of one inch behind reinforcing steel, cleaning and replacing reinforcing steel as required, and placing concrete designed to provide high durability with low permeability.
