UNDERWATER BRIDGE INSPECTION REPORT

STRUCTURE NO. 62555A

WABASHA STREET NORTH BOUND (MSAS 235 NB)

MINNESOTA DEPARTMENT OF TRANSPORTATION
UNDERWATER BRIDGE INSPECTION

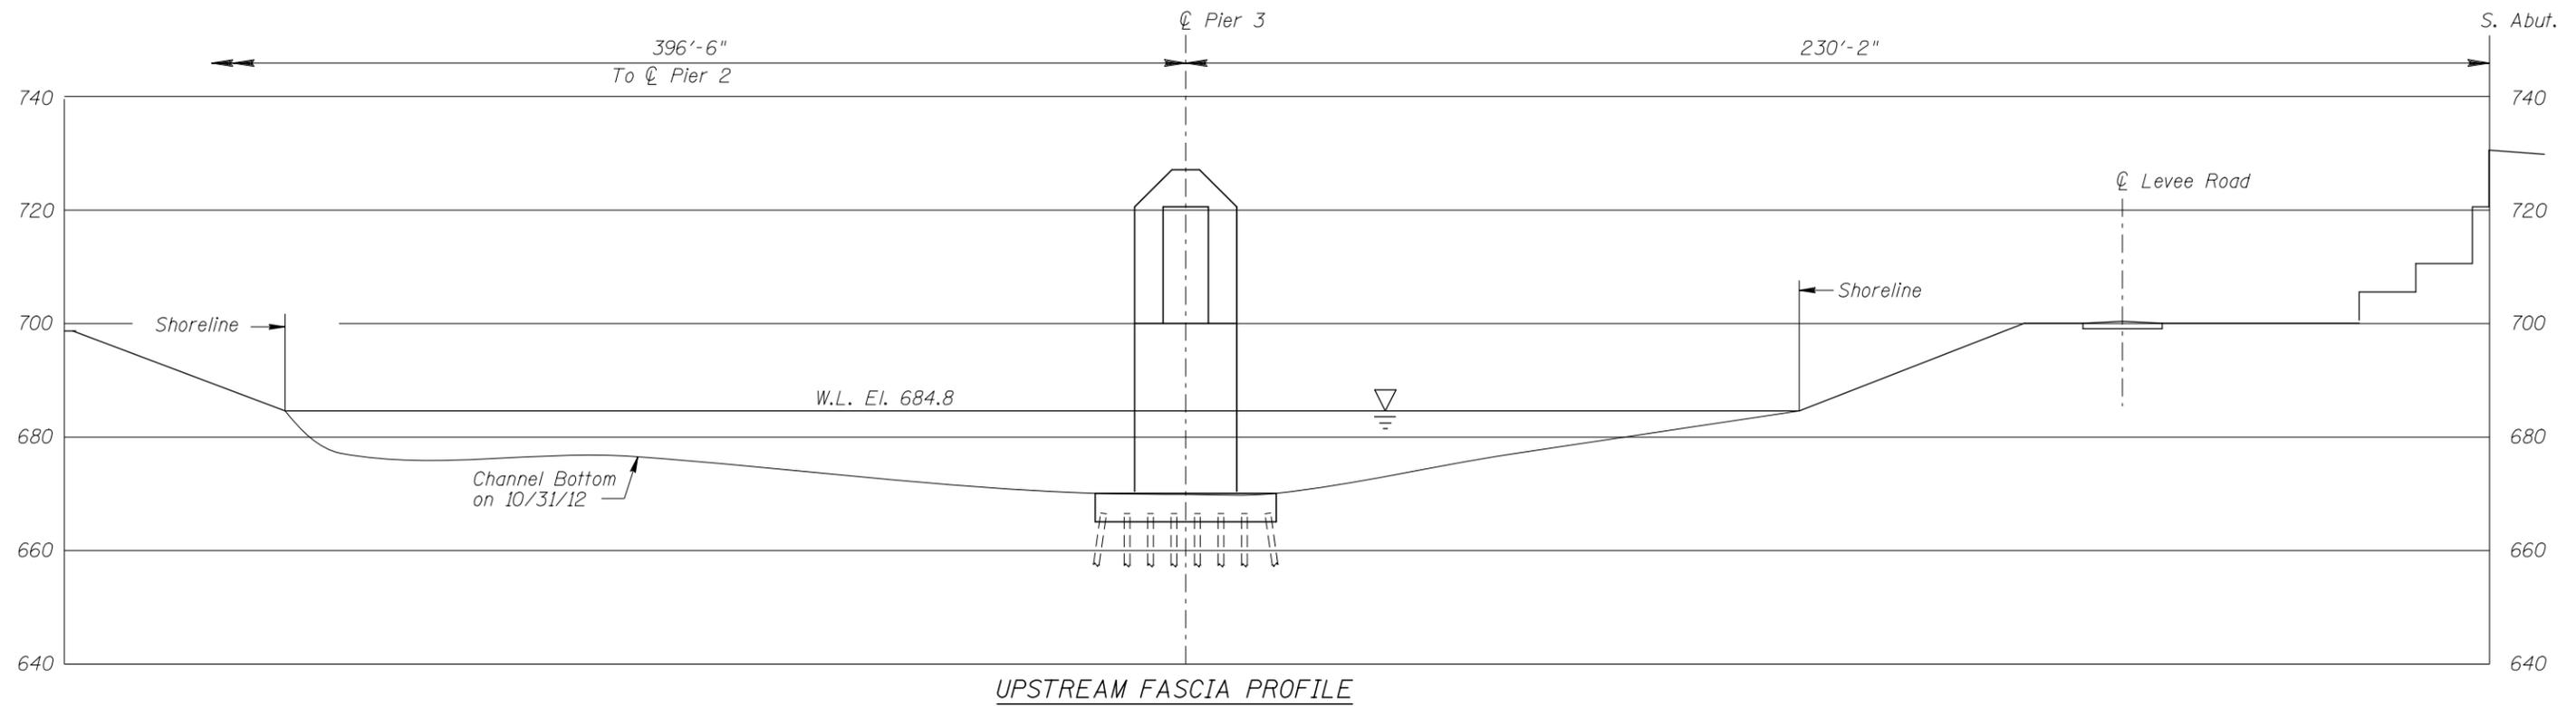
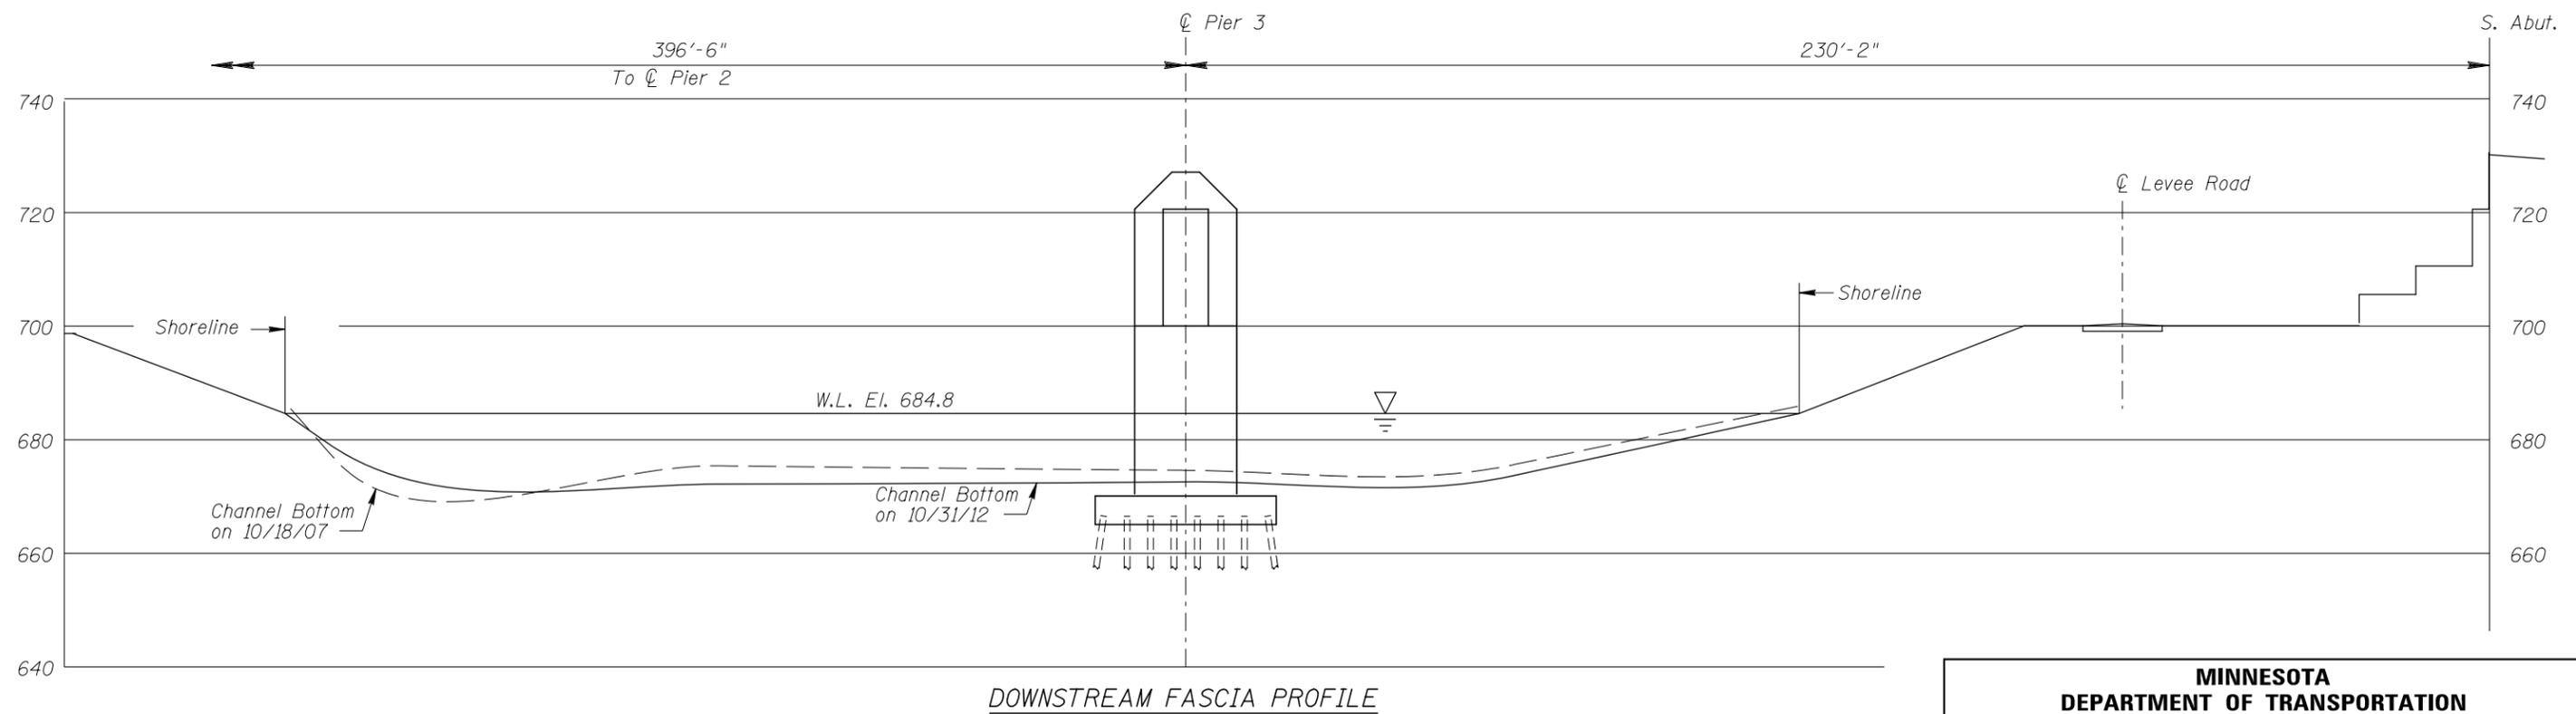
- 1 The concrete was in good and sound condition with no structurally significant defects observed.
- 2 A 6 foot wide portion of the top of the footing was exposed along the entire upstream side and north face of Pier 3.
- 3 A minor accumulation of timber debris, consisting of 12 inch diameter logs, was observed at the downstream end and sides of the pier column extending from the channel bottom up 1 to 3 feet.
- 4 The channel bottom material around Pier 3 consisted of sandy infilling allowing up to 1 foot of probe rod penetration.
- 5 The embankments were well armored with 1 foot diameter riprap.

Reinspect the submerged substructure units at the normal maximum recommended
(NBIS) interval of sixty (60) months.
