UNDERWATER BRIDGE INSPECTION REPORT

STRUCTURE NO. 62555B

WABASHA STREET SOUTH BOUND (MASA 235 SB)

MISSISSIPPI RIVER

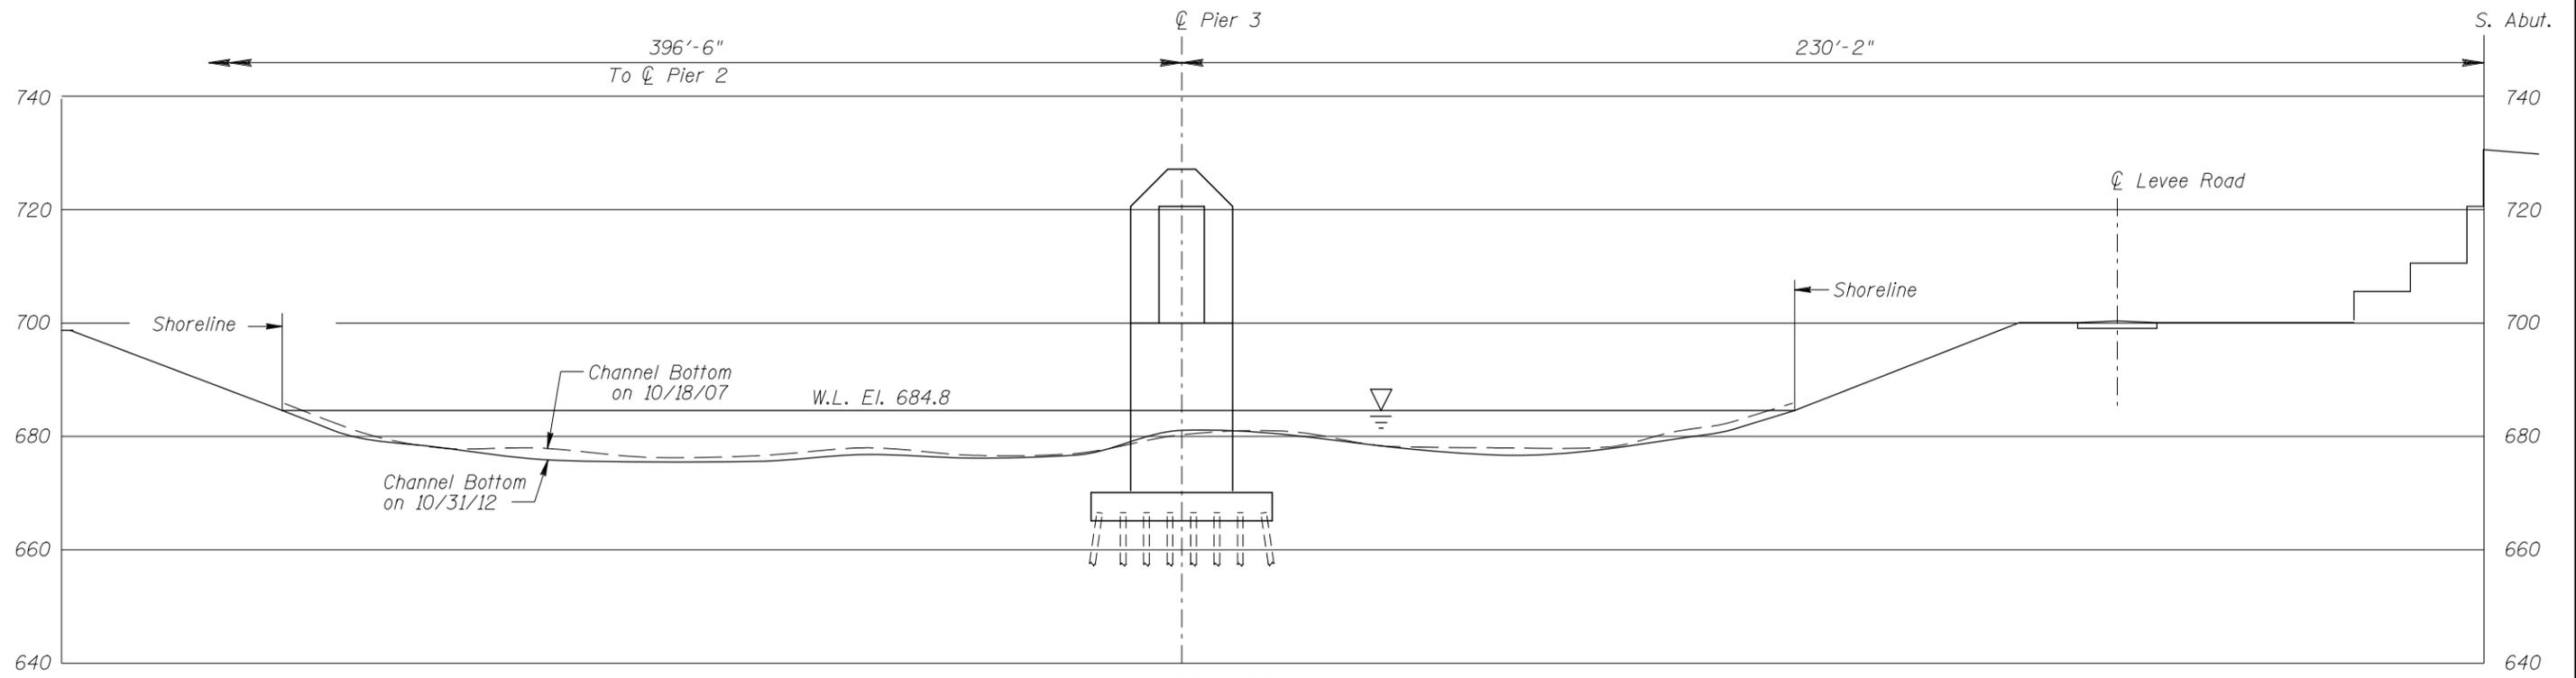
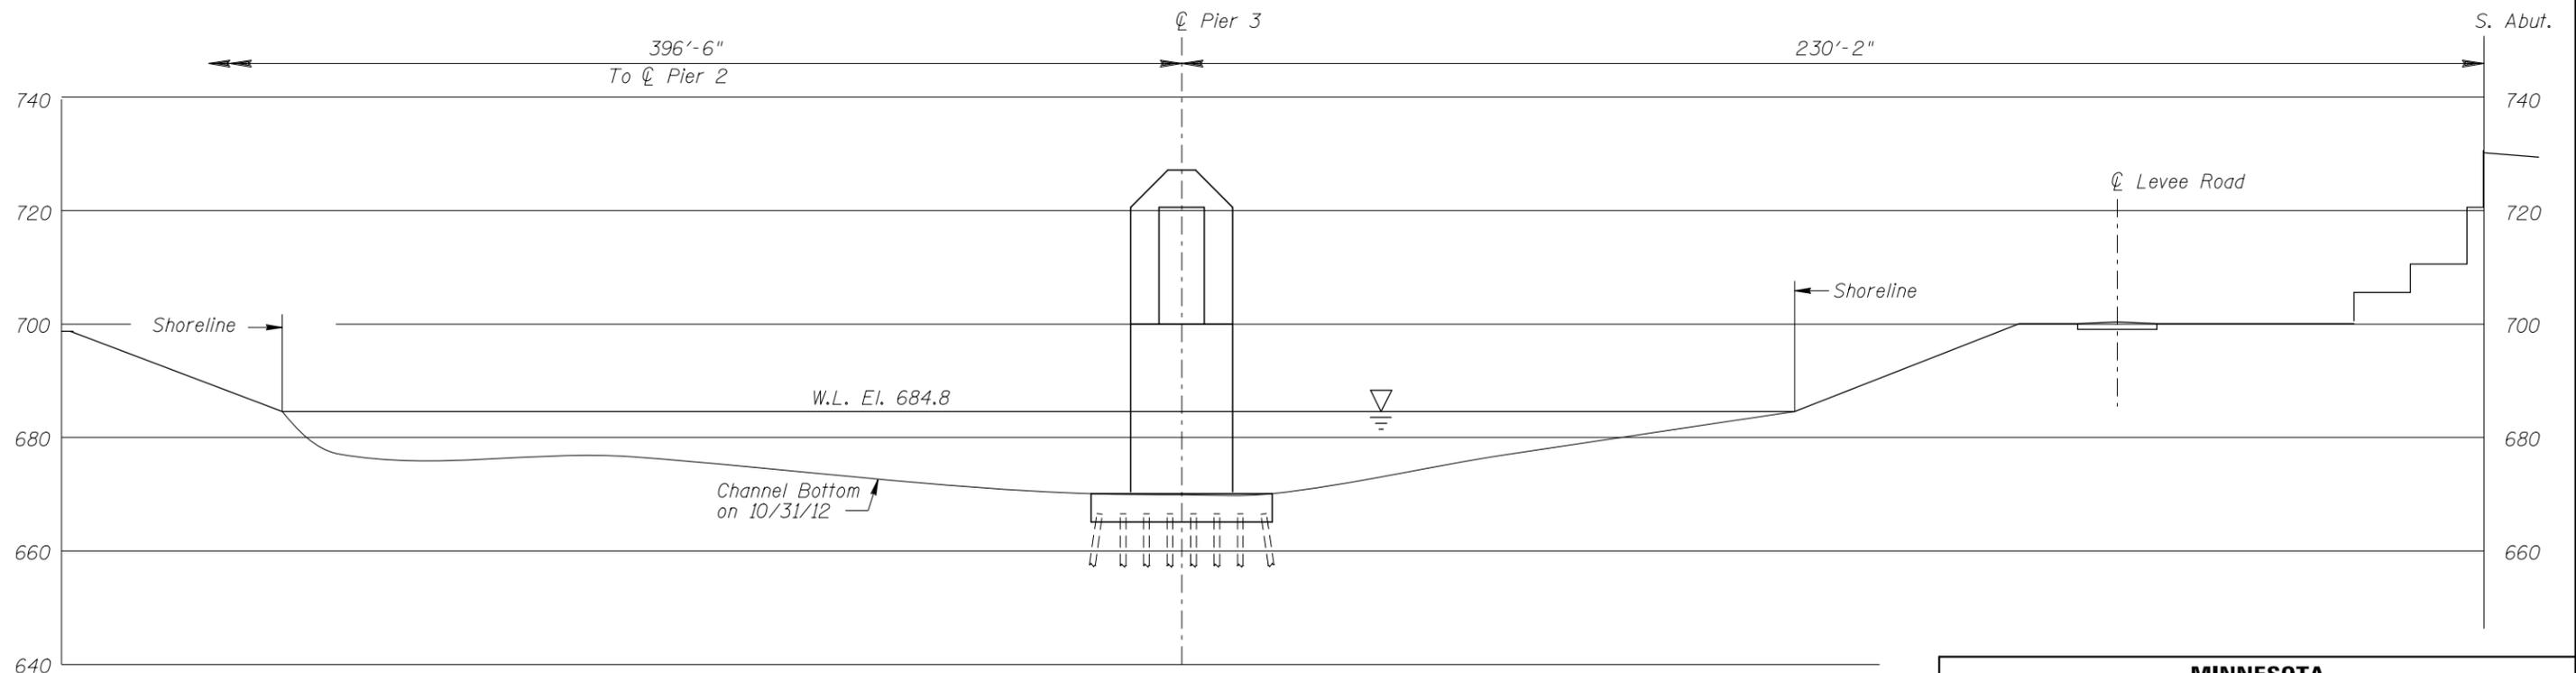
UPSTREAM FASCIA PROFILE

- ① The concrete was in good and sound condition with no structurally significant defects observed.
- ② The channel bottom material consisted of riprap up to 1 foot in diameter at the upstream nose of the pier.
- ③ The channel bottom material downstream of the pier consisted of sandy infilling allowing up to 1 foot of probe rod penetration.
- ④ The embankments were well armored with 1 foot diameter riprap.
