UNDERWATER BRIDGE INSPECTION REPORT

STRUCTURE NO. 62580
RASPBERRY ISLAND (SERVICE) ROAD
OVER THE
MISSISSIPPI RIVER
CITY OF ST PAUL, RAMSEY COUNTY

OCTOBER 31, 2012
PREPARED FOR THE
MINNESOTA DEPARTMENT OF TRANSPORTATION
BY
COLLINS ENGINEERS, INC.
JOB NO. 7423

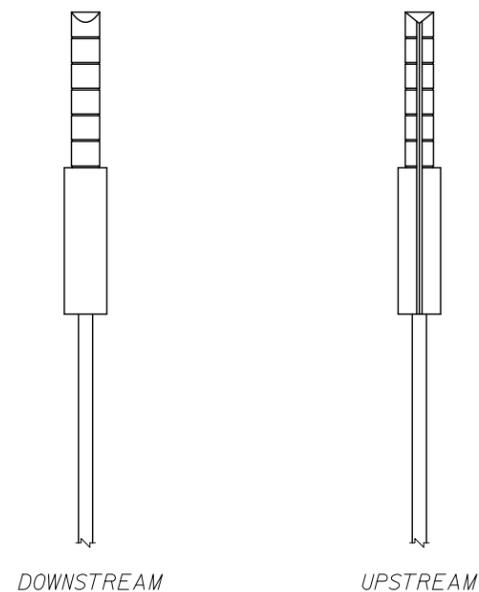
TYPICAL END VIEW OF PIERS

- 3 The channel bottom material consisted of 6 inch diameter cobbles and gravel.
- 4 A minor accumulation of timber debris, with pieces up to 12 inches in diameter, was observed on the channel bottom randomly scattered throughout the piles of Pier 3 extending from channel bottom up 2 to 3 feet.

- 5 Timber formwork and steel angles were observed at the base of the concrete shaft of Pier 4. The bottom of the shaft was poorly formed with rough edges and reinforcing steel protruding from the base.

- 6 The concrete shafts were in good and sound condition and extended 2 feet below the waterline. The submerged steel piles exhibited light surface corrosion with rust nodules up to 1/4 inch in diameter.
