UNDERWATER BRIDGE INSPECTION REPORT

STRUCTURE NO. 70002

THE MINNESOTA RIVER

JOB NO. 2107

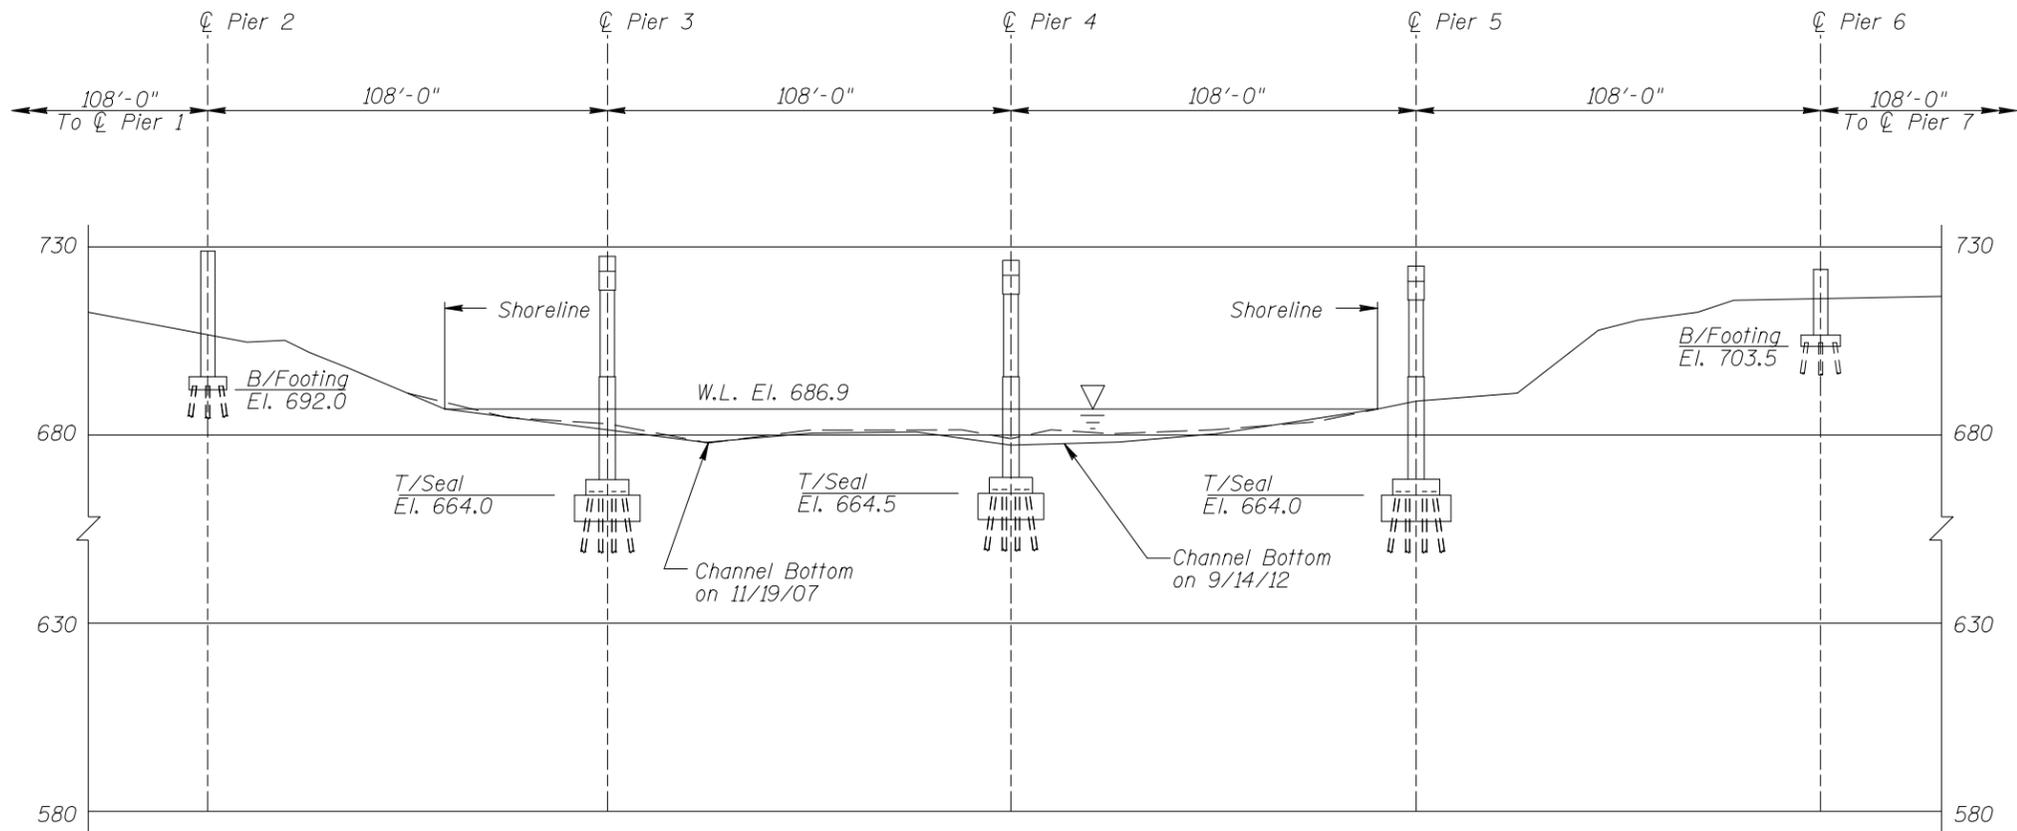
UPSTREAM FASCIA PROFILE

- 3 Random vertical cracks with efflorescence were observed from the top of the shaft ledge to the channel bottom. There were typically two cracks on each pier located near the third points with 1/8 inch maximum width.

- 4 A very heavy accumulation of timber debris consisting of mixed sized drift pieces up to 2.5 feet in diameter, was observed extending across the upstream nose and along both faces of Pier 3. The debris extended up to 50 feet off the pier nose and face and onto the south embankment.

- 5 The channel bottom of Pier 4 consisted of silt, gravel, and clay with up to 6 inches of penetration.
- 6 A moderate accumulation of timber debris consisting of 12 inch diameter and smaller logs and branches was observed from the upstream nose to the upstream quarter points on both sides of Pier 4, extending from the channel bottom up approx. 5 feet.

- 7 A scour depression 5 feet in radius by 2 feet deep was observed at the upstream end of Pier 4.
- 8 The channel bottom of Pier 5 consisted of clay and silt with up to 1.5 feet of probe rod penetration and also stones 6 inches in diameter located at the upstream end.

- (A) Remove the timber debris at Piers 3 and 4. The current extent of debris can adversely affect the scour conditions at the bridge and creates a potential for significant lateral forces exerted on the substructure.
