UNDERWATER BRIDGE INSPECTION REPORT

STRUCTURE NO. 70532

CSAH NO. 9

MINNESOTA RIVER

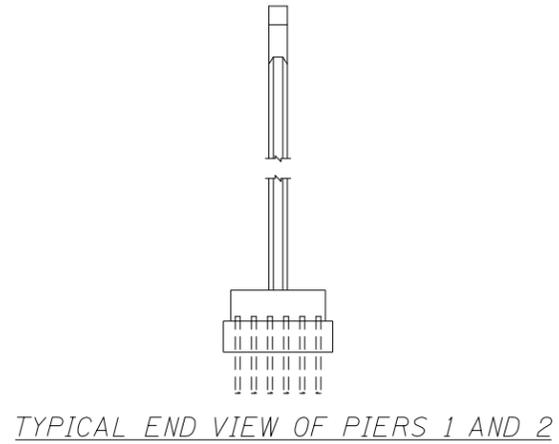
- INSPECTION NOTES:**
- 1 The channel bottom consisted of firm silty clay with a maximum probe rod penetration of 3 inches.
  - 2 A heavy accumulation of timber debris consisting of logs and branches 18 inches in diameter and smaller was observed around the entire perimeter of Pier 2 extending 10 feet off the upstream nose and faces and from the channel bottom to 7 feet above the waterline.

- 3 A moderate accumulation of timber debris, consisting of up to 12 inch diameter drift pieces, was observed at the upstream nose of Pier 1, extending up to 5 feet off the pier nose and from the channel bottom to the waterline.

- 4 The concrete was smooth and sound with no notable defects or deterioration.
  - 5 Remnants of a old abandoned sheet pile cofferdam were encountered extending 2 to 3 feet up out of the channel bottom along the south face of pier 2.
