UNDERWATER BRIDGE INSPECTION REPORT

STRUCTURE NO. 70535

CSAH NO. 1

MINNESOTA RIVER

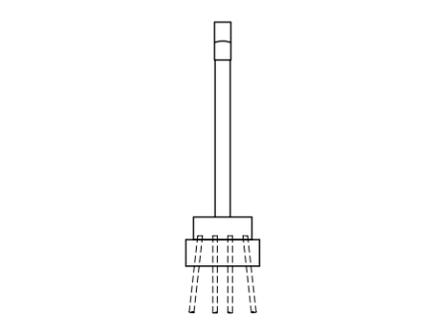
The substructure units inspected at Bridge 70535, Piers 1 and 2, were in good condition with no defects of structural significance observed. A moderate accumulation of timber debris was observed at the upstream end of Pier 2, and a dry scour depression was observed around Pier 3. Heavy embankment erosion was observed along the west shoreline.

- (A) A moderate accumulation of timber debris consisting of 1 foot diameter and smaller logs and branches was observed at the upstream nose of Pier 2 extending from the channel bottom up 4 feet and along the west face from the upstream end to the shaft midpoint extending from the channel bottom up 2 feet.
- (B) A 10 foot radius scour depression 5 to 6 feet deep was observed all around Pier 3 (on easterly bank with no standing water).
- (C) Moderate to heavy embankment erosion was present along the west bank due to a bend in the river and recent flooding.

- 1 The concrete was smooth and sound with no notable defects.
- 2 A 10 foot radius scour depression 5 to 6 feet deep was observed all around the perimeter of Pier 3. The scour hole was dry at the time of inspection.
- 3 The channel bottom consisted of silty clay and rocks with 12 inches maximum probe rod penetration.
- 4 A moderate accumulation of timber debris consisting of 1-foot-diameter and smaller logs and branches was observed at the upstream nose of Pier 2 from the channel bottom up 4 feet and along the west face from the upstream end of the midpoint from the channel bottom up 2 feet.
- 5 The channel bottom consisted of silty clay with 6 inches maximum probe rod penetration along the east face and 6" diameter rocks along the west face of Pier 1.
- 6 Heavy embankment erosion along the west shoreline consisting of up to 15 foot high vertical banks.

- (A) Monitor the extent of the timber debris accumulation at Pier 2, and if found to be increasing, removal during routine maintenance may become necessary.
- (B) Monitor channel bank erosion on the west bank during future inspections.
- (C) Reinspect the submerged substructure units at the normal maximum recommended (NBIS) interval of sixty (60) months.
