UNDERWATER BRIDGE INSPECTION REPORT

STRUCTURE NO. 90608
MINNETONKA BOULEVARD
OVER
ST. ALBAN'S BAY
DISTRICT 5 – CITY OF EXCELSIOR AND CITY OF GREENWOOD

JUNE 6, 2012

PREPARED FOR THE
MINNESOTA DEPARTMENT OF TRANSPORTATION

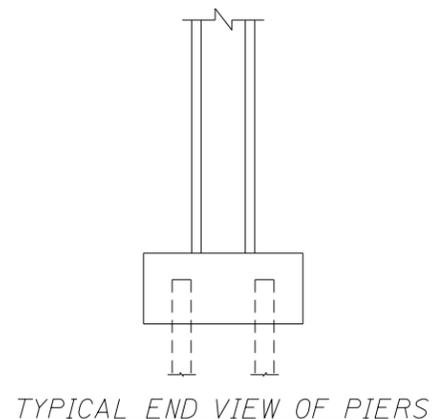
- 2 A spall with associated cracking was observed on the northwest corner of the west end of Pier 1 and was located at the waterline measuring 10 inches high by 18 inches wide with 1 inch maximum penetration.

- 3 A 1/16 inch layer of marine growth was observed on all below water surfaces.
- 4 Two horizontal cracks up to 1/8 inch wide were observed near the waterline. The cracks extended from the midpoint of the pier to the west end.

- 5 A vertical crack along the construction joint was observed near the center of the pier and extended from the top of the pier cap to the channel bottom with 1/8 inch maximum width. Minor section loss and differential movement up to 1/8 inch was observed in the north face crack on Pier 1 from the waterline to the channel bottom.

- 6 A spall with exposed reinforcing steel was observed on the southwest corner of east end of Pier 1 extending from the top of the pier cap to 3 feet above the waterline and measuring up to 3 feet in width with penetrations up to 3 inches deep. Exposed reinforcing steel exhibited up to 50% section loss.

- 10 Three horizontal cracks were observed from waterline up 4 feet. The cracks typically extended along the entire south face of the pier and were up to 1/16 inch wide.

- 11 The west end of the concrete river wall was undermined along a 3 foot length with a cavity measuring 6 inches high with up to 2 feet of horizontal penetration.
