UNDERWATER BRIDGE INSPECTION REPORT

STRUCTURE NO. 94246
ABANDONED RAILROAD (PEDESTRIAN BRIDGE)
OVER THE
MISSISSIPPI RIVER
HENNEPIN COUNTY, CITY OF MINNEAPOLIS

OCTOBER 29, 2012
PREPARED FOR THE
MINNESOTA DEPARTMENT OF TRANSPORTATION
BY
COLLINS ENGINEERS, INC.
JOB NO. 7423

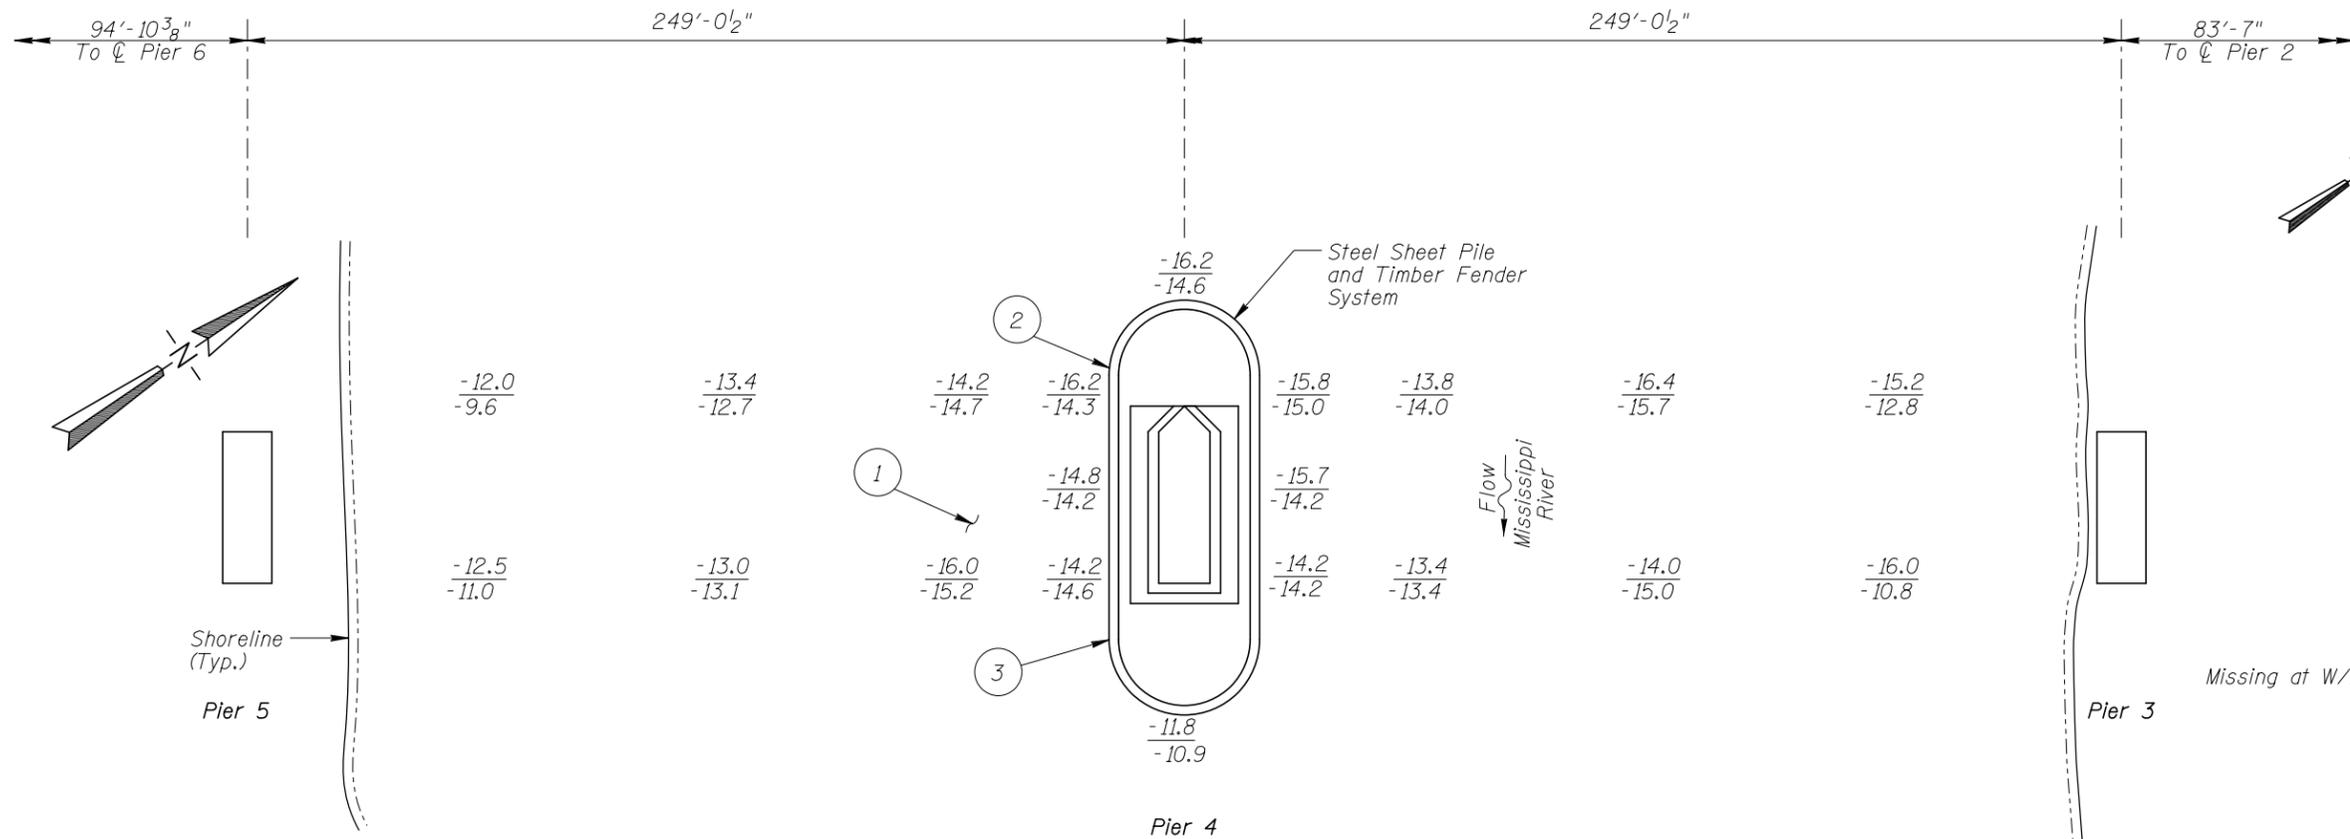
FENDER DAMAGE PLAN
Other random less significant deterioration and impact damage also present.

- 1 The channel bottom material consisted of sand, gravel and areas of riprap, 3 feet diameter and smaller, allowing 2 inches of probe rod penetration.
- 2 The steel sheeting encasing the concrete pier below water displayed a 1/8 inch layer of light to moderate corrosion, random 1 inch diameter rust nodules, and random 1/8 inch deep pitting.
- 3 Fender system timber whalers were in fair to poor condition with some areas of decay and rot at the waterline and several failed connections. Moderate impact damage was evident in several locations around the pier perimeter. (See Fender Damage Plan).

* Depending on the proposed future use of the structure, consideration can be given to replacing the missing, deteriorated and damaged timber fender components during normal maintenance operations.

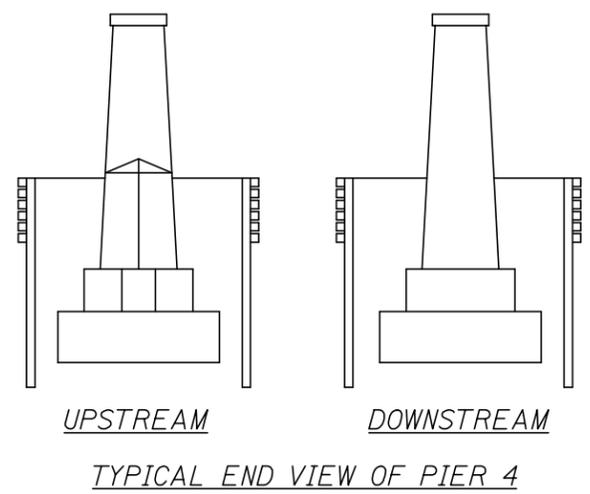
1. Pier 4 was inspected underwater.
2. At the time of inspection on October 29, 2012 the waterline was located approximately 11.5 feet below the top of the steel sheet pile fender system at the downstream end of Pier 4. This corresponds to a waterline elevation of 725.5.
3. Soundings indicate the water depth at the time of inspection and are measured in feet.
4. Soundings were taken parallel to the bridge at 1/4 point intervals between the substructure units.
