UNDERWATER BRIDGE INSPECTION REPORT

STRUCTURE NO. L5773
MUN 1 (BLACK DOG RD.)
OVER
BLACK DOG CREEK
CITY OF BURNSVILLE

MAY 21, 2012

BY
COLLINS ENGINEERS, INC.

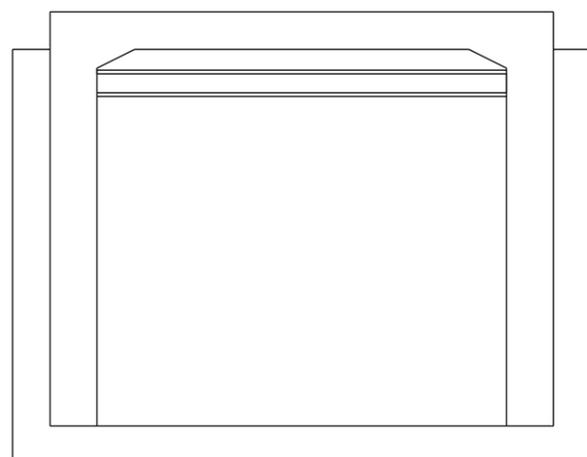
TYPICAL END VIEW OF STRUCTURE

- ① Channel bottom material consisted of a concrete floor.
- ② Channel bottom material consisted of construction debris and riprap up to 2 feet in diameter.
- ③ Channel bottom material consisted of silty clay with up to 6 inches of probe rod penetration.
- ④
- ⑤ T
- ⑥
- ⑦
- ⑧
