HydInfra Inspection Manual

Culvert and Storm Drainage Systems

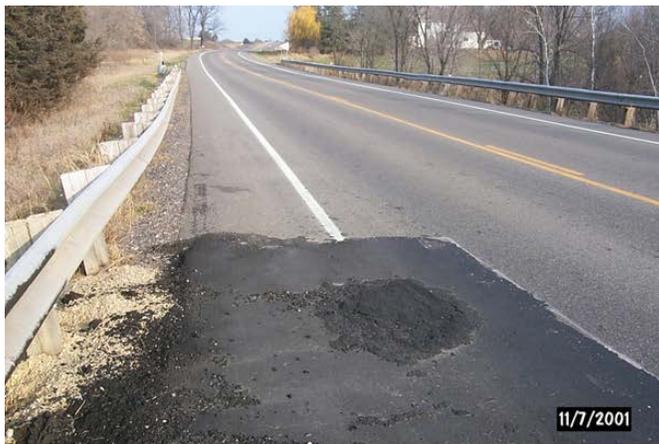
MN 95 near MP 89, near Marine on the St. Croix

The general conditions of the roadway and adjacent area are used as clues to help determine the condition rating for each hydraulic feature that is inspected. These general conditions may be indicators of concealed structural problems.

Road surface may indicate condition of pipe
