**XX-ROD-002 TH 40 Causeway and Highway Segment**

**Other Name:** Milan Crossing, LQP Narrows  
**Location:** TH 40 from 750' NE of LQP CSAH 33 to 650' SW of Chippewa CSAH 30  
**County:** Lac qui Parle, Chippewa  
**Township:** Hantho Twp, Kragero Twp  
**TRS:** 119N 42W, Sec 19; 119N 43W, Sec 24-25  
**Built:** 1934-1941  
**Designer:** Meyer, Norling, MN Dept Hwys  
**Builder:** WPA, MN Dept Hwys

**XX-BRI-003 TH 40 Causeway: Bridge 5380**

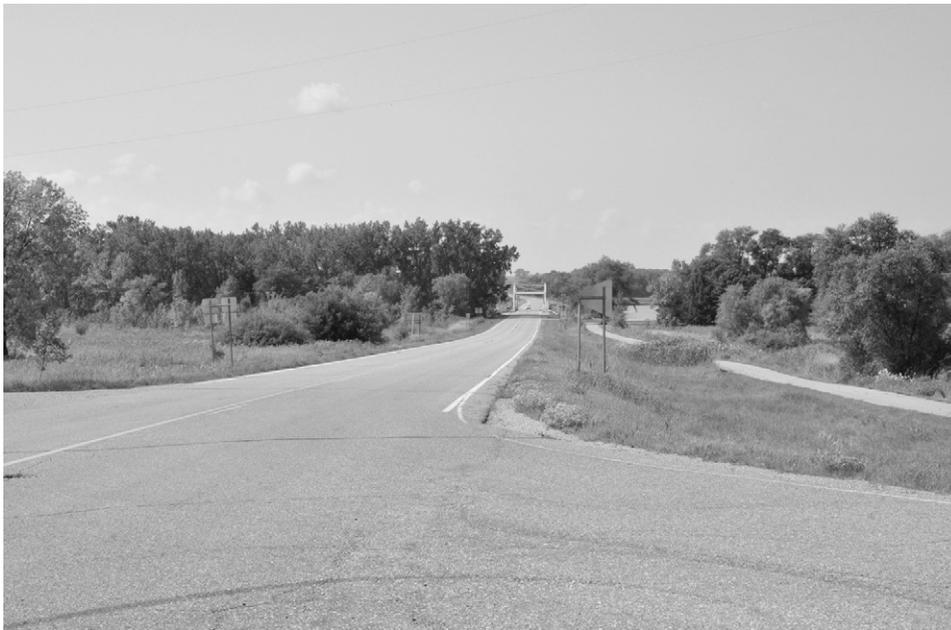
**Fig. 151. XX-ROD-002.** TH 40 Causeway and Highway Segment, the intact WPA-built segment begins 650' toward the river from this junction (facing SW)

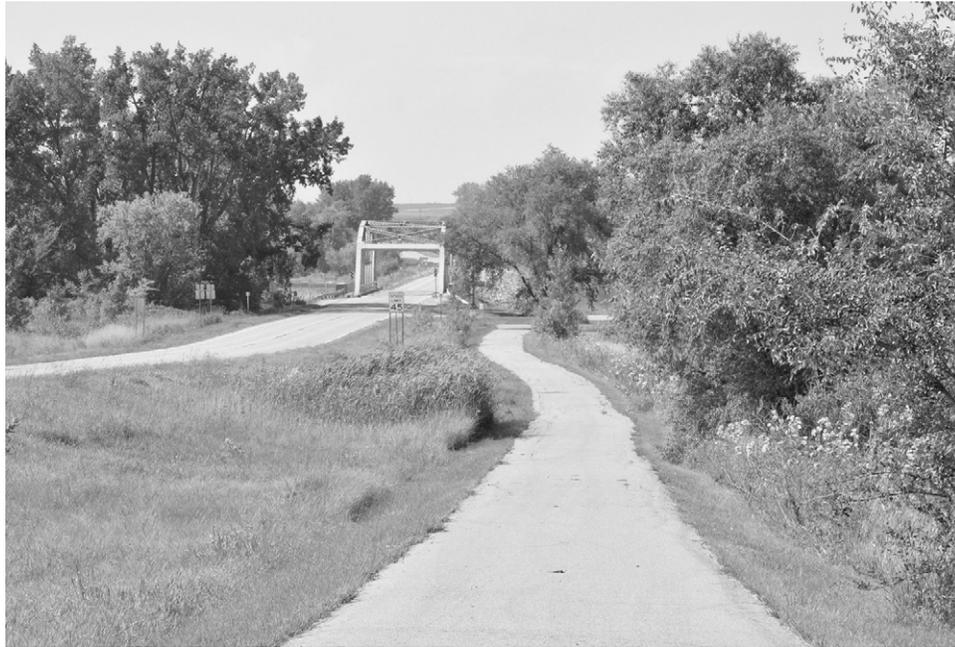
**Fig. 152. XX-ROD-002.** TH 40 Causeway and Highway Segment with recent bike path on the north side of the highway (facing SW)

A bituminous-paved bike path, about 10' wide, has been built recently along the northern side of TH 40 east of the reservoir.

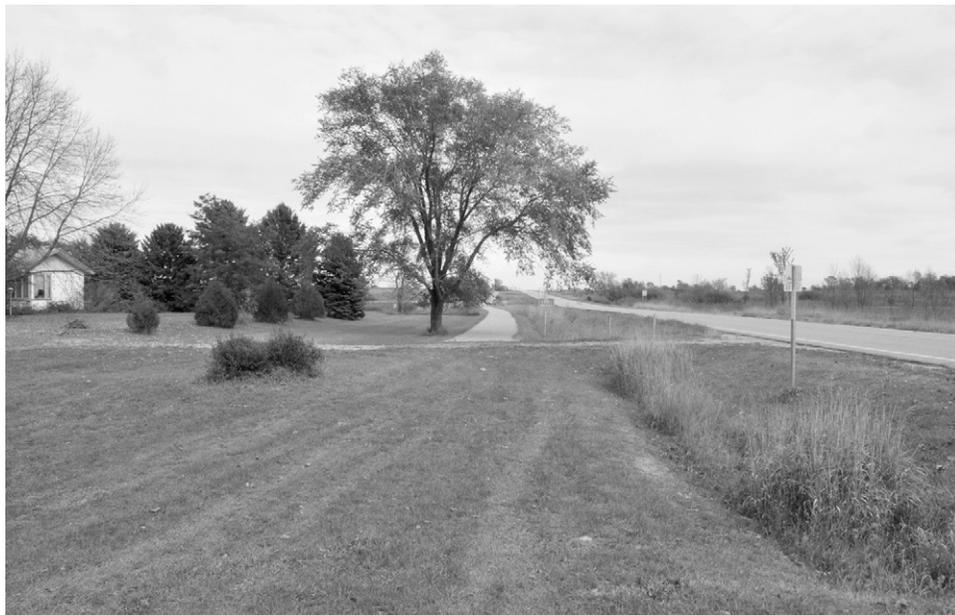
**Fig. 153. XX-ROD-002.** TH 40 Causeway and Highway Segment with recent bike path on the north side of the highway (facing NE)

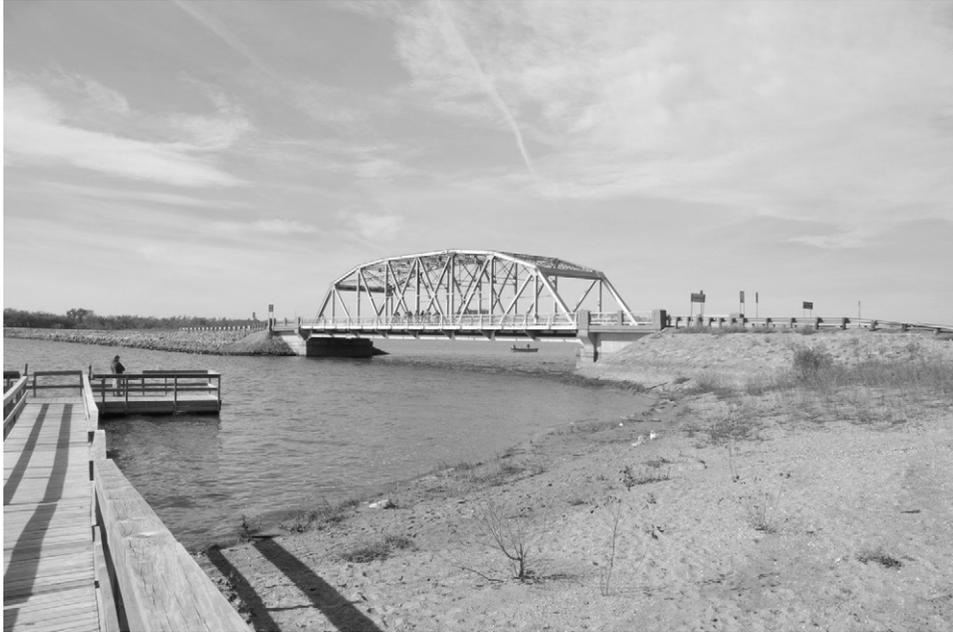
**Fig. 154. XX-ROD-002. TH 40 Causeway and Bridge 5380 with Milan Beach at lower right (facing W)**

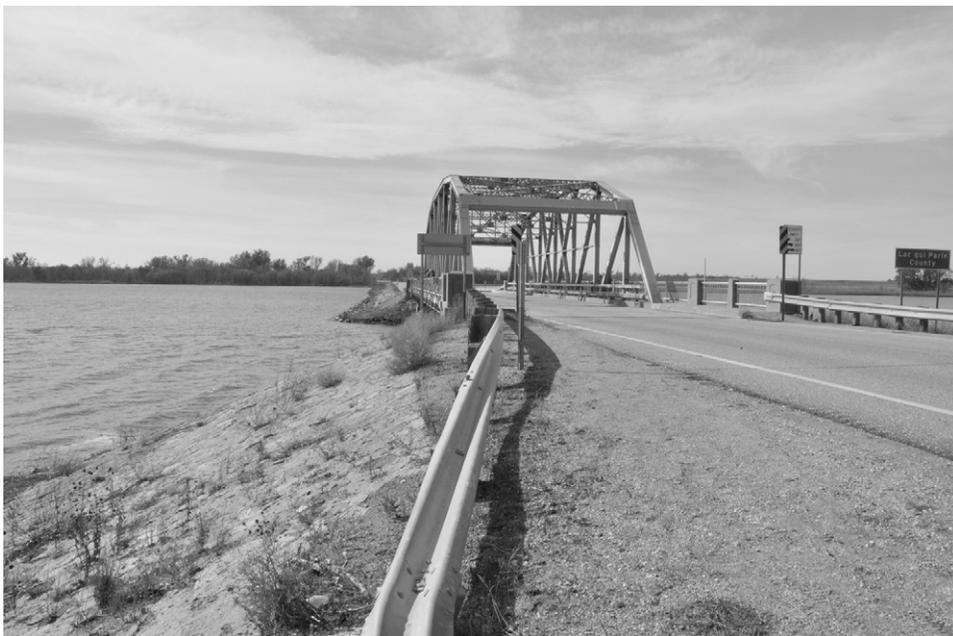
**Fig. 155. XX-ROD-002. TH 40 Causeway and Bridge 5380 (facing SW)**

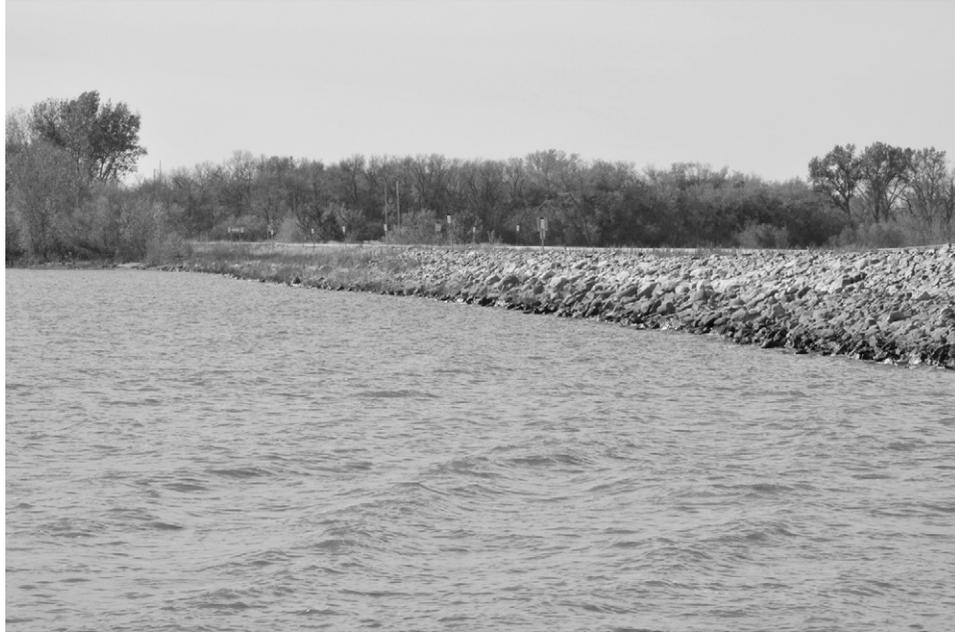
**Fig. 156. XX-ROD-002. TH 40 Causeway and Highway Segment, downstream side (facing W)**

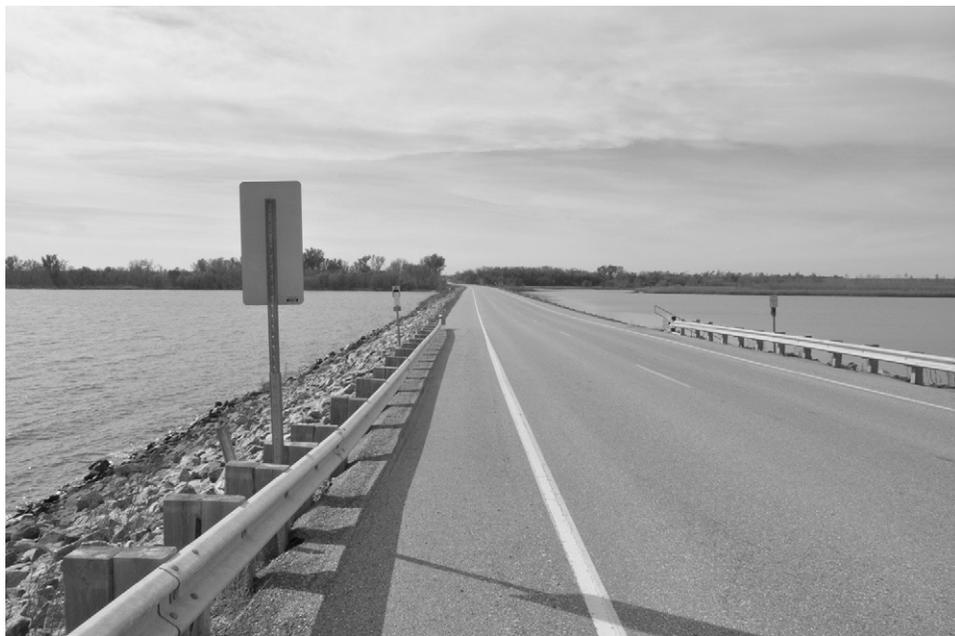
**Fig. 157. XX-ROD-002. TH 40 Causeway and Highway Segment (facing SW)**

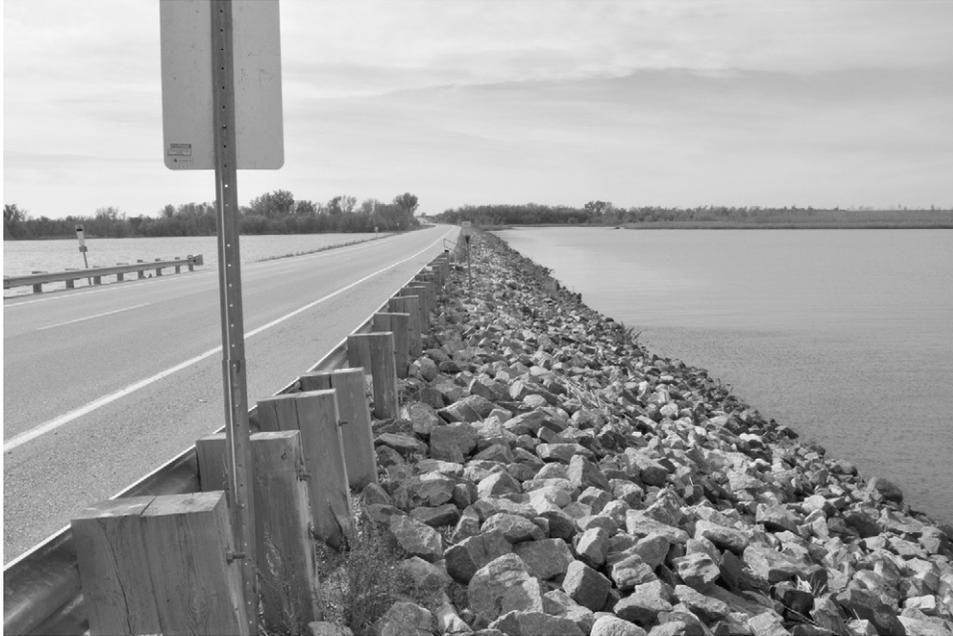
**Fig. 158. XX-ROD-002.** TH 40 Causeway and Highway Segment, upstream side (facing SW)

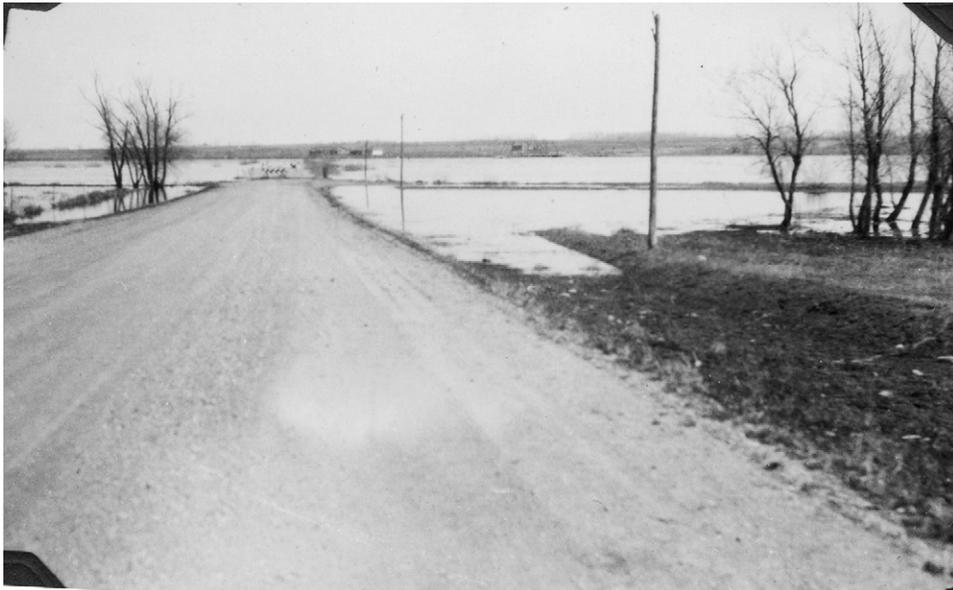
**Fig. 159. XX-ROD-002.** TH 40 Causeway and Highway Segment, being built near southwest end of causeway, ca. 1938 (MHS photo) (facing NE)

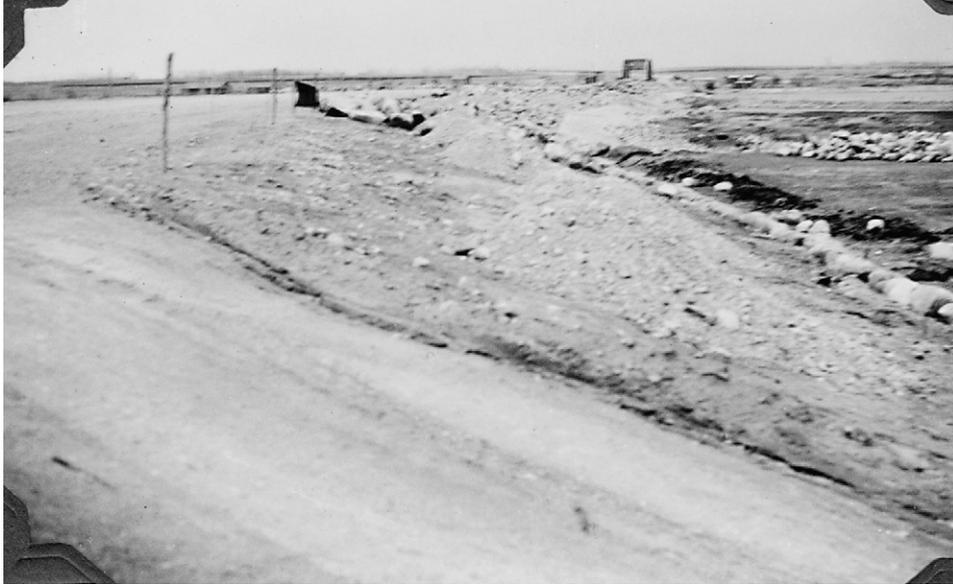
Fig. 160. XX-ROD-002. TH 40 Causeway and Highway Segment, being built near southwest end of causeway, ca. 1938 (MHS photo) (facing NE)

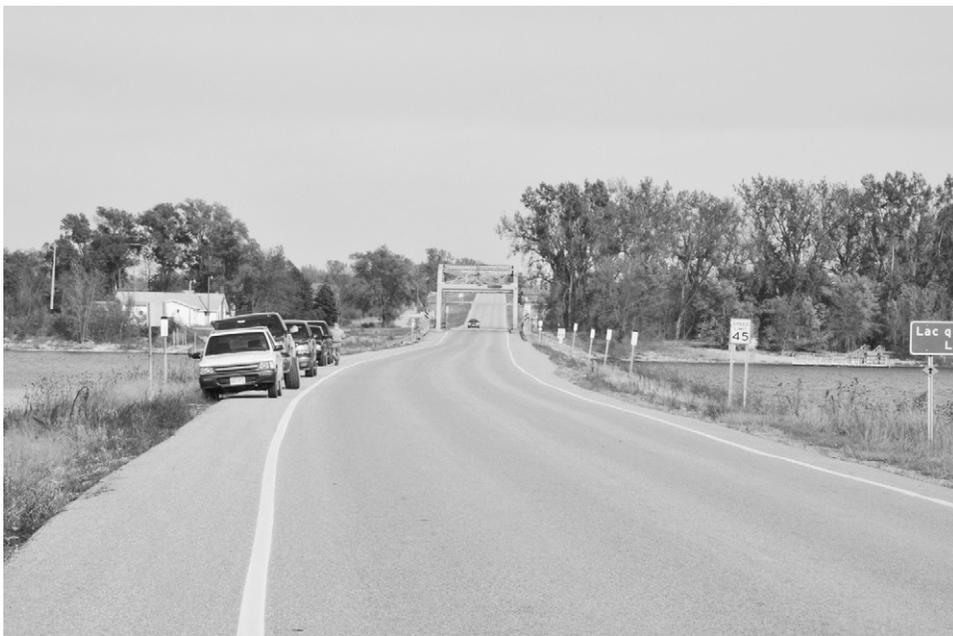
Fig. 161. XX-ROD-002. TH 40 Causeway and Highway Segment (facing NE)

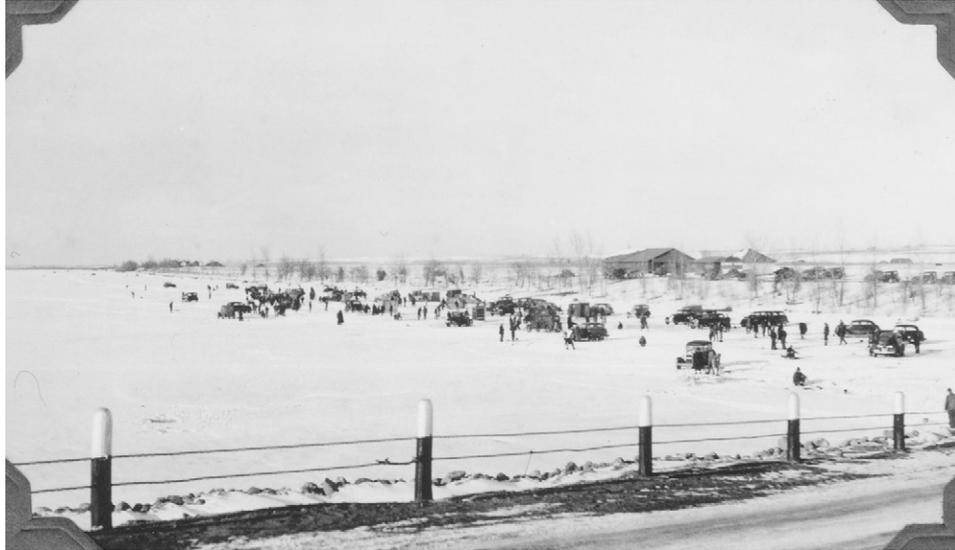
**Fig. 162. XX-ROD-002.** TH 40 Causeway, northeast shore of Lac qui Parle from TH 40 (with ice fishermen), Dec. 1937 (MHS photo) (facing N)

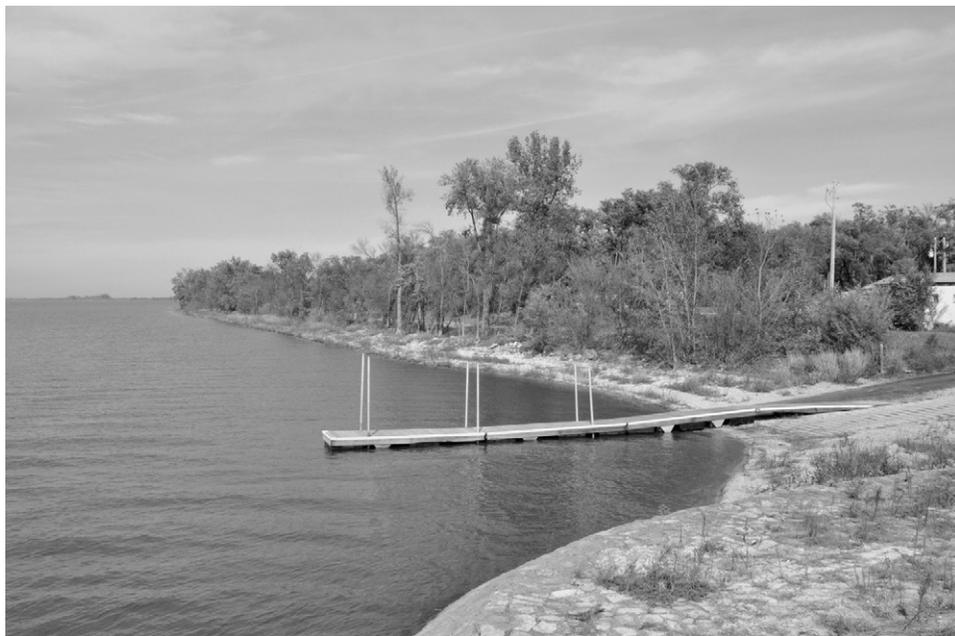
**Fig. 163. XX-ROD-002.** TH 40 Causeway, northeast shore of Lac qui Parle Reservoir from causeway, Milan Beach North Public Water Access dock (facing N)

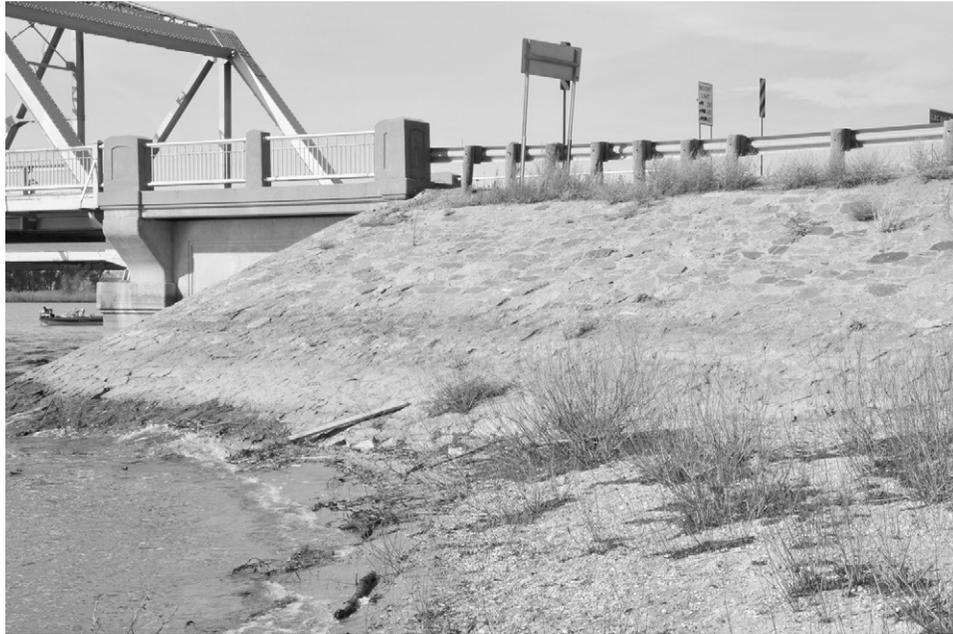
Where the causeway meets the abutments of Bridge 5380, the causeway is curved and is protected by large areas of well-built, hand-fit, mortared granite riprap laid by the WPA. The mortared riprap is more extensive on the eastern end of the bridge. The pieces of granite are flat and come in various shades of gray, red, pink, and black. The rocks are closely-fit in a somewhat interlocking, random pattern so that the riprap forms an even, basically smooth surface. Many of the stones were intentionally placed to display quarry drill marks for aesthetic interest. The hand-fit riprap is in fair to good condition. The areas near the western end of the bridge have been covered by a thin layer of concrete that partly obscures the stones.

**Fig. 164. XX-ROD-002.** TH 40 Causeway, hand-fit riprap at the southeast corner of the bridge (facing NW)

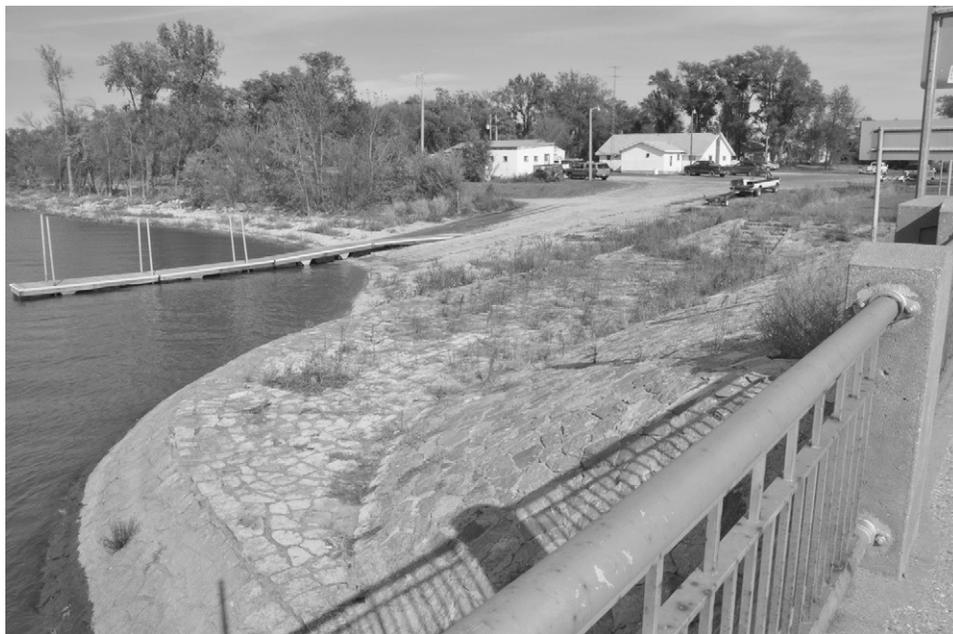
The hand-fit riprap near the bridge is one of the most elaborate extant examples in the Lac qui Parle Flood Control Project. At the northeastern corner of the bridge is a two-tiered area that resembles a small pedestrian concourse allowing visitors to approach the water and bridge. The lower tier is reached via a well-designed and well-built three-part closed-string stone staircase. The upper course, closest to the TH 40 shoulder, has five steps, the middle section has about seven steps, and the lower course has three steps. Aerial photos show that the lower run of steps is sometimes submerged in times of high water. Between the top and middle stair runs, which are perpendicular, is a gracefully curved stone landing. Stones for the stair treads were chosen to display quarry drill marks. The upper and middle sections of the staircase are about 8' wide and the treads have an exposure of about 12" and 18" for walking. (Note: the impressive hand-fit riprap at the eastern end of the bridge is being damaged by uncontrolled weed growth. It is recommended that Mn/DOT control the weeds at this location using chemicals and methods appropriate for this type of sensitive area (above a waterway) so that the stonework is not damaged.)

**Fig. 165. XX-ROD-002.** TH 40 Causeway, small riprapped pedestrian concourse below the northeast corner of the bridge (facing NE)

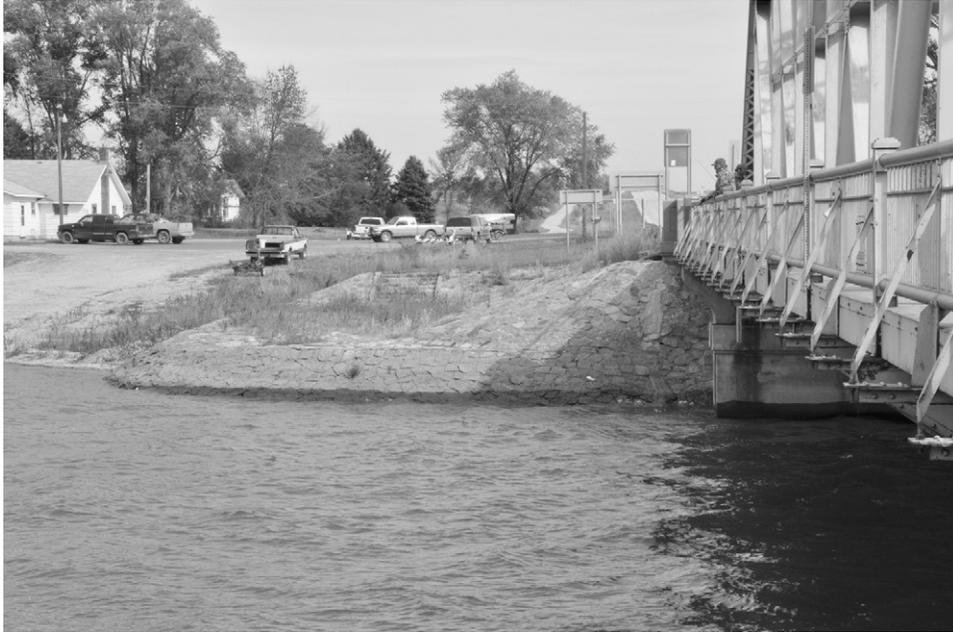
**Fig. 166. XX-ROD-002.** TH 40 Causeway, hand-fit riprap at the northeast corner of the bridge (facing NE)

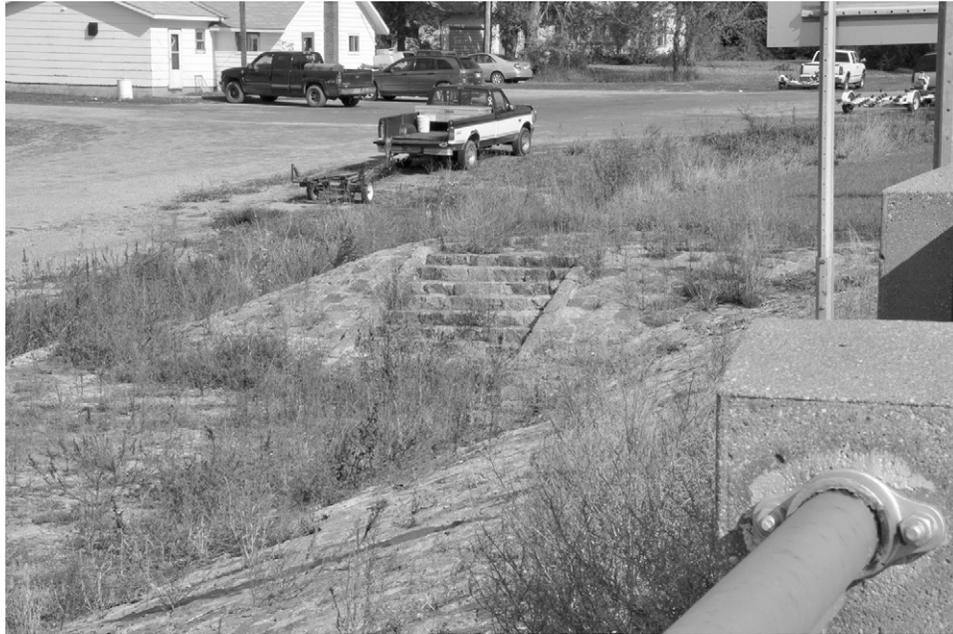
**Fig. 168. XX-ROD-002.** TH 40 Causeway, hand-fit riprap and stone staircase at the northeast corner of the bridge (facing NE)

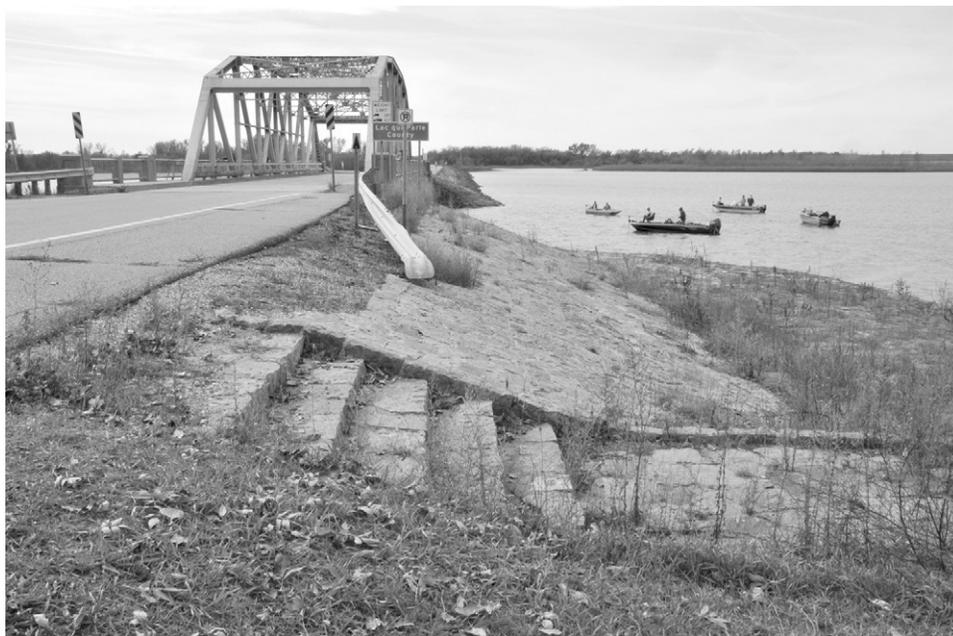
**Fig. 169. XX-ROD-002.** TH 40 Causeway, upper run of stone steps at the northeast corner of the bridge (facing SW)

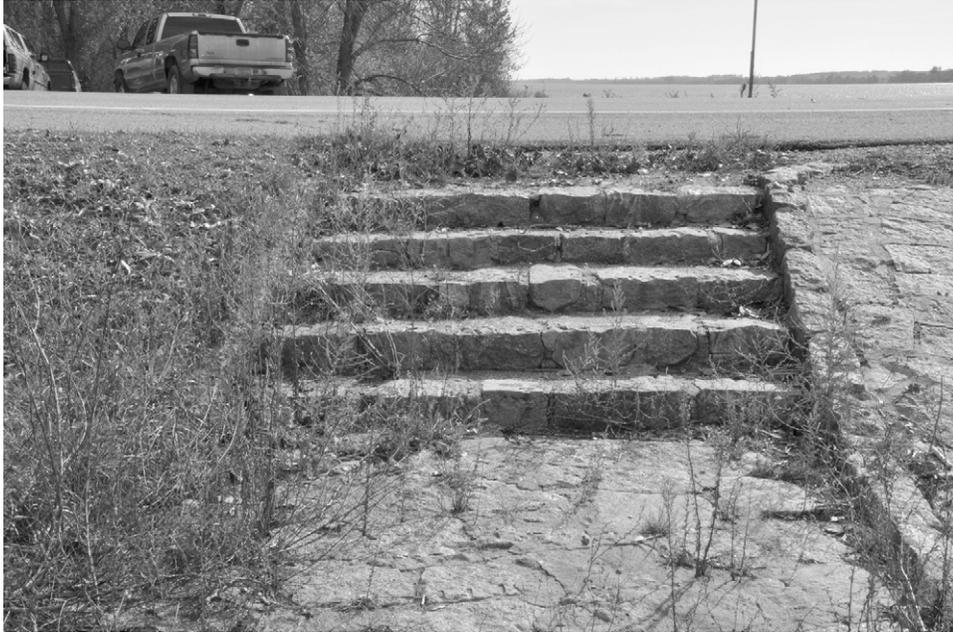
**Fig. 170. XX-ROD-002. TH 40 Causeway, upper run of steps at the northeast corner of the bridge (facing SE)**

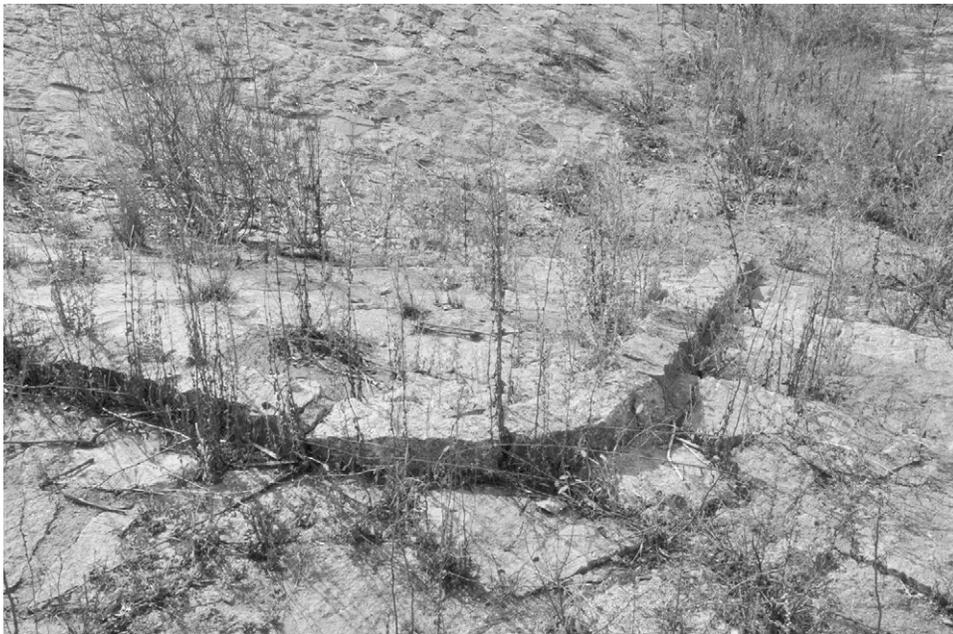
**Fig. 171. XX-ROD-002. TH 40 Causeway, turn in stone staircase (facing NW)**

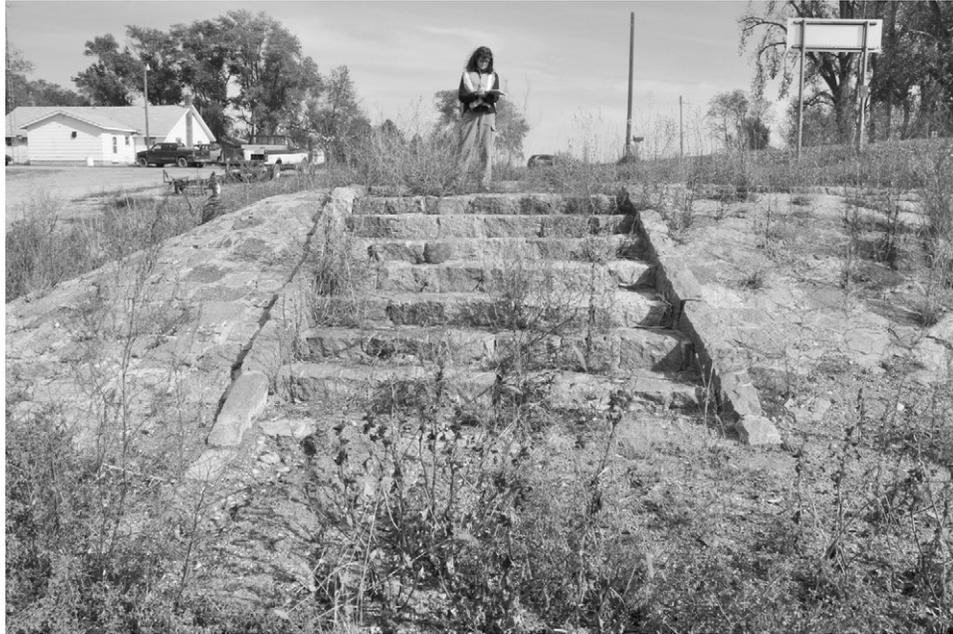
**Fig. 172. XX-ROD-002.** TH 40 Causeway, middle run of stone steps (after turn in staircase) (facing NE)

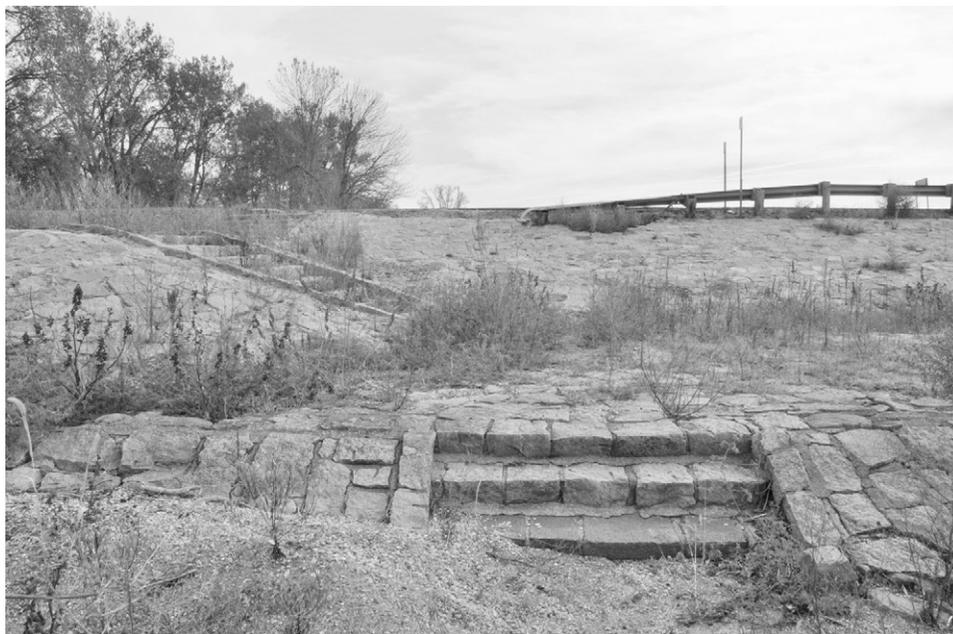
**Fig. 173. XX-ROD-002.** TH 40 Causeway, middle and lower runs of steps (facing SE)

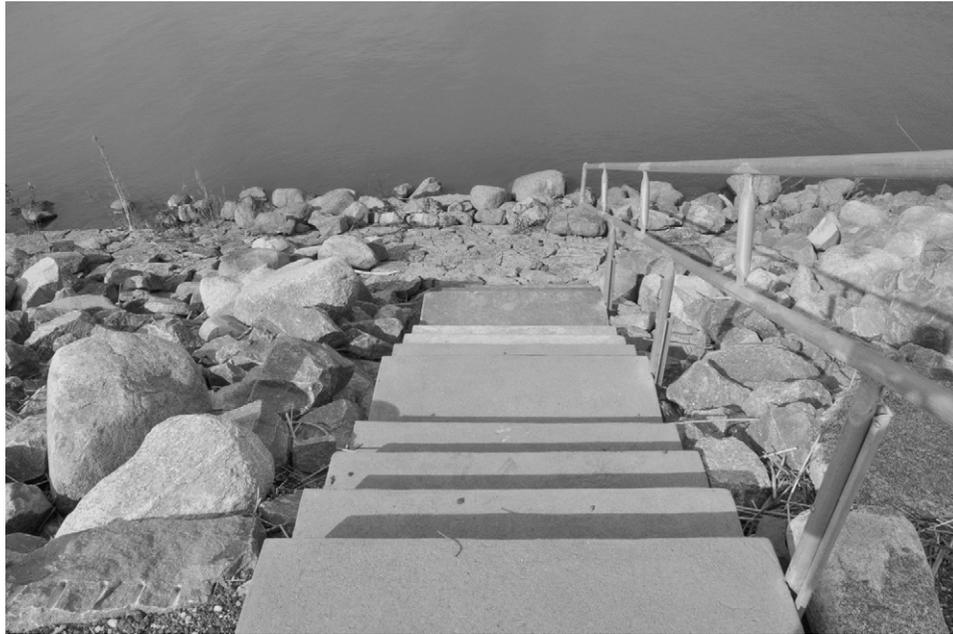
At the western end of the bridge's northwestern guardrail (on the northern side of the causeway) is a recent poured concrete stairway that descends to the water. It has about 11 steps and a pipe railing.

**Fig. 174. XX-ROD-002.** TH 40 Causeway, recent concrete steps southwest of, and built to replace, the stone steps in the next photo (facing NW)

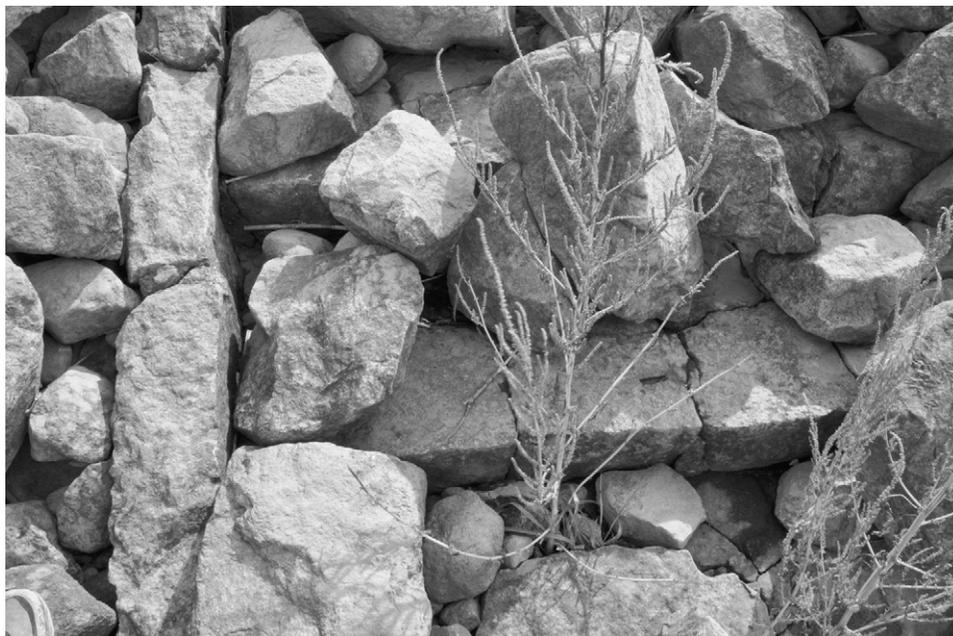
There is another closed-string stone staircase about 350' southwest of the bridge on the northern side of the causeway. It is about 18' long and about 9' wide and descends from the shoulder of the road to the water. It is very similar in style and craftsmanship to the steps at the end of the causeway. The staircase appears to be intact on a 2003 aerial photo. Sometime after 2003 it was covered with a layer of dumped riprap (placed during a riprapping of the entire causeway). The staircase appears to intact under the layer of stones. (Gemini Research recommends that the stones be lifted off the staircase to reveal it.)

**Fig. 175. XX-ROD-002.** TH 40 Causeway, stone steps on northwest side of causeway covered with riprap, stringer and tread barely visible (facing SE)

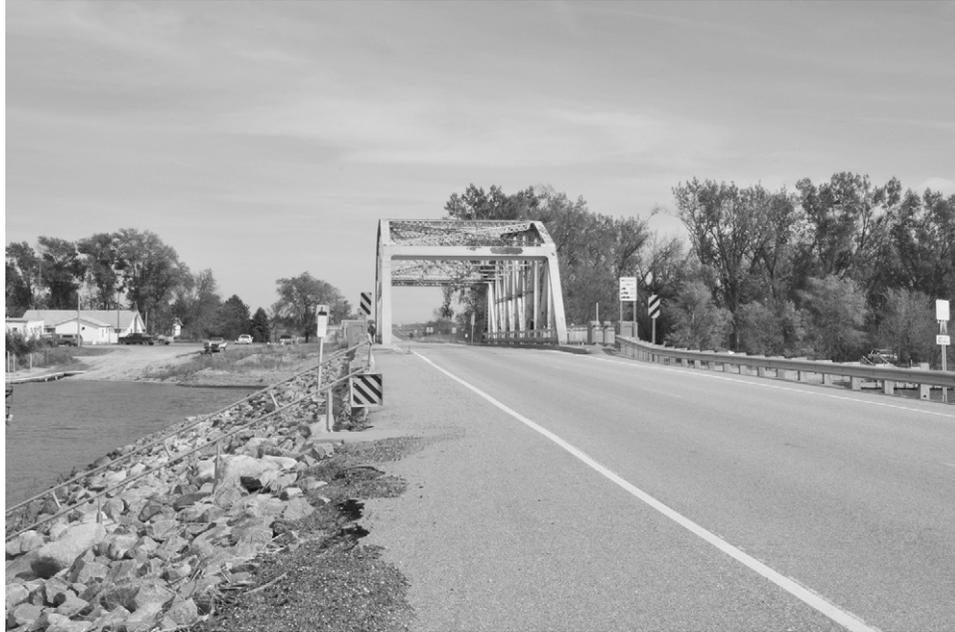
**Fig. 176. XX-ROD-002. TH 40 Causeway (railing of recent concrete steps in previous photo descends at left) (facing NE)**

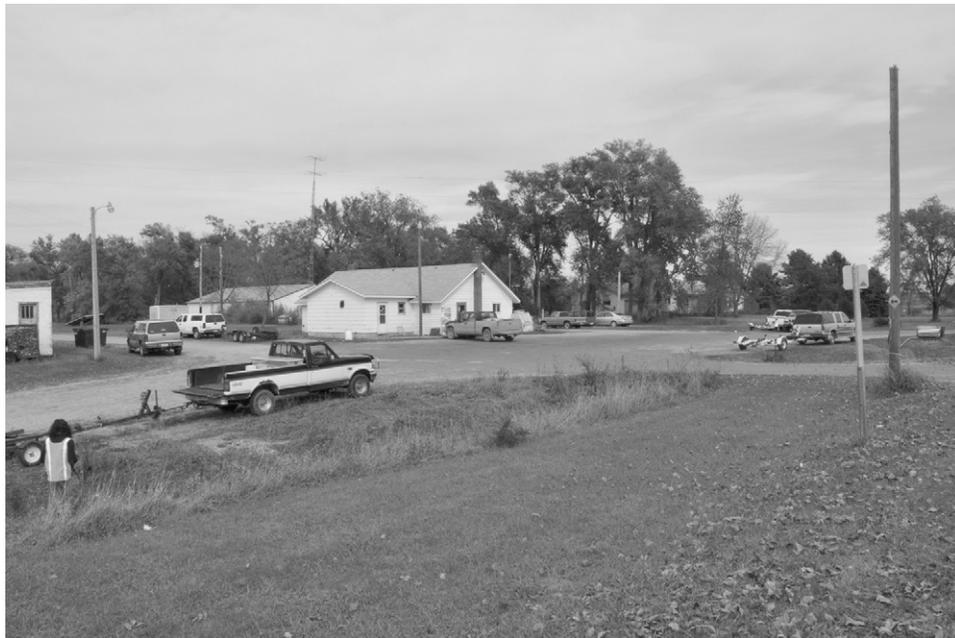
East of the causeway, on the northern side of TH 40, are three entrances: one close to Milan Beach North Public Water Access, one in front of Milan Beach Resort, and one in front of the resort owners' house. A 1938 aerial photo shows the western two entrances newly-built and suggests they are still basically intact today. The eastern does not appear on the aerial photo and was probably added 1960. The ditch west of the western entrance has a stone-paved floor, part of which remains exposed. The stone paving may have originally extended farther east along the ditch. One of the two western entrance roads retains a granite headwall for its culvert. The headwall is about 10' long (north-south).

**Fig. 177. XX-ROD-002. TH 40 Causeway, stone-paved ditch (has tall grasses and is parallel with pickup truck) (facing N)**

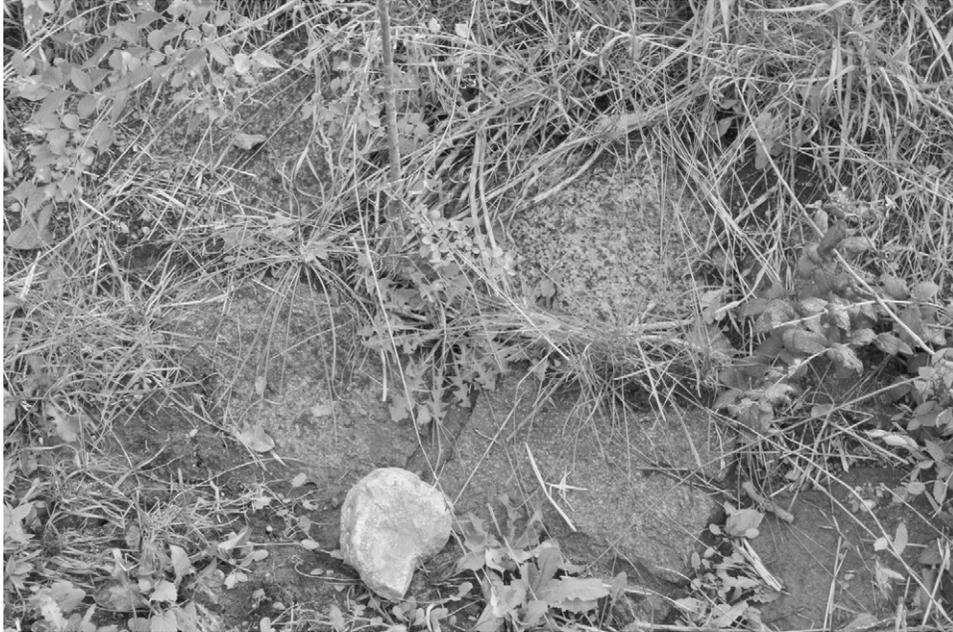
**Fig. 178. XX-ROD-002.** TH 40 Causeway, stone paving in the ditch identified in previous photo (facing E)

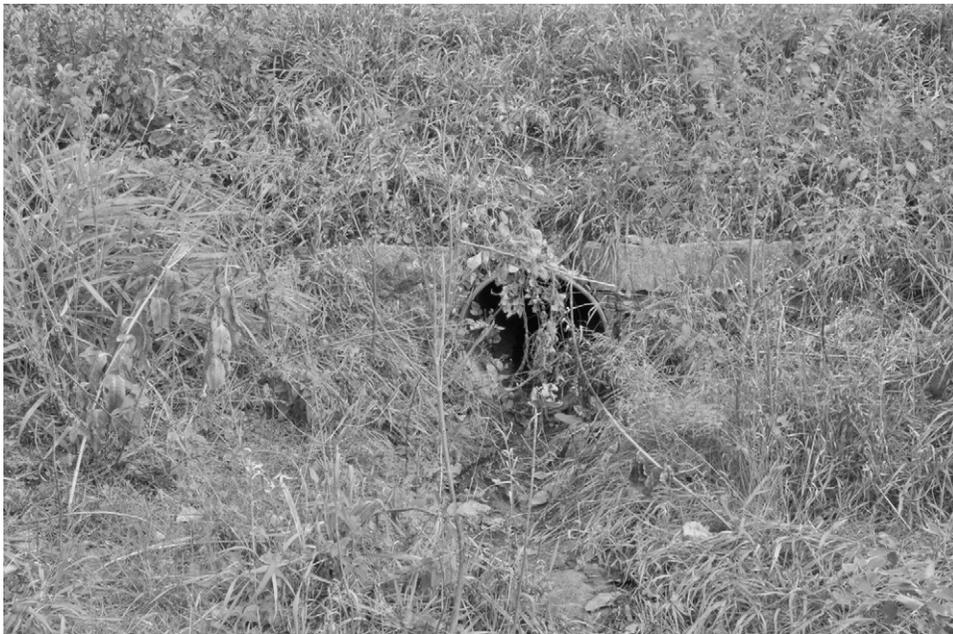
**Fig. 179. XX-ROD-002.** TH 40 Causeway, culvert with stone headwall at the ditch identified in photo above (facing NE)

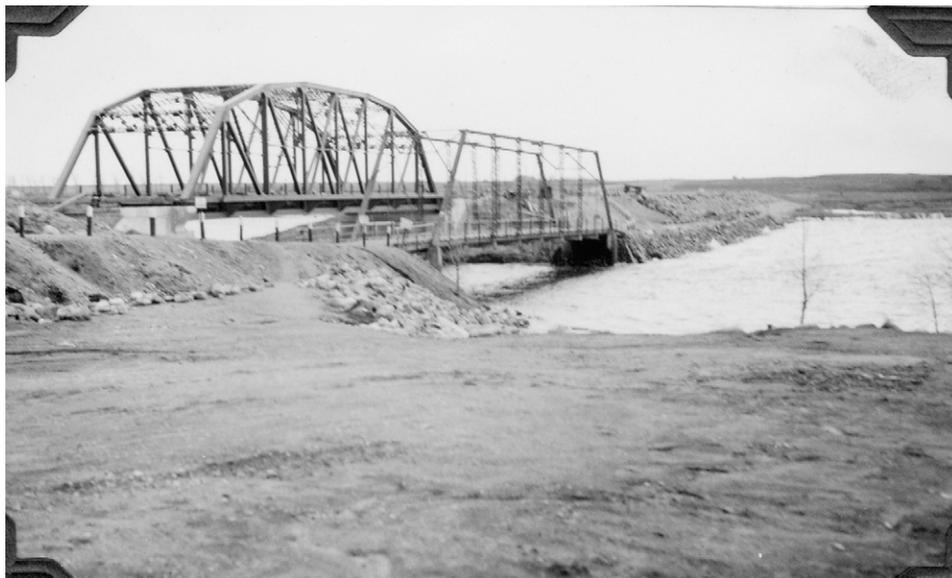
**Fig. 180. XX-BRI-003.** TH 40 Causeway: Bridge 5380 with the previous bridge (at a lower elevation), ca. 1938 (MHS photo) (facing W)

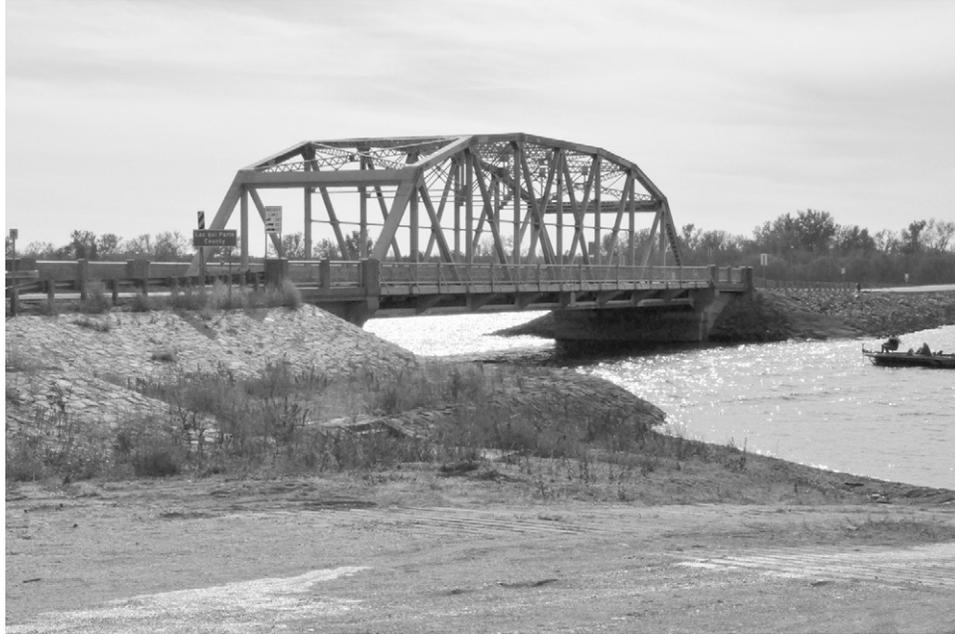
**Fig. 181. XX-BRI-003. TH 40 Causeway: Bridge 5380, view from similar location as previous photo (facing W)**

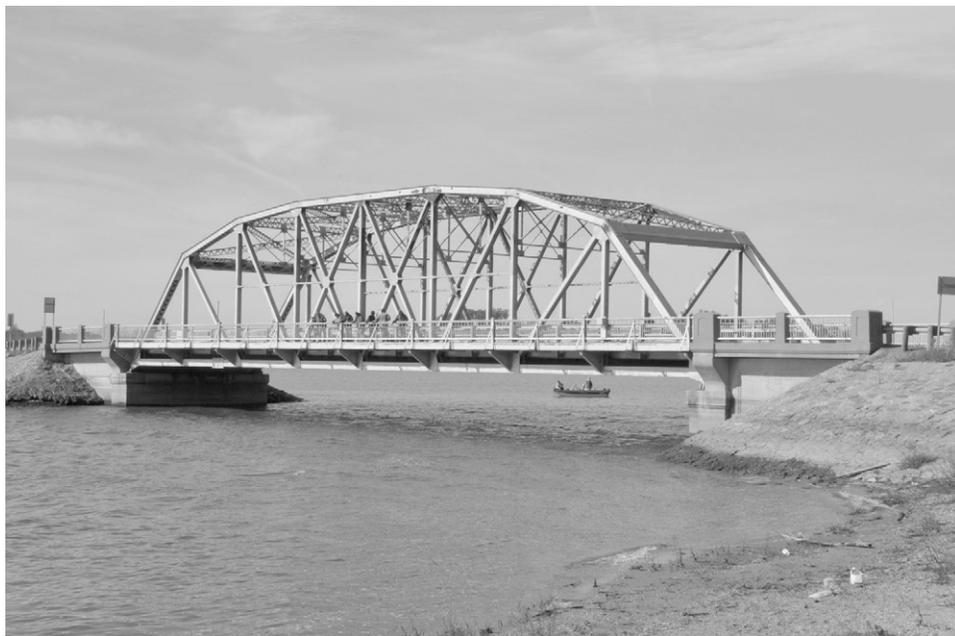
Bridge 5380 is located near the northeastern end of the TH 40 Causeway, which also retains good historic integrity. The bridge spans the main channel of the Minnesota River at River Mile 294. The bridge is a single-span, riveted steel, 8-panel Parker through truss with concrete slab approach spans. The bridge is 220' long with a main span of 162'. There are two approach spans. The deck is 28.5' wide and built of bituminous over concrete which is supported by 11 rolled I-beam stringers riveted to floor beams (Hess ca. 1996; see Hess for more detailed description of the trusses from the Mn/DOT Historic Bridge Survey).

**Fig. 182. XX-BRI-003. TH 40 Causeway: Bridge 5380 (facing W)**

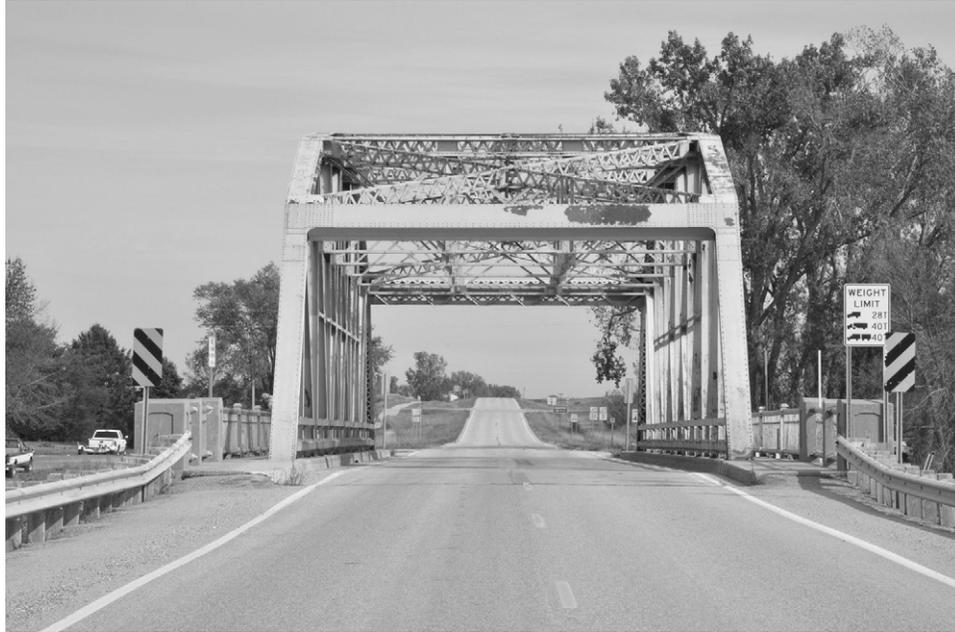
According to the Mn/DOT Historic Bridge Study, in 1967 the MHD “raised and reconfigured [the bridge’s] portal bracing, replacing the original ‘6-X’ configuration of angle-section cross bracing with a sleek, boxed member consisting of a channel section, web plate, and laced angle sections. This alteration significantly altered the bridge’s appearance and compromised its historical integrity under [National Register] Criterion C” (Hess ca. 1996). The portals of the two truss bridges on the TH 119 Causeway were similarly altered at about the same time.

Fig. 183. XX-BRI-003. TH 40 Causeway: Bridge 5380 with rebuilt truss portal (facing NE)

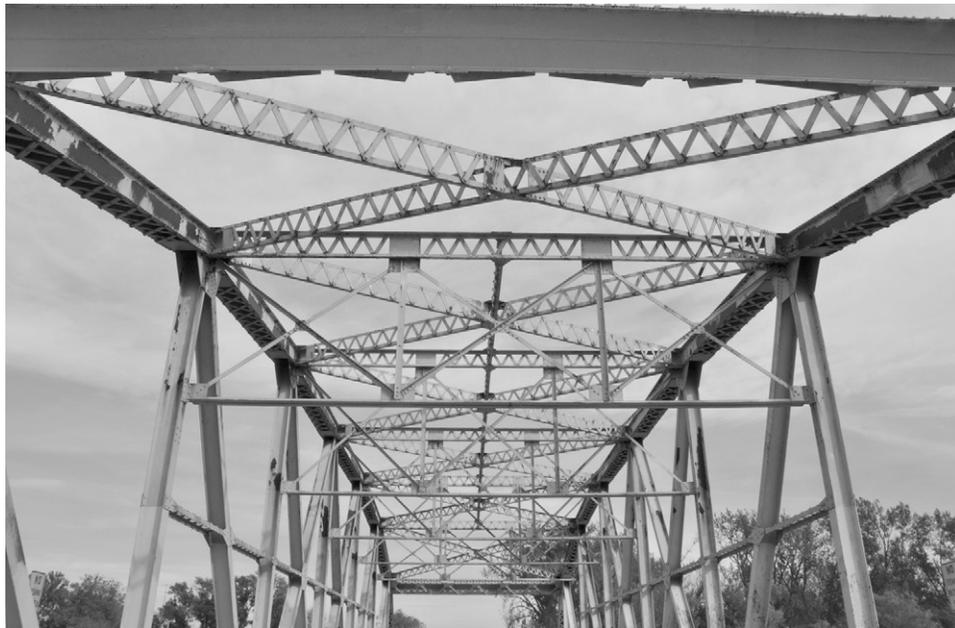
Fig. 184. XX-BRI-003. TH 40 Causeway: Bridge 5380, truss (facing NE)

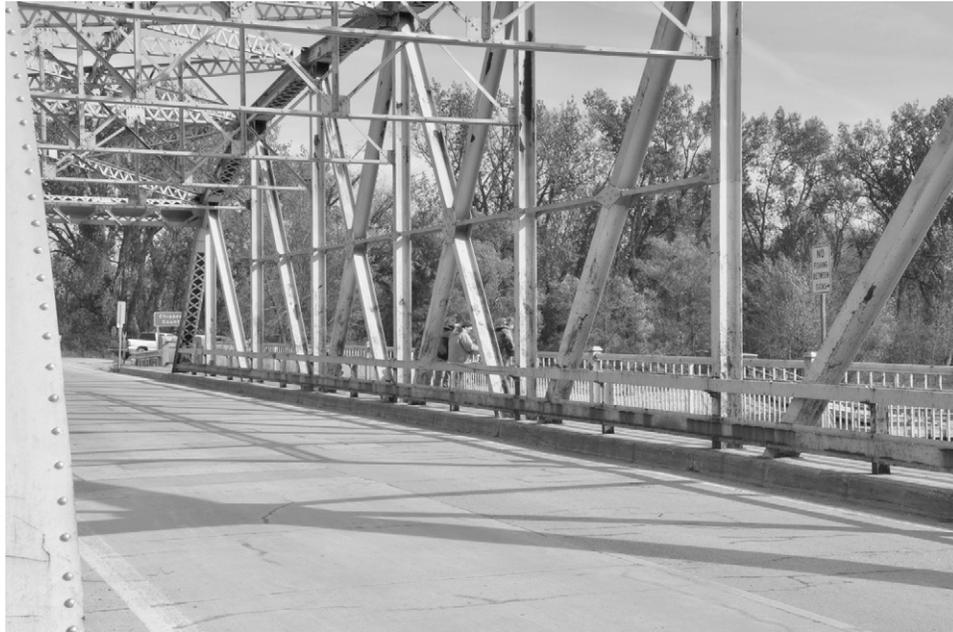
Fig. 185. XX-BRI-003. TH 40 Causeway: Bridge 5380, truss (facing E)
