**XX-ROD-002 TH 40 Causeway and Highway Segment**

**Other Name:** Milan Crossing, LQP Narrows  
**Location:** TH 40 from 750' NE of LQP CSAH 33 to 650' SW of Chippewa CSAH 30  
**County:** Lac qui Parle, Chippewa  
**Township:** Hantho Twp, Kragero Twp  
**TRS:** 119N 42W, Sec 19; 119N 43W, Sec 24-25  
**Built:** 1934-1941  
**Designer:** Meyer, Norling, MN Dept Hwys  
**Builder:** WPA, MN Dept Hwys

**XX-BRI-003 TH 40 Causeway: Bridge 5380**

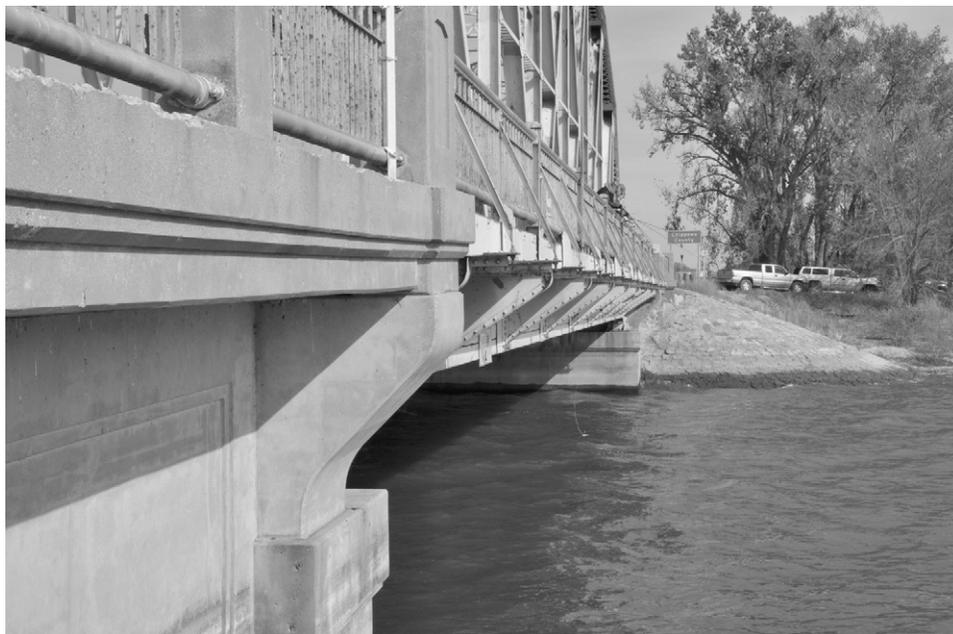
The bridge has poured concrete abutments with somewhat stylized classically-inspired detailing such as entablature-like molding, railing piers with recessed panels, and curving corbel-like forms that support the bridge approaches. The painted metal railings have closely-spaced verticals that are framed at intervals by square posts with classically-inspired caps, and supported at the ends of the bridge by thick poured concrete piers. A heavy metal ring is embedded in each of the four outermost piers, perhaps to support chains to close the bridge to traffic. The bridge has two 3'-wide walkways supported by triangular riveted brackets. The northeastern bridge plate reads "Federal Aid Project 11-A Minnesota 1938." The southwestern plate reads "Minnesota Highway Dept. Bridge No. 5380, 1938."

Fig. 186. XX-BRI-003. TH 40 Causeway: Bridge 5380, downstream side with southwest abutment at left (facing NE)

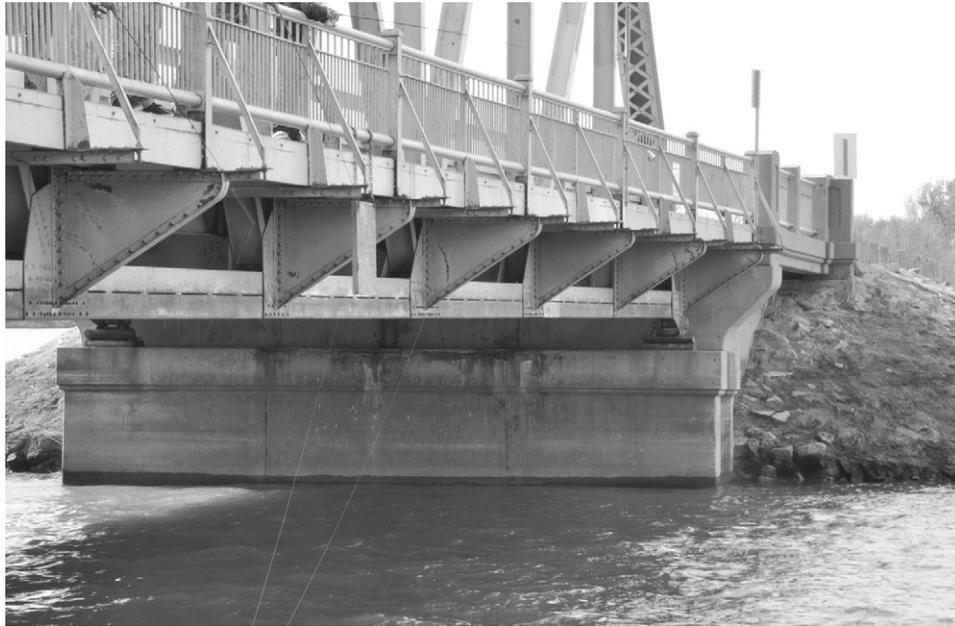
**Fig. 187. XX-BRI-003. TH 40 Causeway: Bridge 5380, upstream side and southwest abutment (facing S)**

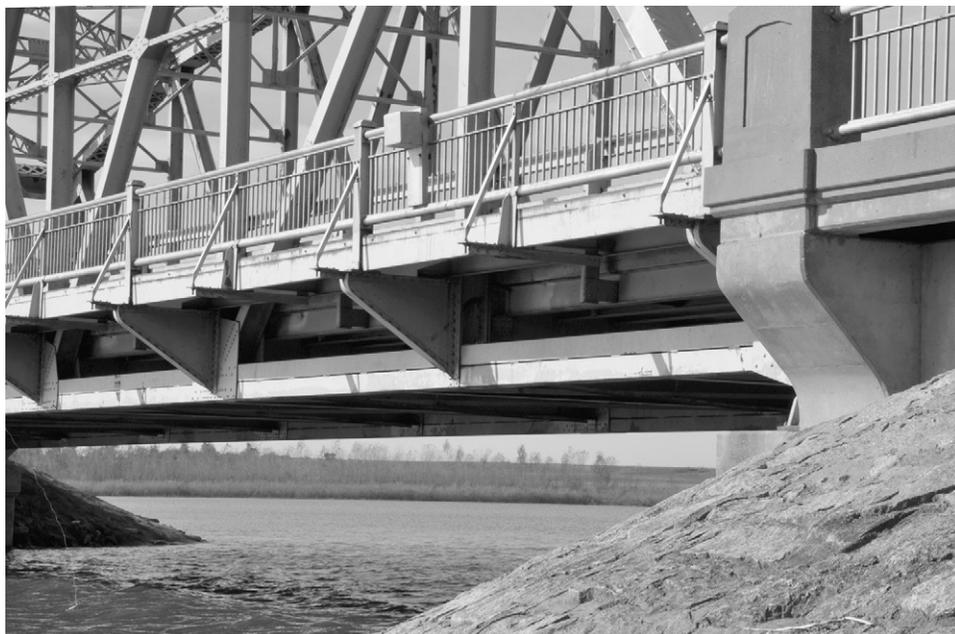
**Fig. 188. XX-BRI-003. TH 40 Causeway: Bridge 5380, downstream side, railing detail (facing W)**

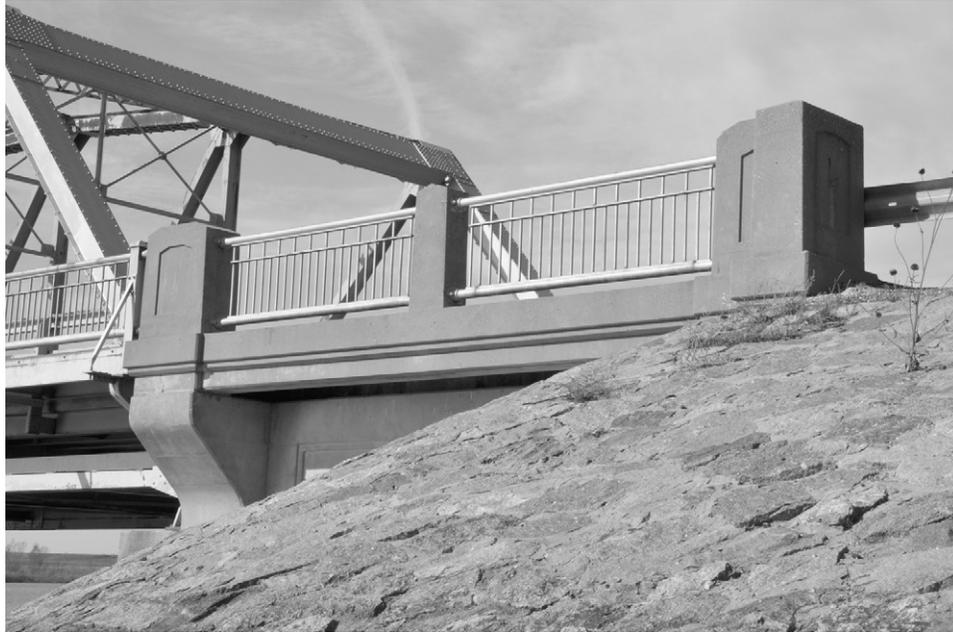
The causeway at each end of the bridge is protected by large areas of nicely-crafted, mortared, hand-fit granite riprap. See the TH 40 Causeway for more information.

**Fig. 189. XX-BRI-003.** TH 40 Causeway: Bridge 5380, downstream side, railing and hand-fit riprap at corner of bridge (facing W)
