Enhanced Crosswalks

What are enhanced crosswalks?

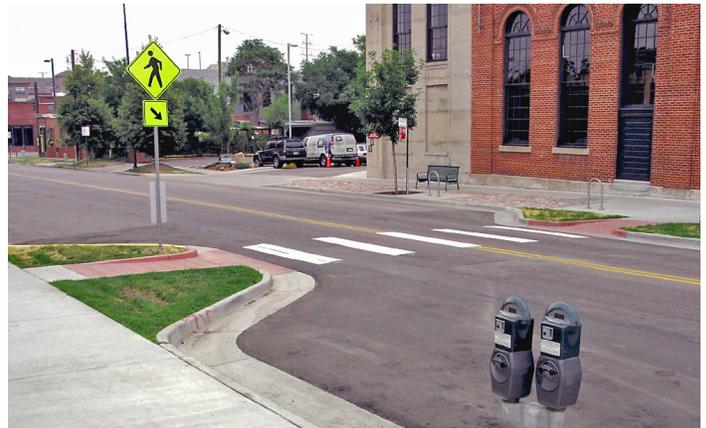
Curb Extensions and Median Refuge Islands are countermeasures that reduce crossing distances. In the case of median refuge islands, allow for pedestrians to cross one direction of travel at a time. These improvements are PROVEN effective with crash reductions in the range of 40 to 45 percent.²

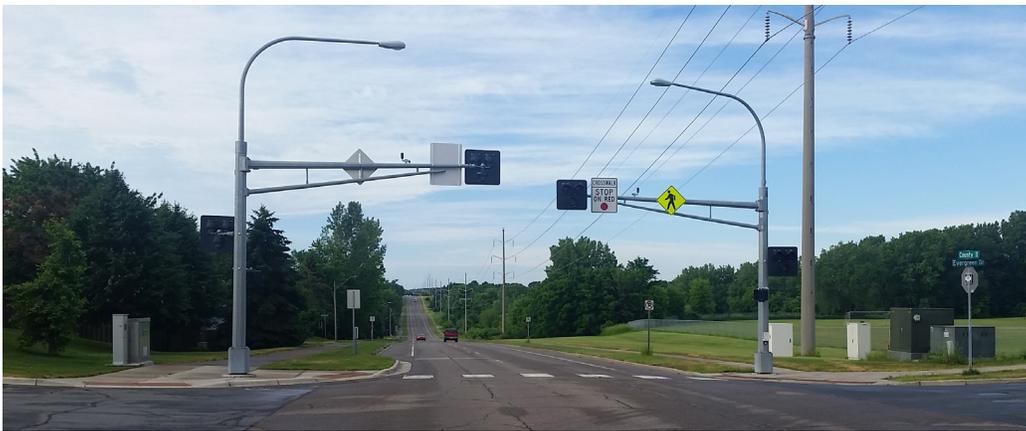
High-Intensity Activated Crosswalk Beacon

HAWK Beacons and RRFBs are relatively new technologies with promising initial research. HAWK beacons and RRFBs have crash reductions over 50 percent⁴, and RRFBs have documented high yielding rates to pedestrians in excess of 80 percent.⁴

- The addition of an RRFB or HAWK to provide approaching drivers with a warning of the presence of a pedestrian attempting to cross the road.
- Four-to-three-lane road conversions (road diet) since the multi-vehicle threat occurs on roads with more than three lanes. **END**

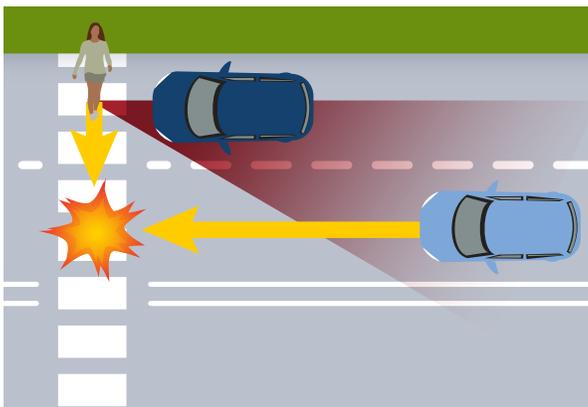
A specific type of conflict at marked and unmarked crosswalks is the multi-vehicle threat. This conflict occurs on multi-lane roads when a vehicle in one lane stops for a pedestrian and a trailing vehicle (in the same direction) in an adjacent lane potentially hits the pedestrian when they emerge from in front of the stopped vehicle. This type of crash occurs as a result of both the pedestrian and driver failing to see one another.
